WARE CONSERVATION AREA APPRAISAL AND MANAGEMENT PLAN

ADOPTED JULY 2016

East Herts District Council
Pegs Lane, Hertford, SG13 8EQ

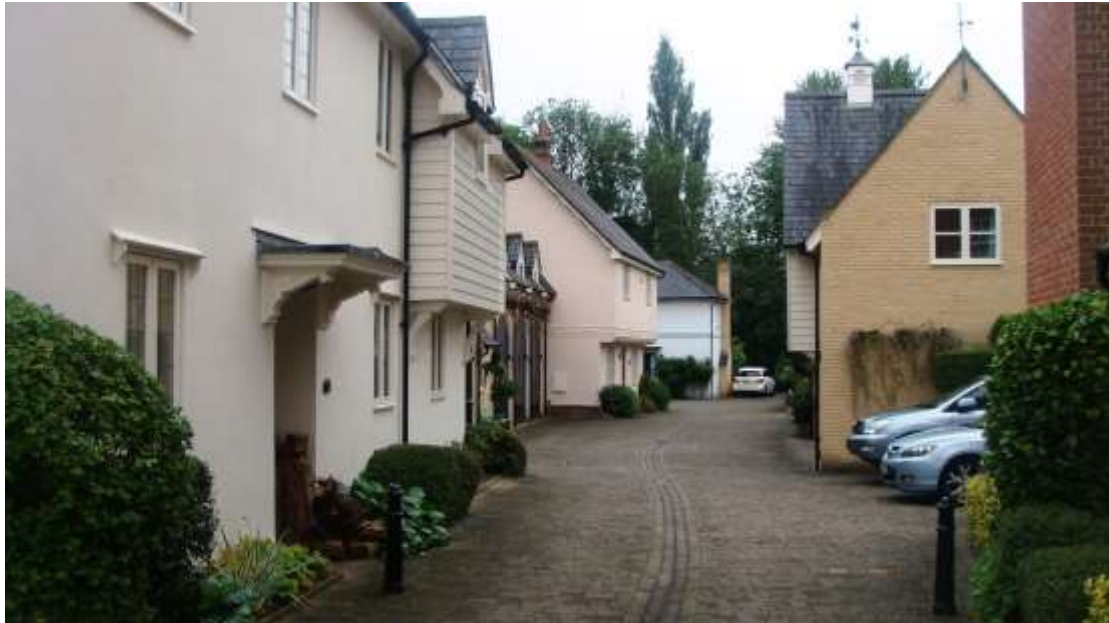
Picture 3. Christopher Court represents a satisfactory safe and traditional design solution. Its use of materials and surfaces is harmonious and reflects the traditional built form of some elements of its historical neighbours. However there is also a place for more contemporary solutions some would say.

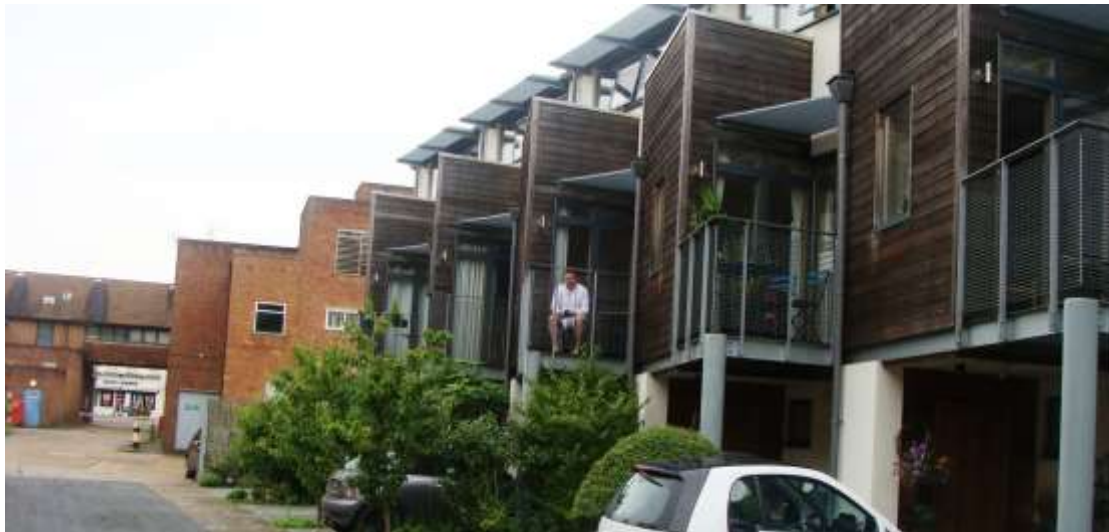
Picture 4. Swan Mews represents a contemporary solution that will not be to every persons taste but history shows with such designs that as time passes appreciation grows.

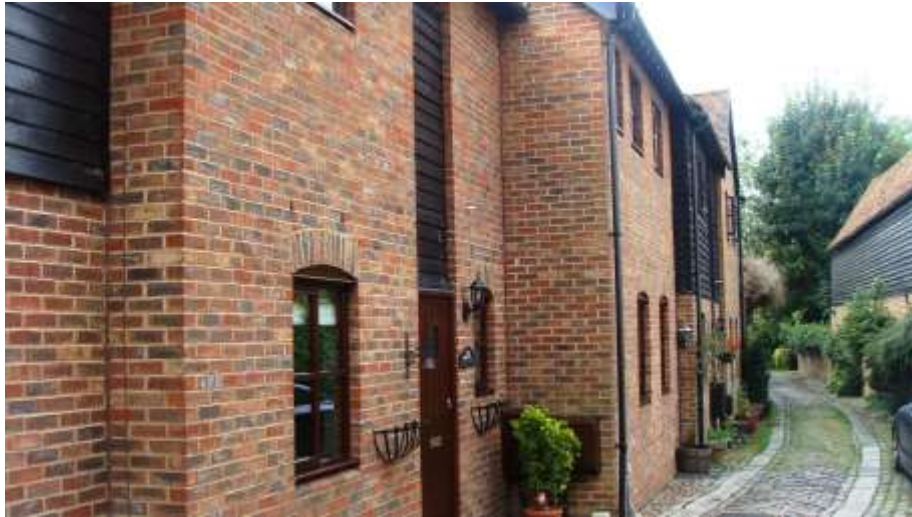
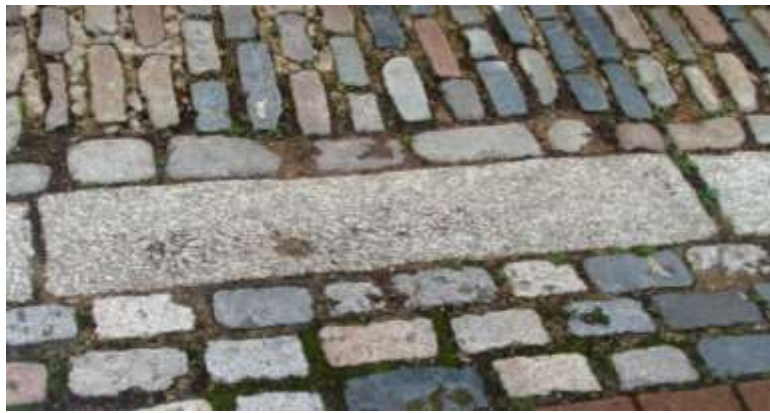
Pictures 5-6. George Walk rear of High Street and between River Lea in same general location as above two examples. A traditional successful solution with use of traditional materials. Simple but effective design. Very importantly the original surfacing has been retained.

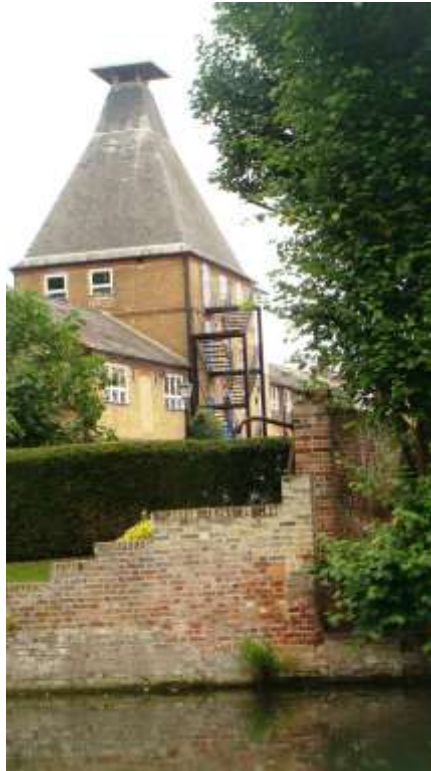
Picture 7. Prominent feature of a converted historic building prominent in the townscape. It is very important that the limited number of such symbols of Ware's past are retained.

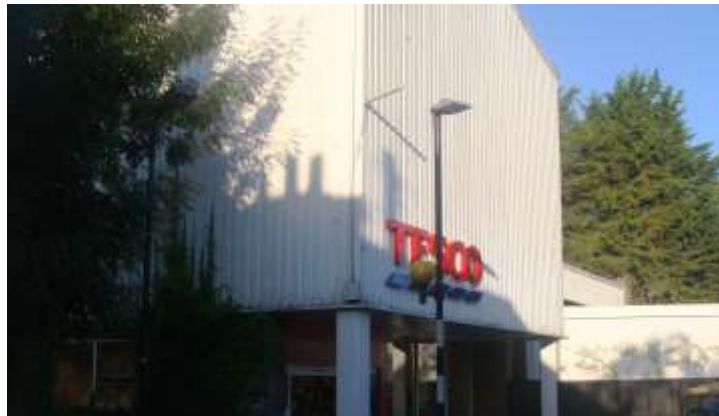
Picture 8. The satisfactory integration of large scale commercial premises in relatively small scale historic environments will always be difficult.

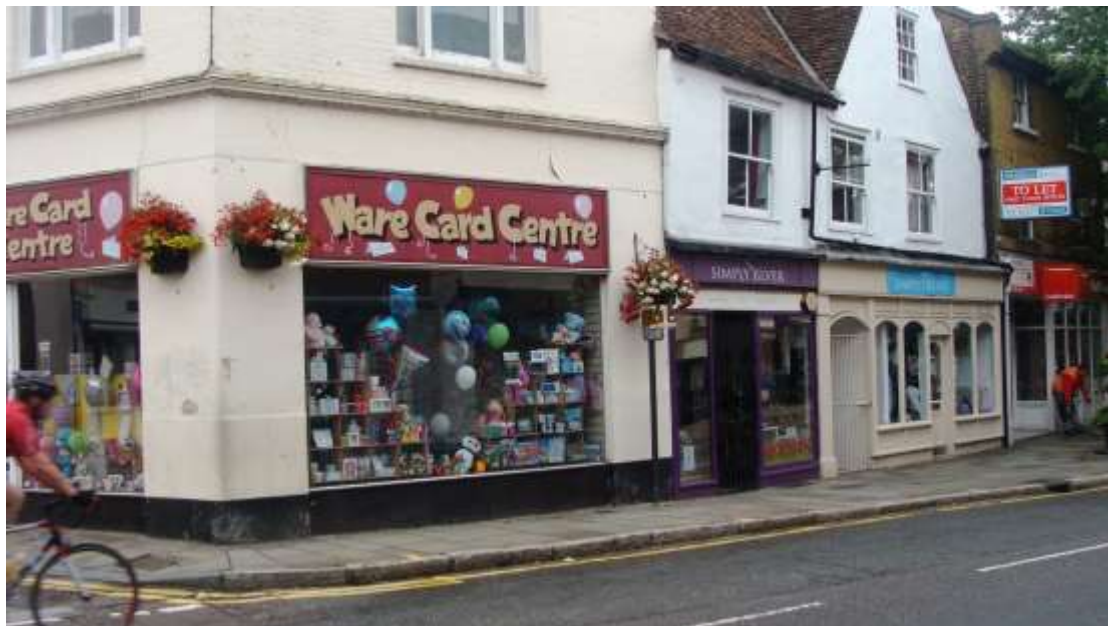
5.4. Shop facias. Throughout the town centre including the High Street where the highest concentration of quality listed buildings is located there are examples of poor sign and facia design that detract. There are District Plan policies relating to shop fronts and advertisements. Whilst the views of the shopkeeper and the planner may appear to differ this should not be the case as both parties have the same general objective of securing the viability of shopping centres which can be achieved in part by creating a high quality environment which attracts new businesses and shoppers. The Council has produced a number of Conservation Area guidance notes including a leaflet on shop fronts which is available on line. A number of Councils elsewhere in the

Picture 9. Some shop fronts display eye catching displays that many would consider inappropriate to the historic environment. It is not only the individual property that is affected but also its historic neighbours.

country have produced similar guidance and it may be worthwhile contacting a selection and exploring this subject further (see below).

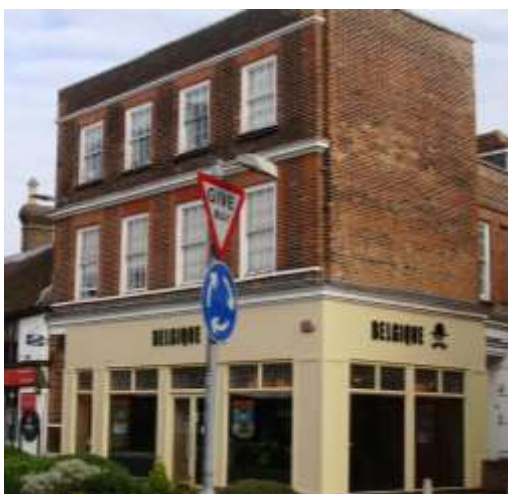
5.10. No.12 High Street - Grade II. Former maltsters house became shop late 19th century. Front range 3 storeys. First and second floors, 4 sash windows with glazing bars flush-set with exposed boxes, under rubbed flat arches. In the 18th century the house was the home of the Burr family, prominent Quaker maltsters, and the Friends Meeting House (demolished 1889) was directly behind. *This building no longer appears on the Councils Heritage at Risk Register following recent improvements and restoration and occupation of the ground floor. However upper windows still appear to be in need of restoration.*

Picture 10. No. 12 High Street. Removed from Register following improvements and occupation of ground floor - condition of upper windows need repairs.

5.48. Elements out of character with the Conservation Area. Upper windows to no. 12 High Street need repairs. No. 19 Church Street - important Listed Building in decline – has been included on the Council's Heritage at Risk Register - untidy site - potentially eligible for grant assistance. Poor condition to front elevation to no. 92 High Street - Wok u Like. Poor condition to rear elevation of listed building 96 - 96A High Street (see photos above in respective sections). Poor condition to rear elevations of listed buildings No.77 and No. 79 High Street.

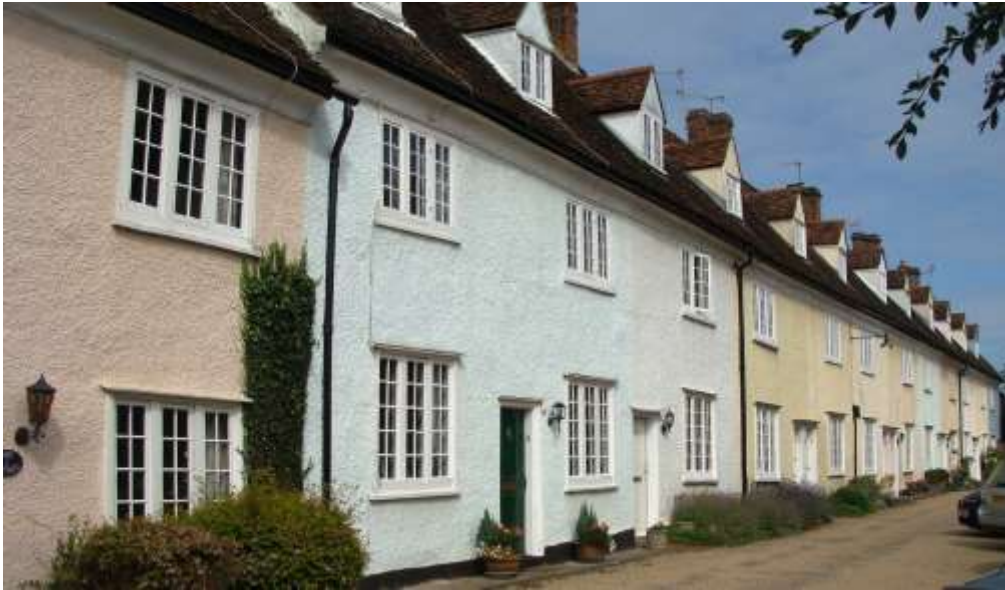
5.11. Nos. 3-12 Bluecoat Yard - Grade II*. Terrace of 10 houses, all one building, built as 'nurse cottages' for Bluecoat School. Circa 1687-89. Timber-framed, plastered, pebbledashed and colourwashed, old tiled roof above coved plastered eaves cornice, with one gabled casement dormer to each dwelling, 5 red brick chimneys, 2 storeys and attics. Behind each dwelling, and linked in some by a covered passageway, is a single storey continuous range of washhouses, mid 19th century. Christ's Hospital purchased the Bluecoat Yard buildings in November 1685.

Picture 11. 17th century 'nurses cottages' for Bluecoat School.

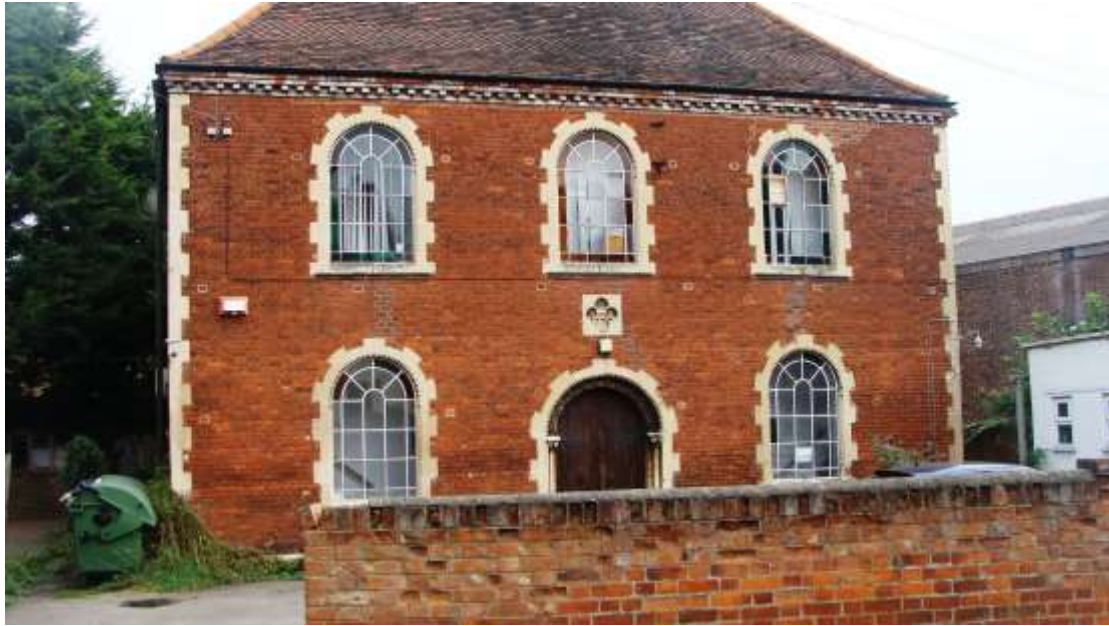
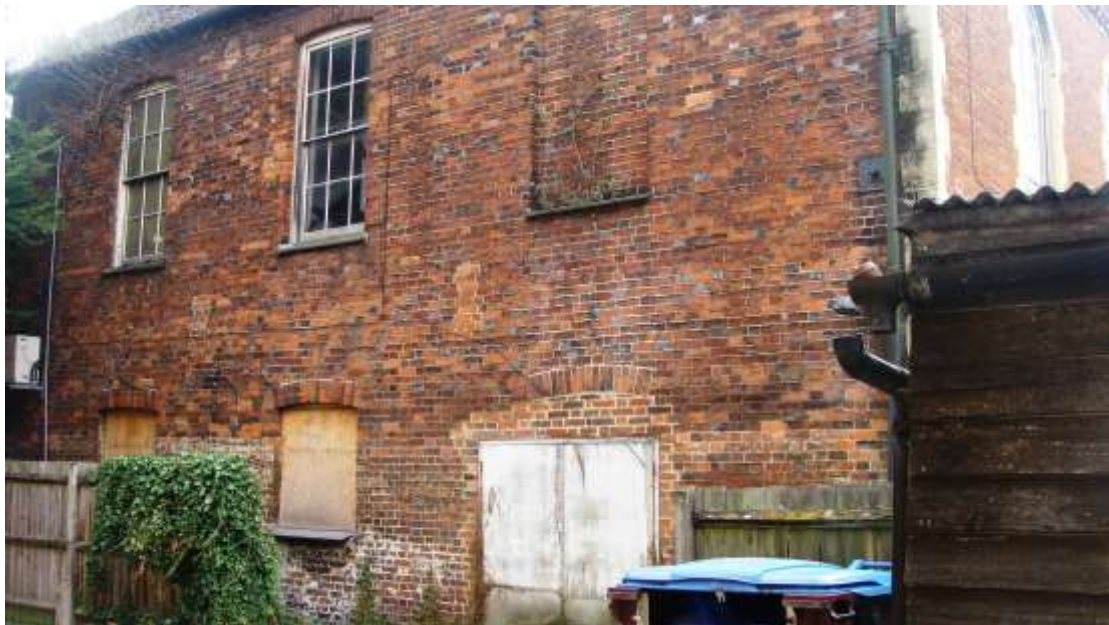
5.12. No.19 Church Street, former old independent chapel - Grade II. Chapel now subdivided as printing works and offices (*i.e. at the time of listing*). 1778, altered mid 19th century. Dark red brick with both stone dressings and quoins, old tiled roofs, hipped. Bands of fish-scale tiles. Brick dentil cornice. Central entrance with mid 19th century Neo-Norman arched surround with colonnettes and zig zag ornament. Above is stone panel, 19th century bearing date of original construction, 1778. Arched windows with glazing bars and quoin surrounds, and zig zag ornament. Built as Independent Chapel, first Minister, William Goodwin, a radical writer, who became father-in-law to the poet Shelley. The Old Independent Chapel closed in 1918, and was subsequently used as a church hall, Masonic Hall, United Services Club, auction room and **printing works**. *This building is in a deteriorating condition and has been included on the Council's Heritage at Risk Register. Seek to remedy through the planning process.*

Pictures 12-13. The high quality and deteriorating condition of no. 19 Church Street- building now included on the Council's Heritage at Risk Register.

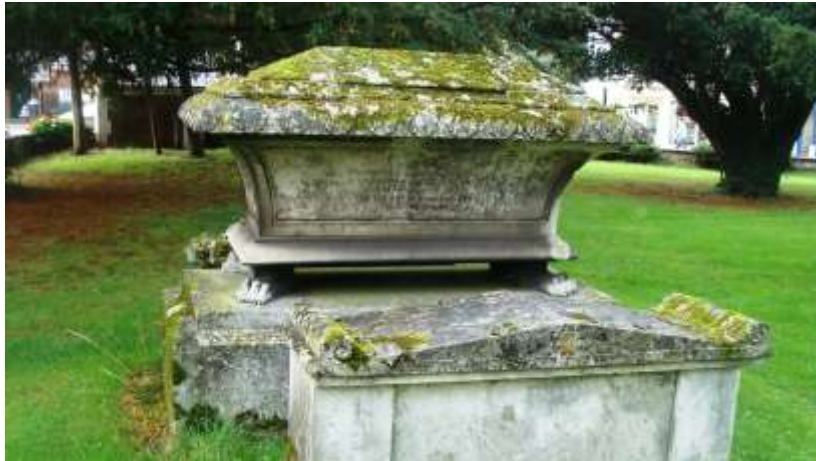
5.13. Edward Chuck tomb in west churchyard, Church Street - Grade II. 1852. In the form of a sarcophagus on a stepped plinth, all in Portland stone. Neo-classical design raised on 4 claw feet. Moulded base, coved sides with inscribed panels, overhanging top, with surround of carved leaves, and raised lid. Edward Chuck (1782-1852) was the principal maltster in Ware. For the last 20 years of his life he resided at No.87 High Street. He was killed in a carriage accident. His widow Elizabeth Moore Chuck is also interred in the tomb.

Picture 14. The Edward Chuck tomb in the west churchyard - a fine example of its type and period.

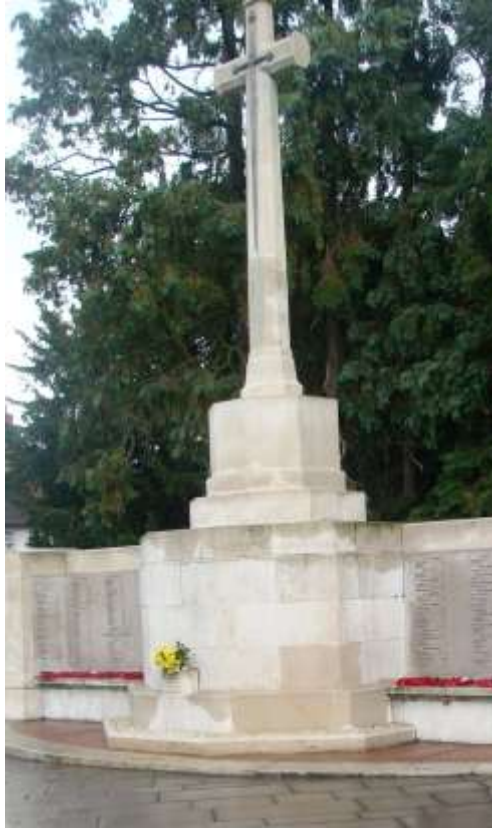
5.16. War Memorial - Grade II. 1921. Designed by Sir Reginald Blomfield. Portland stone memorial, incorporating central 'cross of sacrifice', with octagonal shaft and arms, with bronze sword fixed to face.

Picture 15. The prominent and centrally located War Memorial, erected 1921.

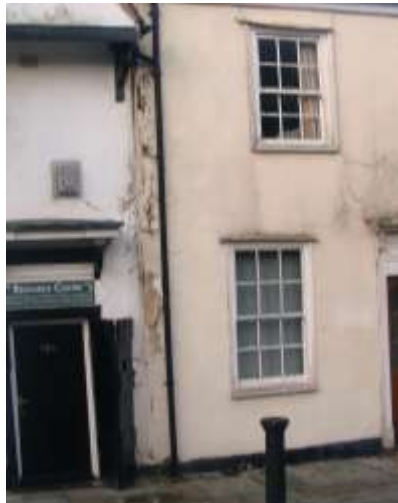
5.17. Nos. 96 - 96A High Street, Rear elevation to West Street. Listed buildings in deteriorating conditions. Source owners and seek their co operation in carrying out remedial works.

Picture16. Nos.96 - 96A High Street facing onto Tudor Square. Remedial works required.

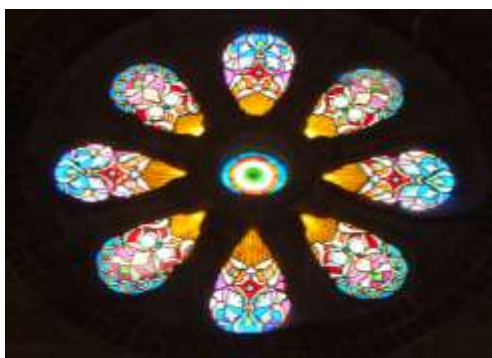
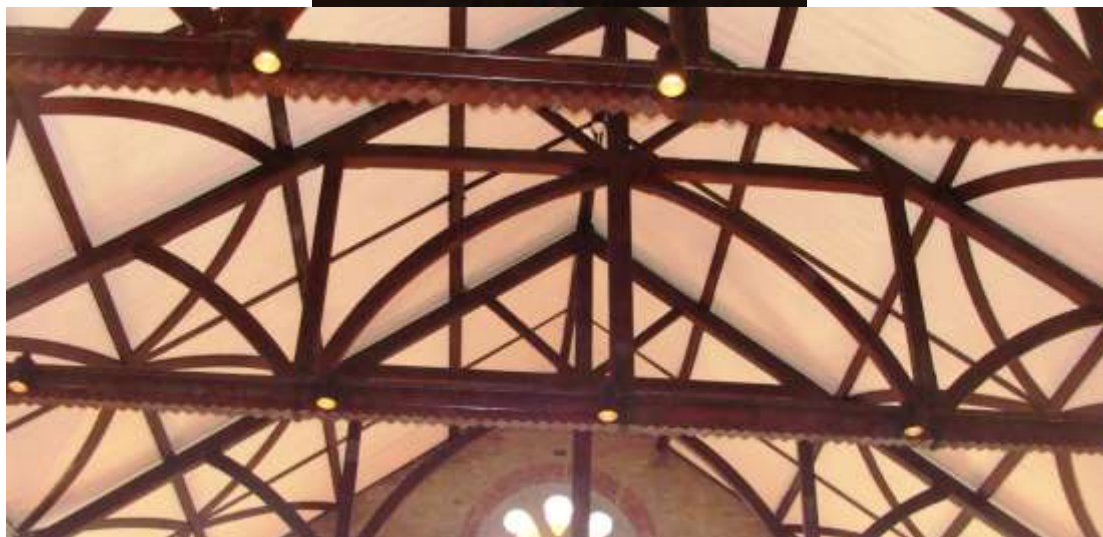
Pictures 17-18. Internal detailing - Leaside Methodist Church.

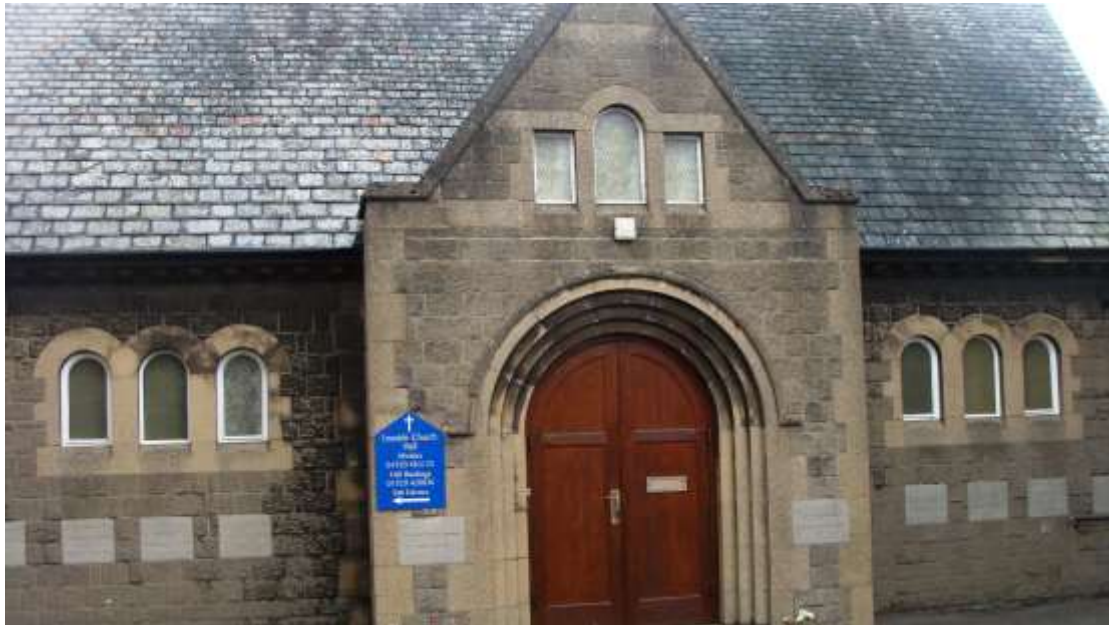
and West Street. In part this was because access to some areas was not available at the time of survey. The detailed processing of future applications may reveal other such buildings. Leaside Church Hall. Interpreted as being in the curtilage of Leaside Methodist Church and United Reform Church, the latter being a grade II listed building. Stone detailing and window surrounds. Prominent central entrance. Slate roof.

Picture 19. Leaside Church Hall a good quality building of its type.

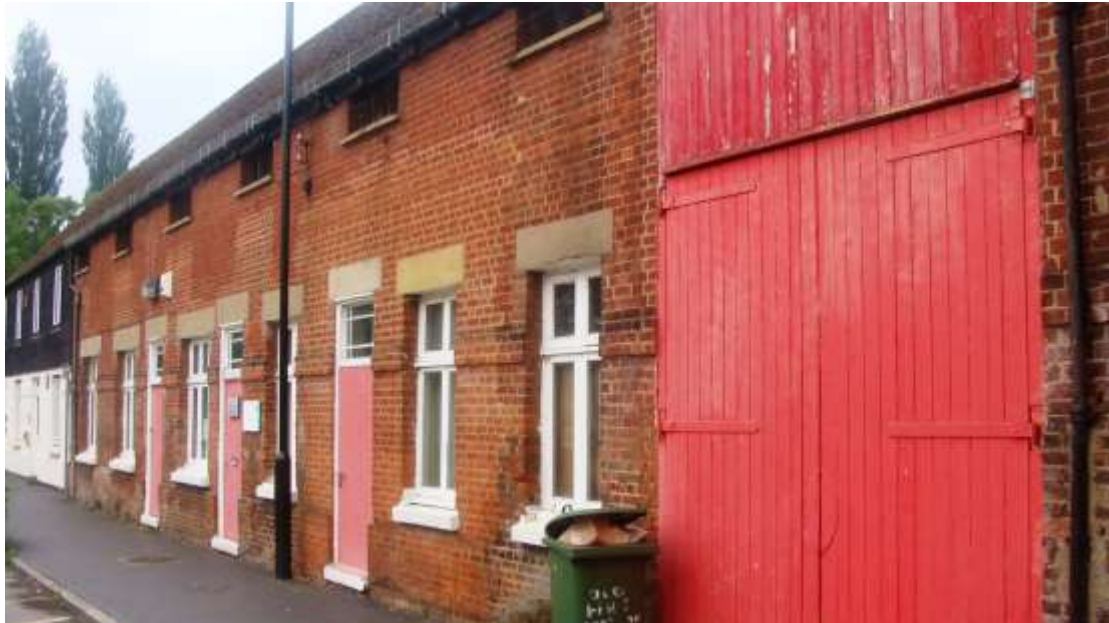
5.22. Ware Neighbourhood Police Station and Hertfordshire Social Care, Entrance to Burgage Lane. Two storey, principally of brick construction with tiled roof. Early door detailing being entrance to the old Fire Station? Opportunities for repainting/ refurbishment. Repairs to window/door frames. Modest expenditure and the introduction of a coordinated colour painting scheme could secure significant visual improvements to this building fronting a public car parking space. Detail administered by existing planning controls.

Picture 20. Simple building identified on modern mapping as being 'The Old Fire Station' that should be retained. Some coordinated repainting/refurbishment would be beneficial.

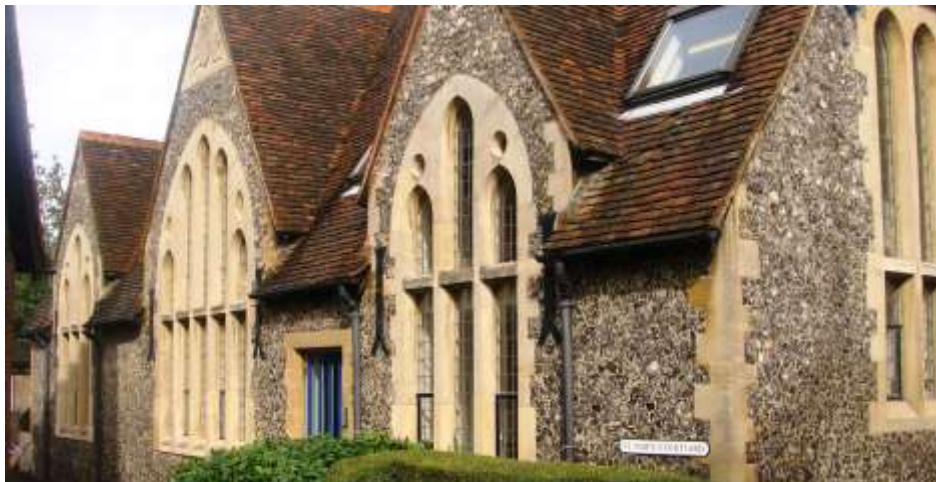
5.23. Group of buildings in various non residential uses, St Mary's Courtyard. Late 19th century in appearance and interpreted as having been part of former school complex that occupied the site. Flint and brick construction with tiled roofs and chimneys. Many good quality original features including fine stone window detailing to no.1 St. Mary's Court. Later plaque commemorating restoration in mid 1980's. As buildings are in commercial use retention of detail administered by normal development control.

Picture 21. Fine window detailing interpreted as being originally part of 19th century National School that existed on this site.

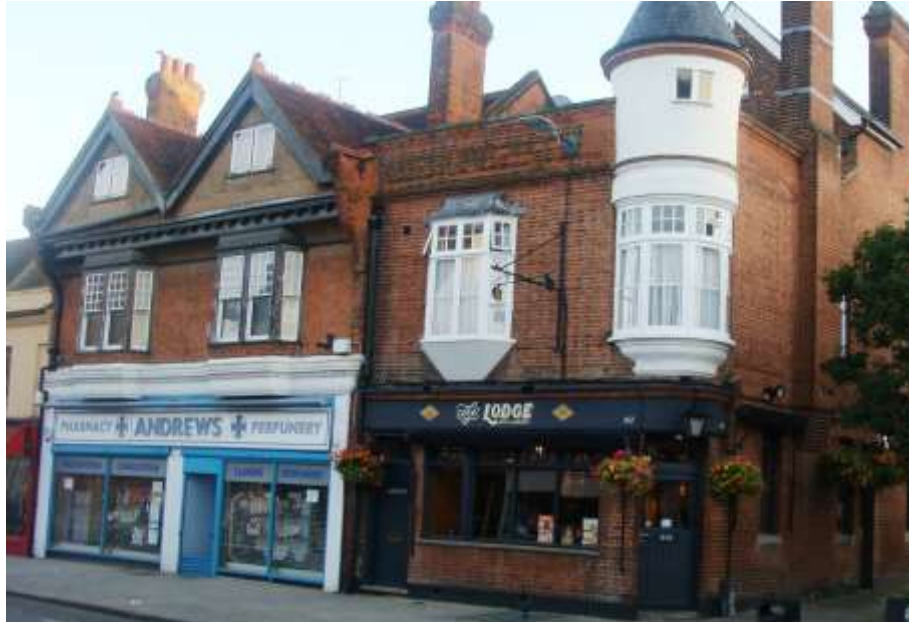
5.24. Andrews Pharmacy and The Lodge - High Street. Interesting range of commercial properties to ground floor, 19/20 century in appearance. Complex tiled roof structure with tall brick chimneys, some decorative ridge tiles. Oriel window detailing including circular corner detailing and turret. An unusual grouping worthy of retention. A more co-ordinated

Picture 22. Interesting commercial premises High Street where a more coordinated shopfront and facia design would be most beneficial to the townscape.

and sympathetic facia design would be most beneficial. Retention of commercial and ancillary use detail administered by normal development control.

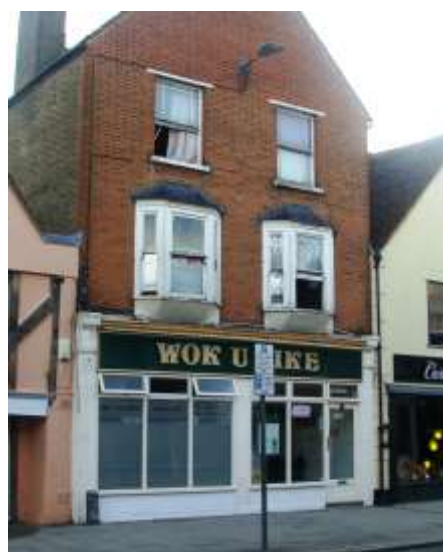
5.25. No. 92 High Street - Wok u Like. A tall building with early window detailing to first and second floors. Bay windows to first floor. In some respects a mediocre building but bay windows features worthy of retention. In need of repairs but as it is not listed it is not a candidate for the Council's Heritage at Risk Register. However the owner's cooperation in undertaking necessary repairs should be sought.

Picture 23. A prominent shop in the High Street in urgent need of restoration and improvement. The dominant nature of the facia detracts.

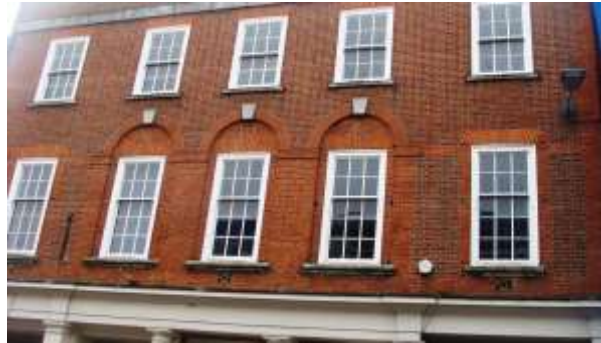
5.27. Former Sorting Office - south side High Street. Ground floor now Saffron Walden Building Society offices. Red brick façade above with two ranges of early/original vertical sliding sash windows with central three to first floor having semi circular red brick arched detailing.

Picture 24. Former sorting office, now ground floor occupied by Saffron Walden Building Society. A good quality non listed building of late 19th/early 20th century appearance that contributes to the quality of the street scene with features that should be retained via normal planning control.

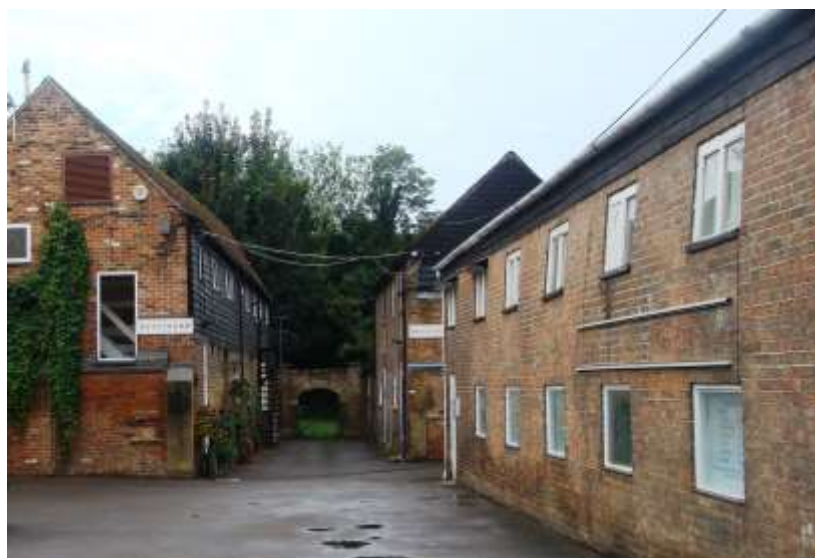
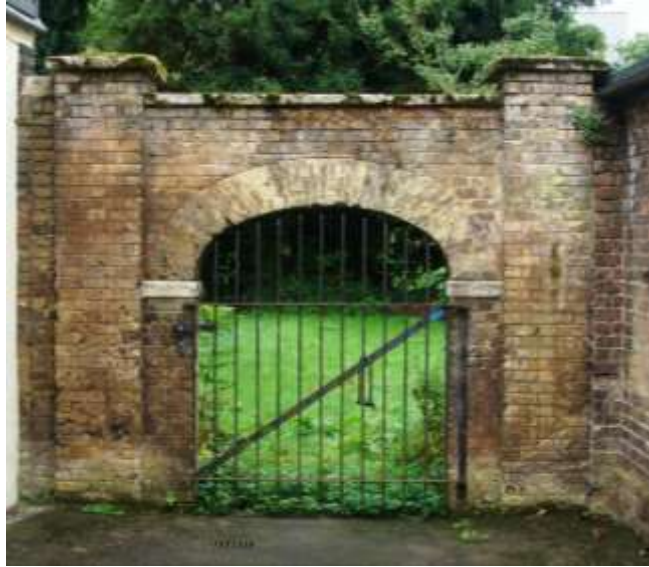
5.29. Commercial properties (Bailey Gomm) to rear of High Street. A range of commercial properties constructed of brick tiled roof and some weather boarding. Presumed to be former 19th century malt houses, whose historic presence and linear form dominated this area. Distinctive gate providing access to the river Lea beyond.

Pictures 25-26. Former Maltings buildings linked by distinctive archway and gate, providing access to river Lea beyond, probably of 19th century date.

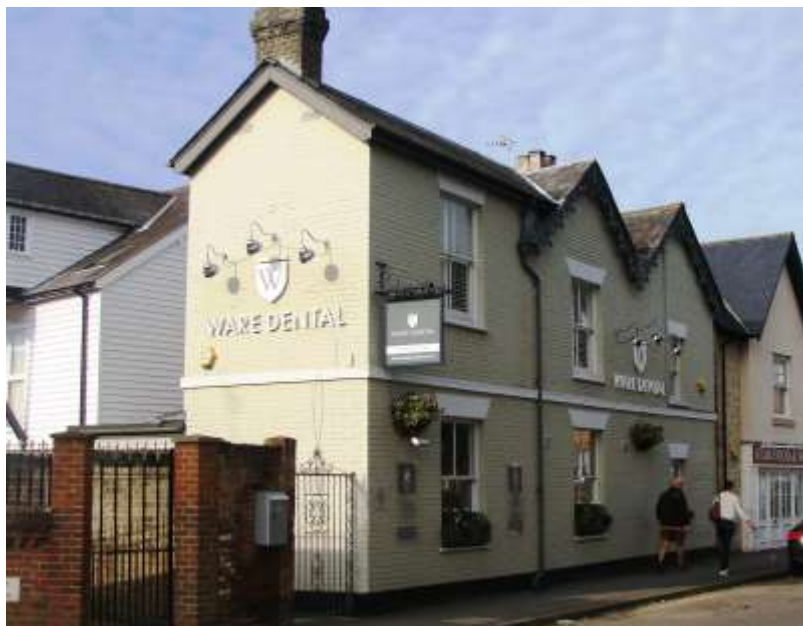
5.30. Ware Dental building - Star Street. Tall narrow painted brick two storey late 19/early 20th century building with slate roof chimneys with pots. Adds to quality of the street scene in this location and now included within the Conservation Area.

Picture 27. Ware Dental building Star Street, a small extension to the Conservation Area now includes this building.

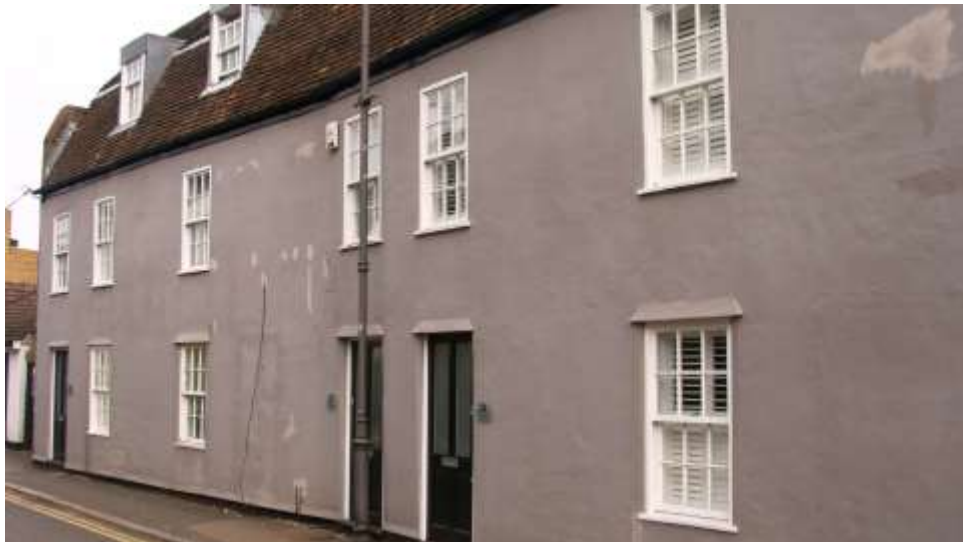
5.32. Nos. 22 - 24 Church Street. 19th century of earlier. Rendered two storey building with dormers in slate mansard roof. Vertical sliding sash window detailing to common design. An Article 4 Direction to provide protection for selected features may be appropriate subject to further consideration and notification.

Picture 28. Nos 22 - 24 Church Street. An interesting building whose common window design to ground and first floors is harmonious.

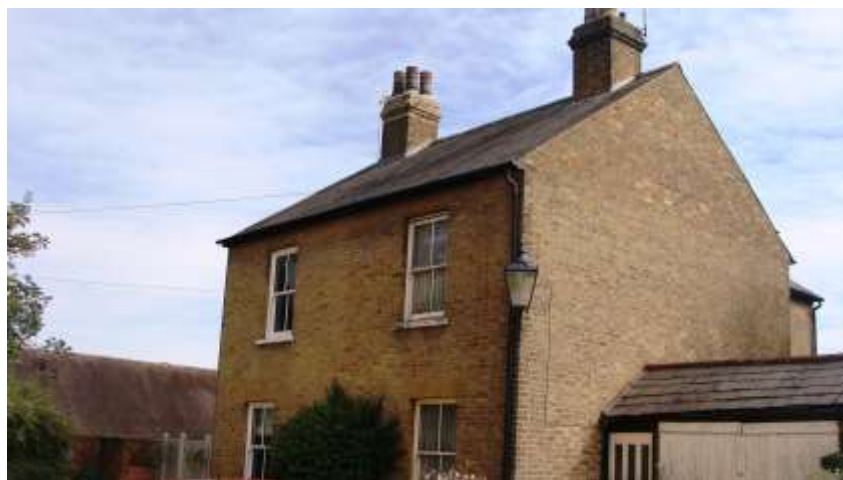
5.33. Nos. 14 - 15 Bluecoat Yard. Two storey cottages of early 20th century date of yellow brick construction with slate roof and chimneys with pots. Early/original windows. Original street lamp attached? An Article 4 Direction to provide protection for selected features may be appropriate subject to further consideration and notification.

Picture 29. Early 20th century pair of cottages - Bluecoat Yard, worthy of retention adding to the general visual and historic interest of this most important area.

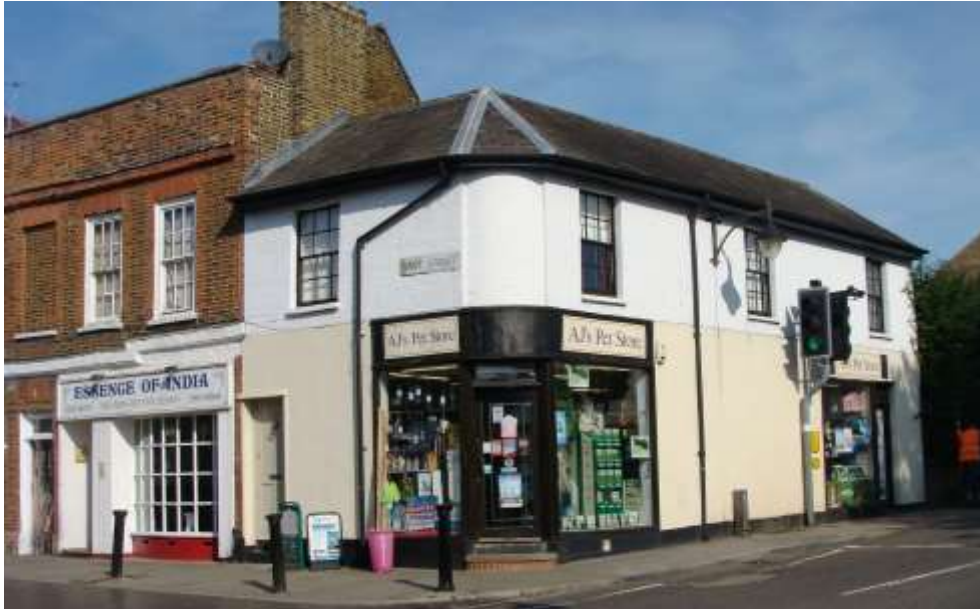
5.34. AJ's Pet Store corner of East Street/New Road. Small 19/20th century commercial building with slate roof. Provides a different style and scale in comparison with adjoining listed properties on East Street, thus adding interest and diversity to the street scene in this location.

Picture 30. Small scale commercial building whose different scale and historic detailing adds visual interest and diversity to the street scene.

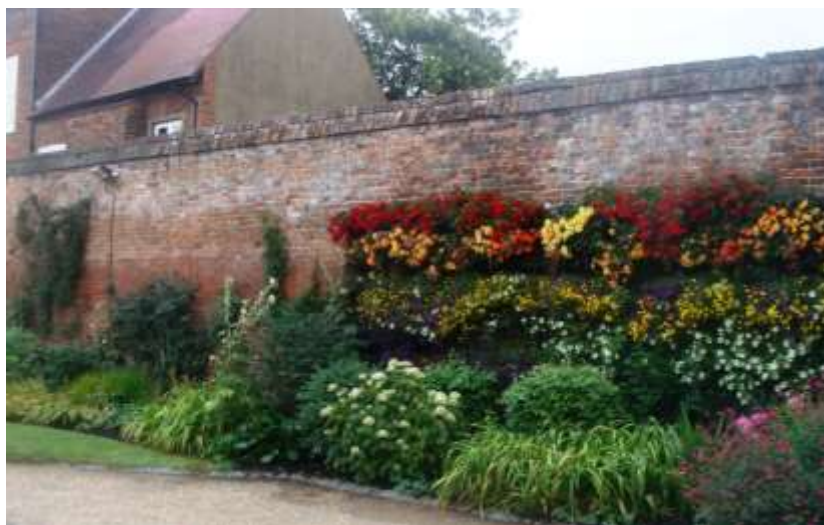
5.36. Impressive tall red brick wall to west of no. 87 High Street forming boundary with The Priory.

Picture 31. Tall red brick wall to west of no. 87 High Street forming boundary with The Priory.

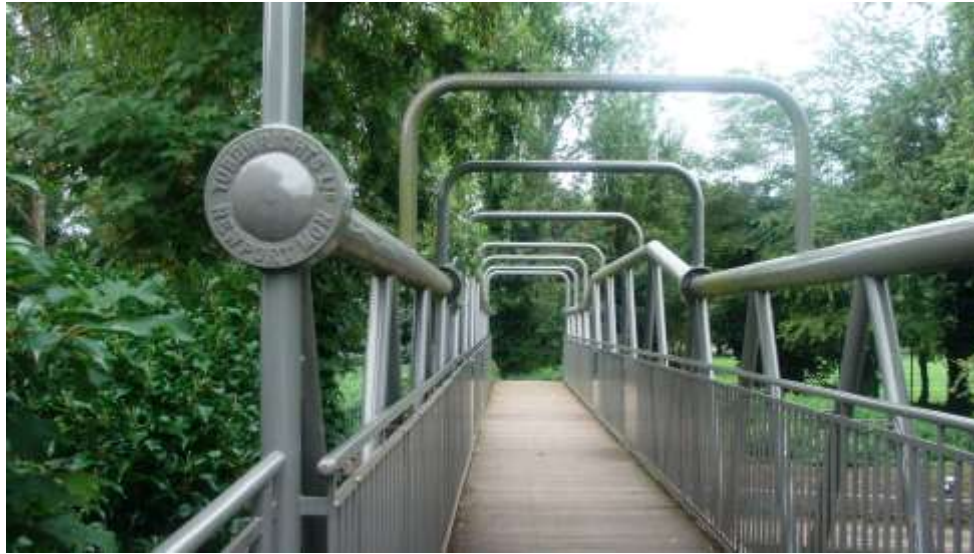
5.37. Contemporary bridge over river inscribed with maker's name, Tubewrights Ltd. Newport Mon.

Picture 32. Fine contemporary footbridge. Modern architectural solutions certainly can be appropriate in an historic location.

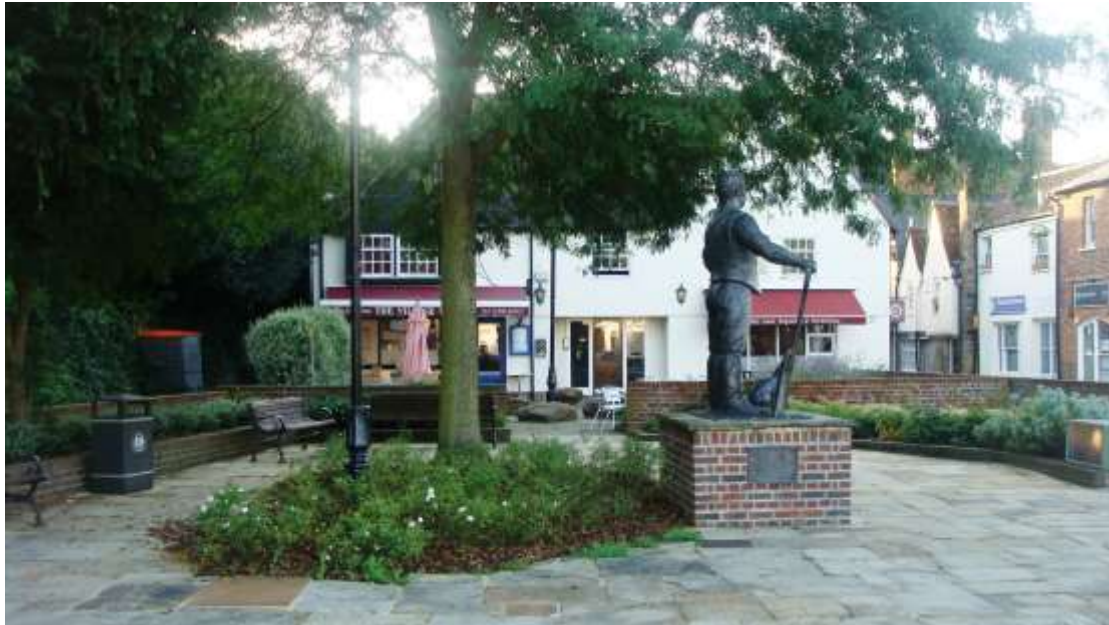
5.43. Malt makers Garden (Margaret Davenport Garden of Remembrance). This garden provides an important and pleasant open space with seating in a key location. It is maintained by the District Council who perhaps might consider whether further improvements can be achieved.

Picture 33. What is the general opinion of the quality of this important open space in a key historic location?

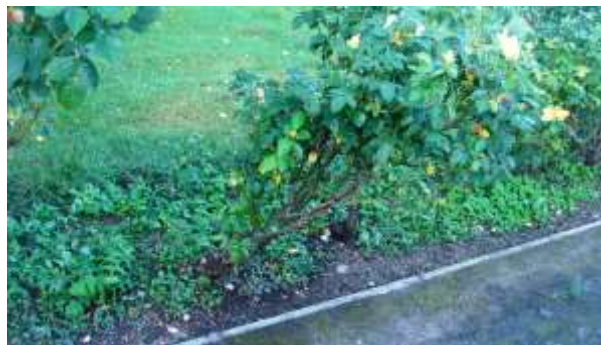
5.44. Main churchyard. A fine open space providing a setting for one of the principle historic buildings in the town. A formal avenue of Lime trees traditional to churchyards adds real quality. The area adjacent to Church Street requires some attention including the permanent removal of self set sycamores. In landscape terms the presence of Rose bushes is questioned on two counts. Firstly there is the issue of high maintenance and incidence of a large weed presence in their earth beds. Secondly there is a question mark about the visual contribution they make to the essential open nature of the churchyard. Perhaps when they reach the end of their lives thought can be given as to the wisdom of replacing them.

Picture 34. Rose bushes in the churchyard. Would not a simpler and easier solution be to replace them and problematic earth beds (seasonally weedy) seeded with grass at their eventual demise?

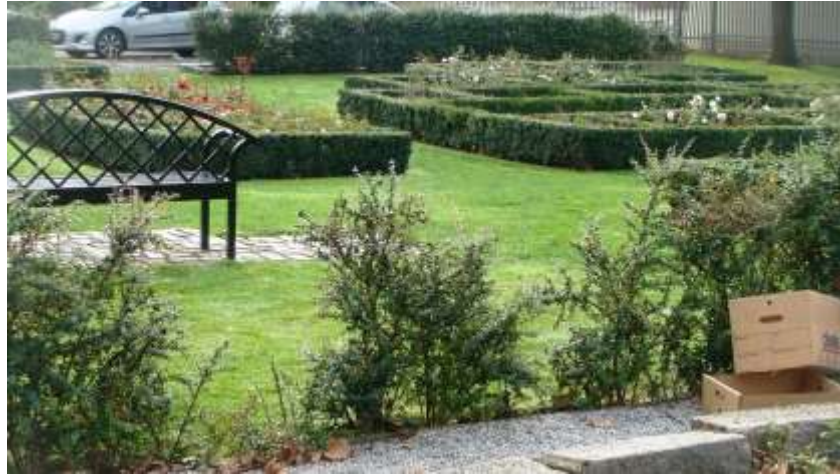
5.45. Former Quaker burial ground Kibes Lane. This is an important open space located between two areas of car parking. It is laid out in a formal manner with good quality seating provided by the Ware Society. However it lacks a sense of enclosure and the rather bedraggled

boundary hedging does not formally define the edge in a fitting manner. It is suggested landscape advice be sought. Also small area of open space with trees, corner Kibes Lane/Bowling Road.

Picture 35. Former Quaker burial ground - Kibes Lane. It is considered this generally attractive and historically important open space lacks a sense of enclosure and could be improved by a more satisfactory and effective boundary treatment.

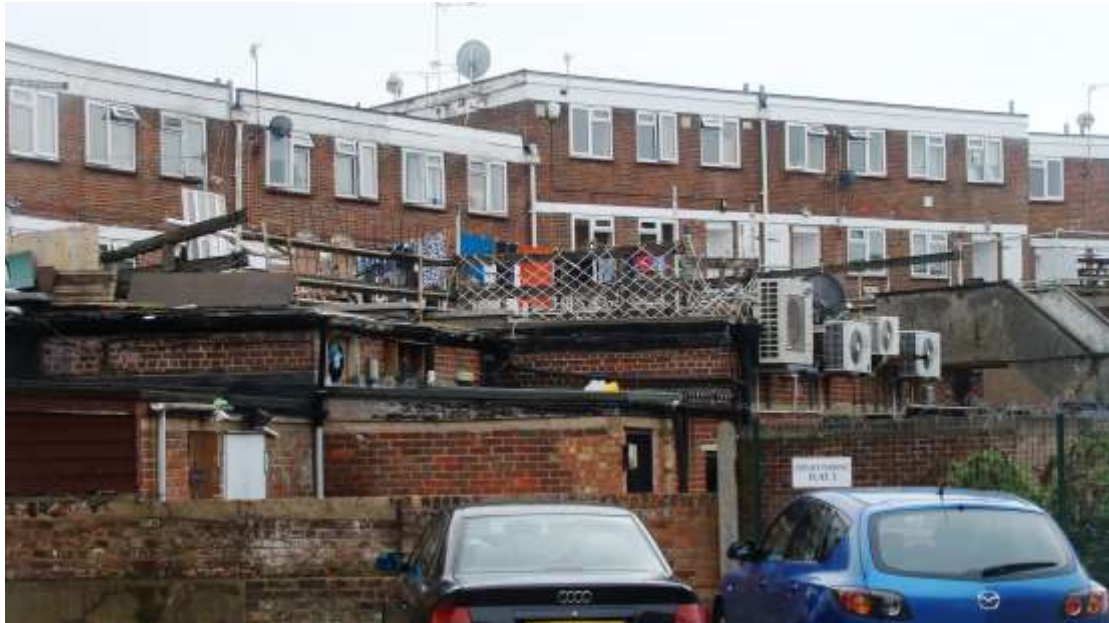
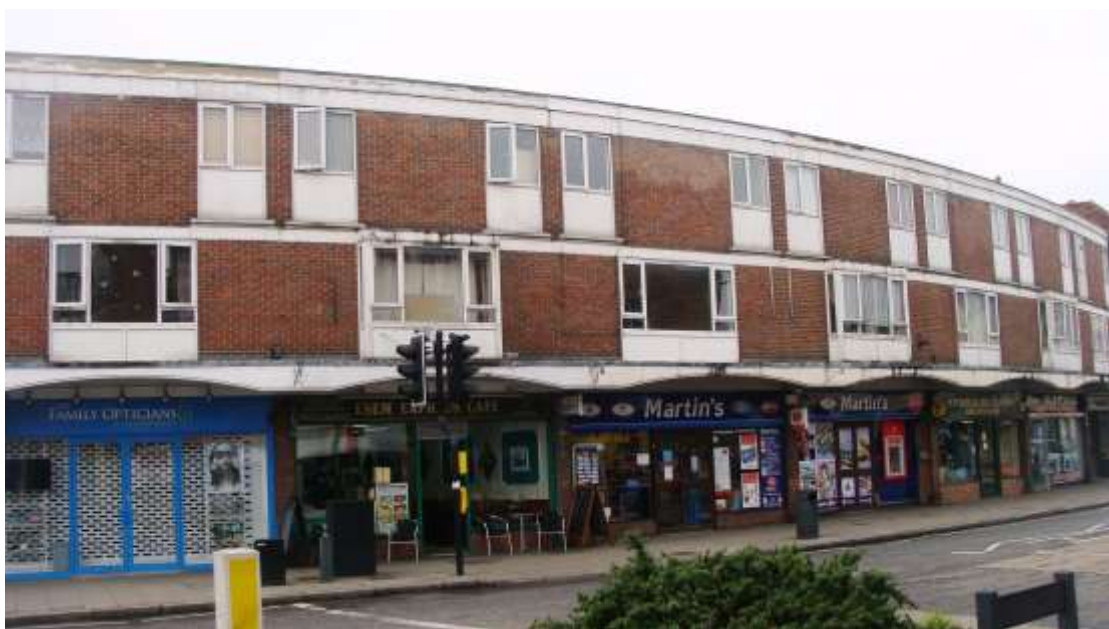
5.49. Strategic corner east end of High Street /Bridge Foot. A poor quality mid 20th century development with car park to rear located in a key historic location backing on to the river. It detracts from the high quality neighbouring buildings. Perhaps the identification of this site in the Appraisal may generate interest for appropriate redevelopment.

Pictures 36-37. Modern mid 20th century development in strategic historic location at east end of High Street whose scale and quality detracts. Should there be future interest in redevelopment great care will need to be exercised in achieving a satisfactory design solution.

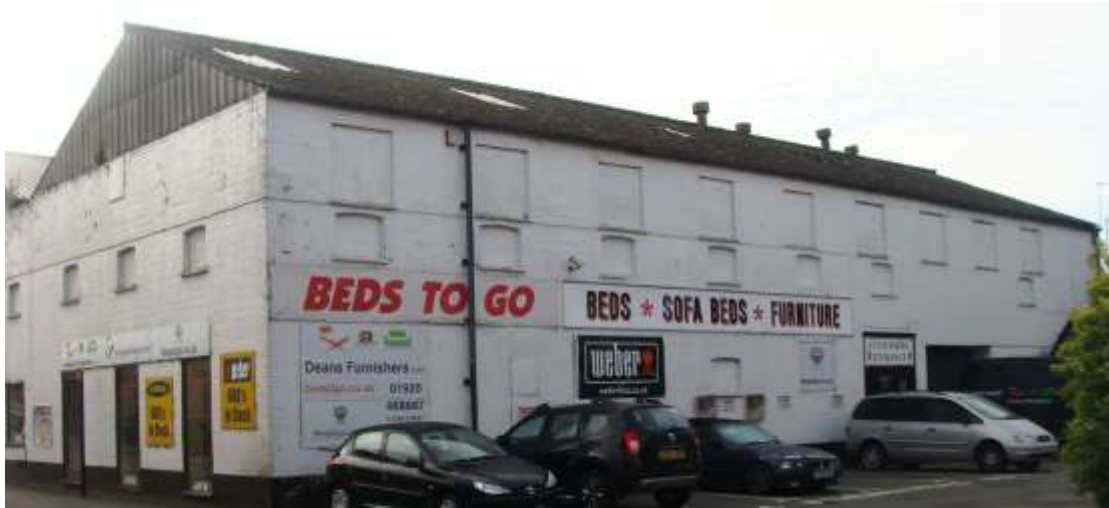
5.50. Sites south side of Star Street including Ware Bathroom Centre and adjacent building including Beds to Go etc. The Bathroom Centre building has a more recent extension to the rear but this aside, the remainder of these buildings are visually unattractive with their shallow pitched roofs and advertising. The area in whole or part could be a candidate for future redevelopment.

Picture 38. Large commercial site south side of Star Street which detracts from the quality of the Conservation Area and which may be a suitable candidate for future redevelopment.

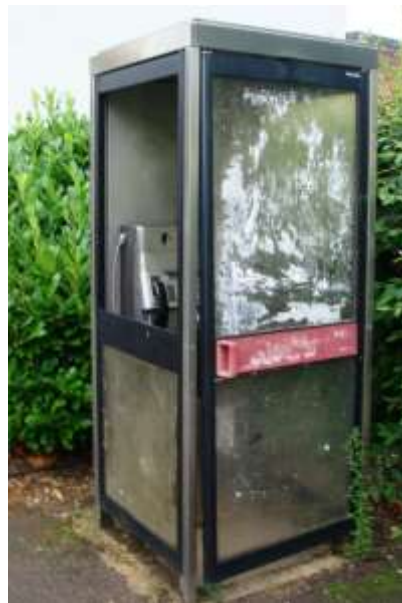
5.51. Modern 20th century telephone kiosk - car park area corner Kibes Lane/New Road. Telephone kiosk in poor condition and of poor appearance. Missing glass panel. It should either be repaired or if not in active use, consideration given to its removal.

Picture 39. Modern 20th century telephone kiosk, vandalised and in poor condition. Its repair or removal if no longer in active use recommended.

96- 96A High Street and Nos. 77 and 79 High Street. Repair/ remove telephone kiosk corner of Kibes Lane/ New Road. Consider options to improve poor quality wall northern boundary to EHDC car park, Kibes Lane/New Road.
