WARE CONSERVATION AREA APPRAISAL AND MANAGEMENT PLAN

ADOPTED JULY 2016

East Herts District Council
Pegs Lane, Hertford, SG13 8EQ

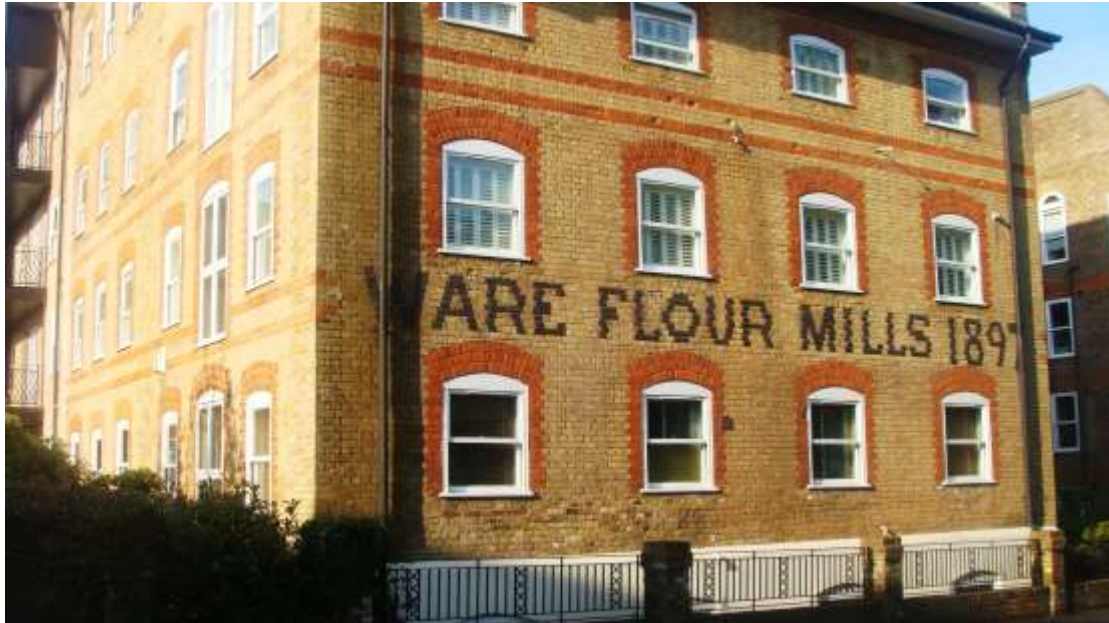
Picture 40. Successful conversion of non listed Ware Flour Mills buildings corner of Amwell End and Viaduct Road. The visual impact of modern window detailing is limited and works relatively well because of its repetitive design.

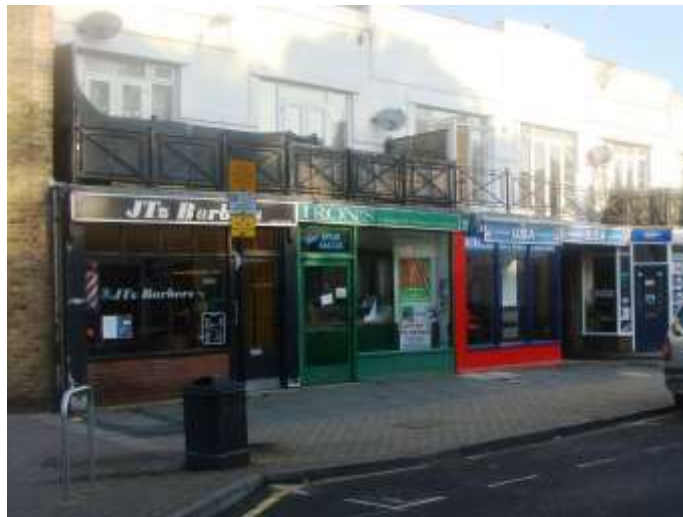
5.59. Commercial buildings on the western side of Amwell End are modern and in combination they make little or no visual contribution to the Conservation area. In addition to the condition of some individual buildings referred to below there is a lack of co-ordination in the shop front and fascia designs. In relation to shop fronts and fascia design there are proposals set out in the Management Section to which the reader is referred. As a whole Amwell End would benefit from general environmental improvement. In this respect it may be appropriate to consider obtaining the views of a landscape consultant.

Picture 41. The whole of Amwell End would benefit from general improvements. This is particularly the case in respect of the western side which is composed of later ranges of properties.

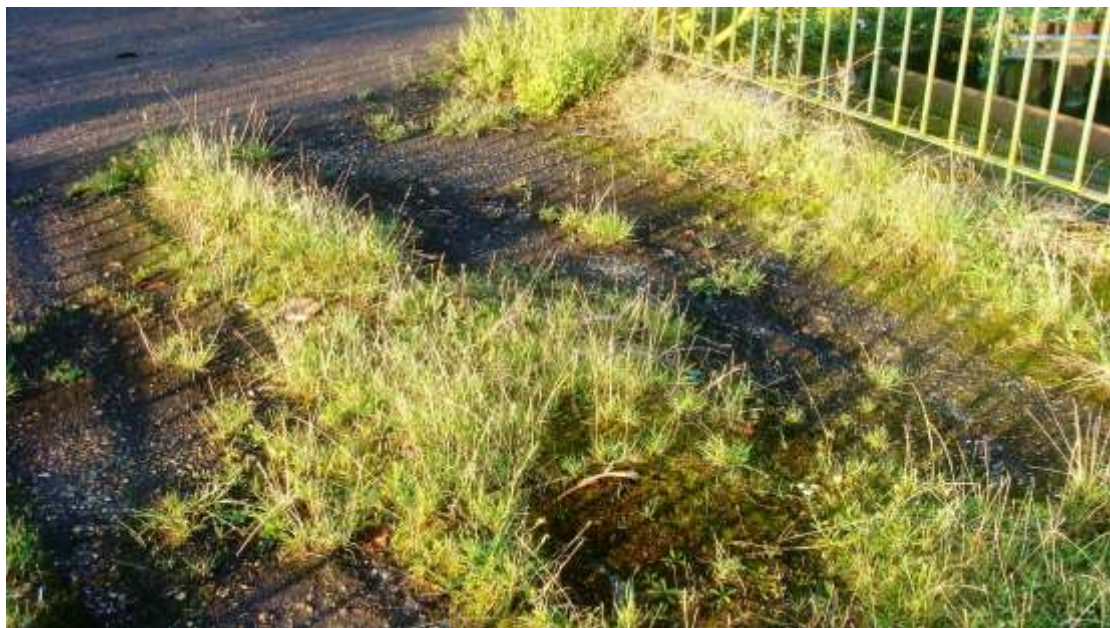
Picture 42. Vegetation on surface to listed bridge Hertford Road in need of removal. It is hoped it remains structurally sound?

5.97. Opportunities to secure improvements. Enter negotiations with Thames Water and consider initiating repairs to a number of identified railings adjacent to New River. Similarly discuss with Thames Water condition of listed bridge on Hertford Road and removing vegetation. Source owner of no.19 Amwell End and seek improvements to property. Consider future of prefabricated buildings and site at Broadmeads occupied by Scouts and Air Training Corps. Consider opportunities for general visual improvements to Amwell End. Consider respectively improving and or removing 2 no. information boards corner of Amwell End, River Lea. Also notice board, New River Path. Improve site corner of Amwell End, Station Road.

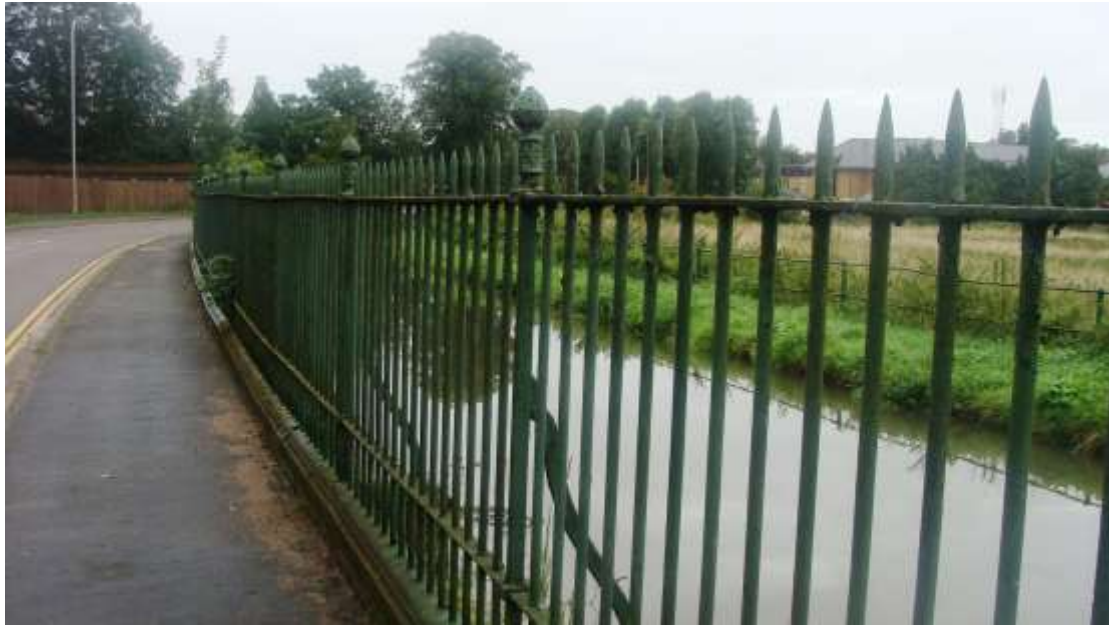
5.65. Railings north side of London Road - Grade II. Mid 19th century. Cast-iron railings forming southern boundary to New River Company land, running along back of footpath, north side of London Road. Standard pattern of railing with pointed shafts in lengths between square uprights, with acorn finials, and curved braces, set on cast-iron saddleback copings, and a yellow-brown stock brick base with buttresses. (There is a similar grouping of listed railings nearby and to the west alongside Hertford Road).

Picture 43. Fine listed railings believed to be owned by Thames Water which make a very positive contribution to this part of the Conservation Area.

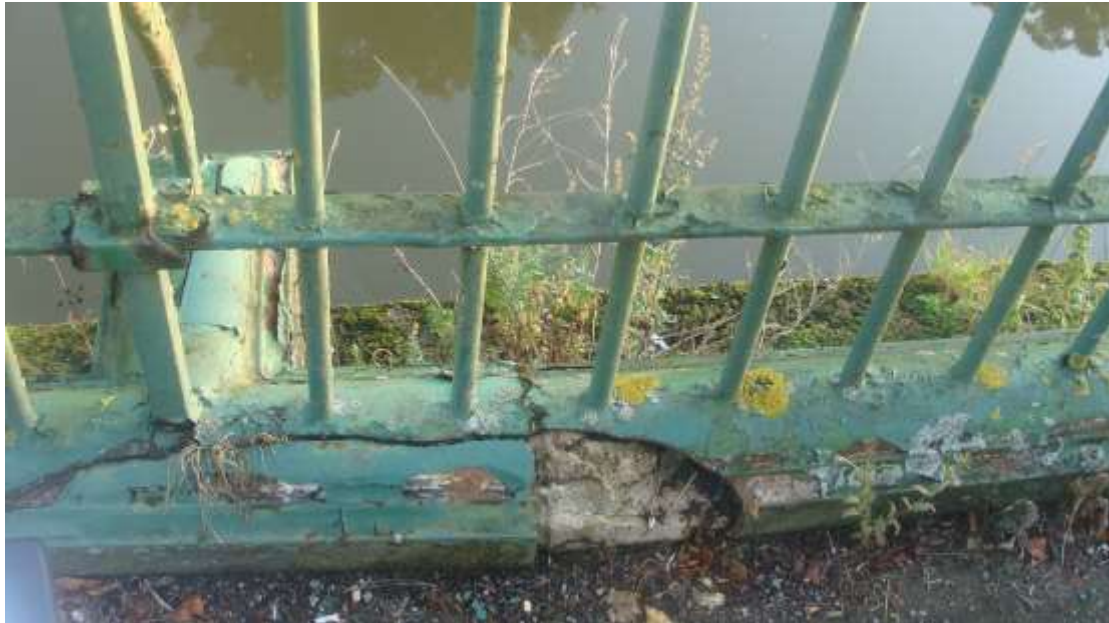
Picture 44. Detail of railings some of which are in need of repair and or repainting. In some areas removal of self set sycamores would be beneficial.

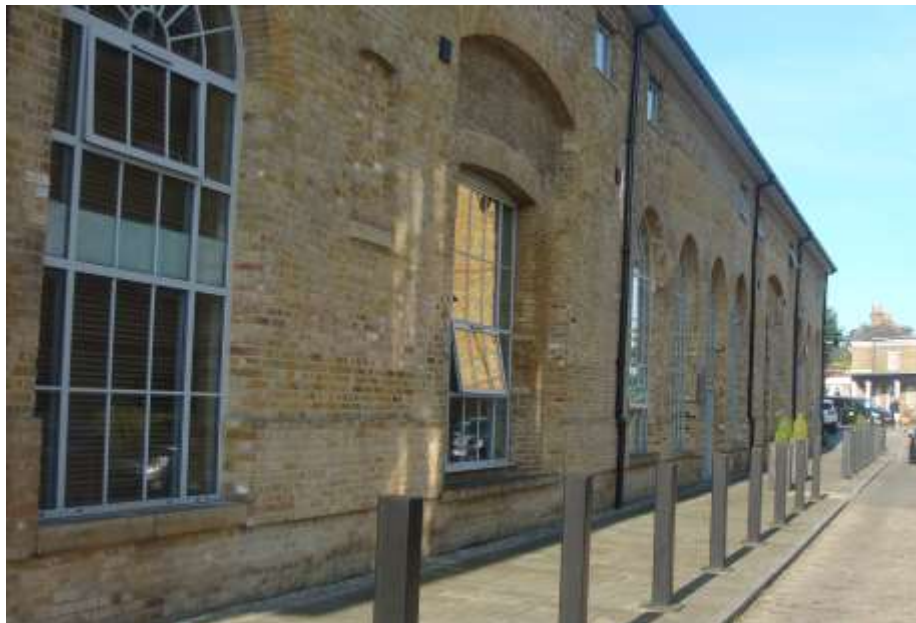
5.66. Main Goods Shed at Ware Railway Station, Station Road (*now converted to residential - The Carriages*) Grade II. Former railway goods shed incorporating granary. Mid 19th century. Main front of 9 bays: semicircular windows set back under round gauged brick arches, alternate with high-level rectangular windows with glazing bars set in the top of tall recessed panels under camber bricked arches, each with a parapet above. Simple brick eaves cornice.

Picture 45. Former Goods Station now most satisfactorily converted.

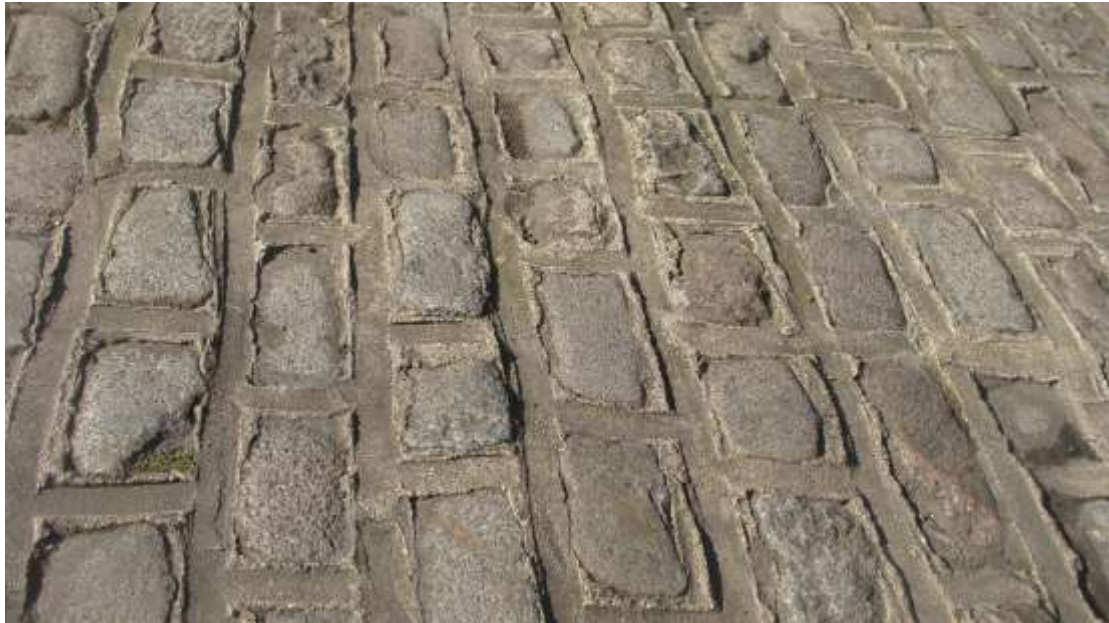
Picture 46. Surface detail adjacent to former Goods Station - a small but important detail.

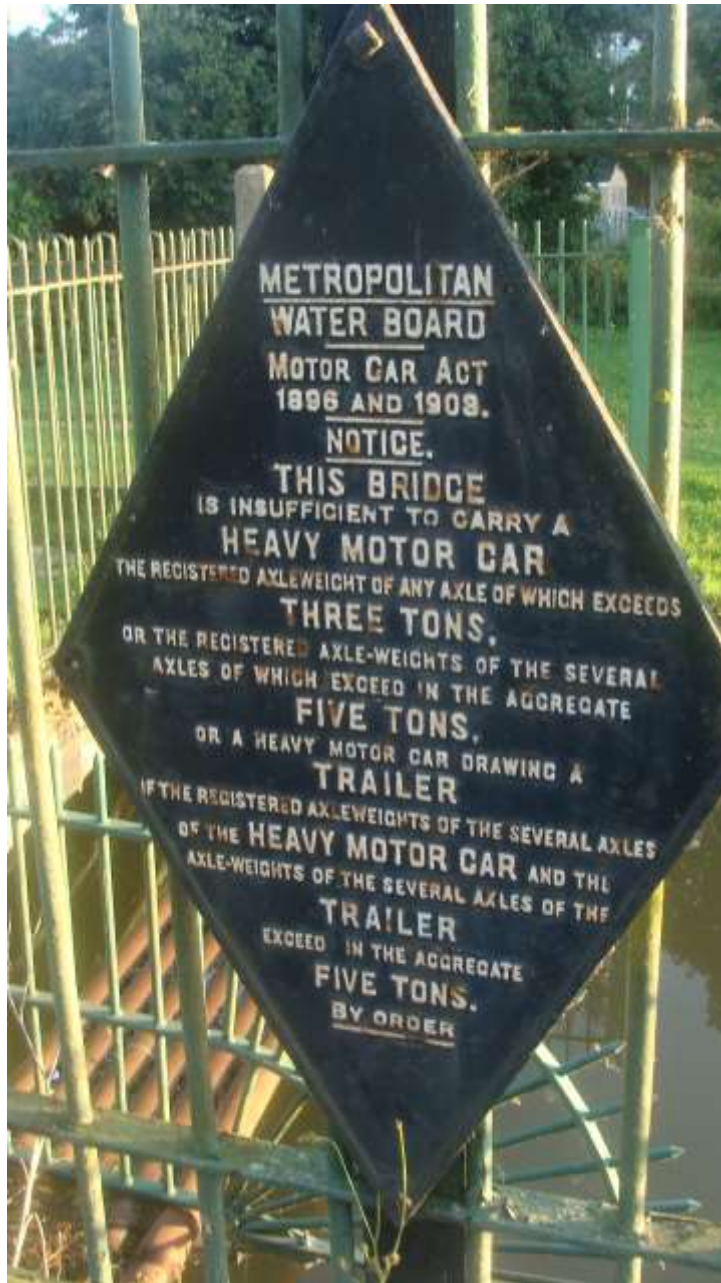
5.67. Weight Restriction Plaque, New River - Grade II. Weight restriction plaque. Circa 1908. Lozenge-shaped cast-iron plaque bolted to timber post attached to railings, (north of Hertford Road) to give warning of weight limits on adjacent bridge. Raised lettering records that the plaque was erected by the Metropolitan Water Board to advise of weight limits under the Motor Car Acts, 1896 and 1908, three tons registered axle weight, or aggregate axle weights of five tons.

Picture 47. Most interesting and unusual listed weight restriction plaque.

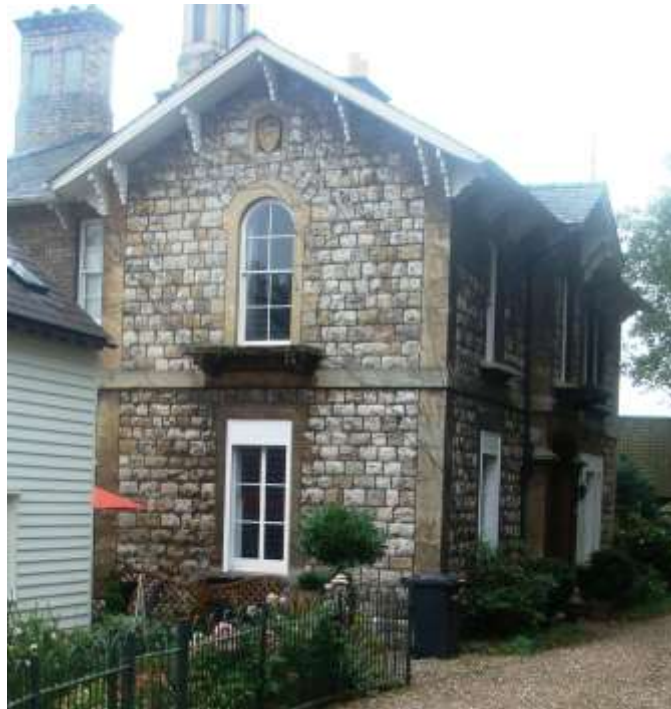
5.70. Chadwell Lodge. Mid 19th century stone-built, with squared, coursed rubble, and ashlar plat band, window surrounds and quoins. Broad-eaved Welsh-slated roof with moulded fascias and barge boards. Elaborate stone chimneys.

Picture 48. Chadwell Lodge an unusual mid 19th century building.

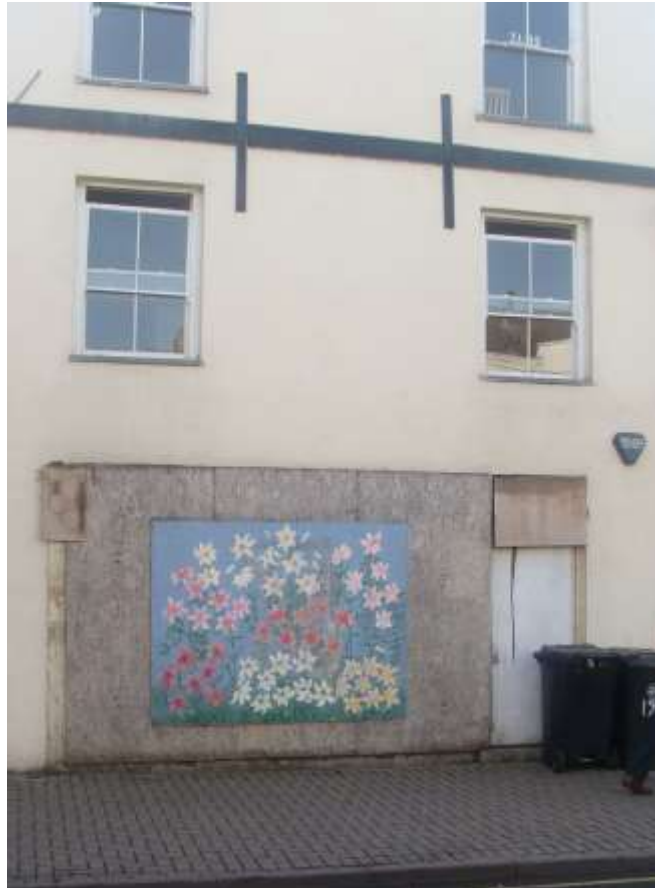
5.71. No.19 Amwell End - Grade II. 18th century front to earlier building, 20th century alterations. Stucco, with plat band at second floor level and moulded cornice, parapet partly conceals corrugated asbestos roof. 3 storeys, 2 sash windows, with divided glazing, and horns, on first floor; 2 sash windows, with small panes on second floor, all recessed with concealed boxes, within stucco reveals. Modern shopfront on ground floor. *This building is in poor condition and repairs need initiating.*

Picture 49. No.19 Amwell End, a building in need of repair and occupation.

5.89. Elements out of character with the Conservation Area. The poor condition of no. 19 Amwell End (picture above). Vegetation on listed bridge, Hertford Road (picture above).

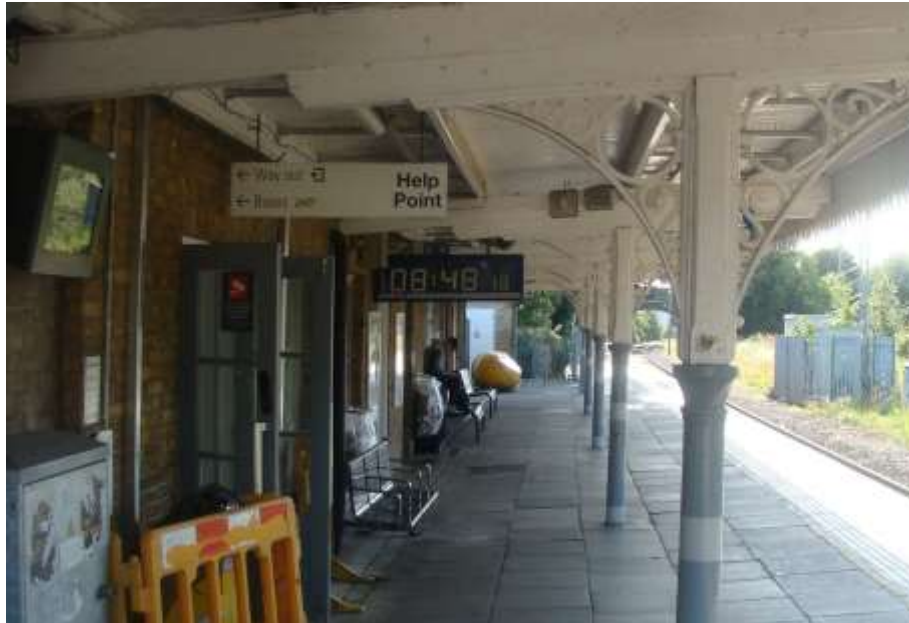
5.75. Station Building. 19th century yellow brick with slate roof and 2 no. chimneys with pots. Platform area with wooden canopy above supported by 6 no. decorative metal supports. An important building

representative of the town's industrial heritage and diversity. Features protected by existing controls.

Picture 50. 19th century station part of the industrial heritage of the town. Canopy and cast iron supports are typical.

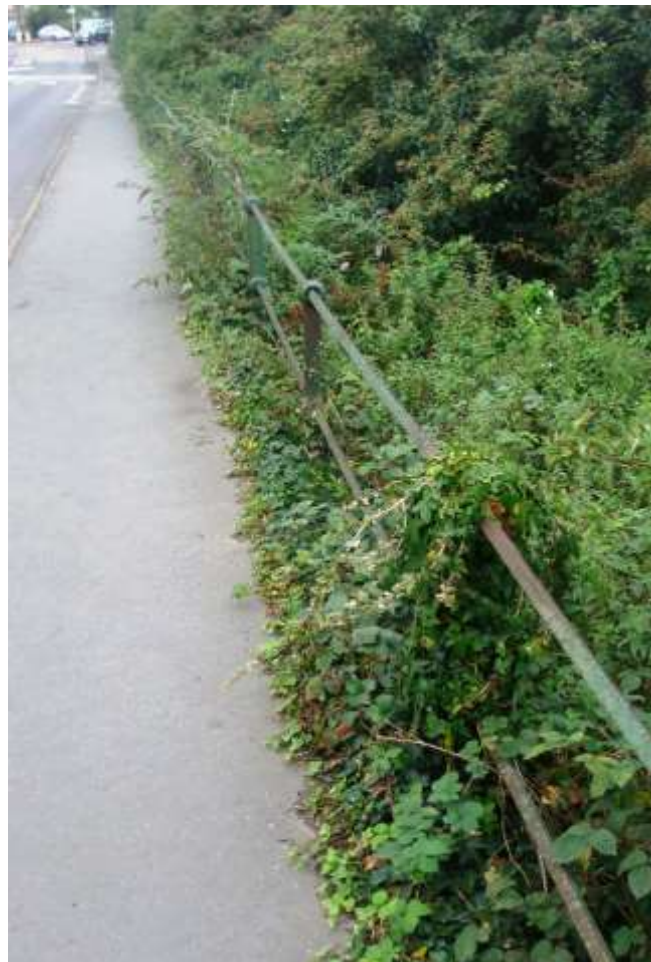
makes them features of considerable visual interest and add to the environmental quality of New River. Constructed of horizontal rails supported by metal posts. Several sections are in need of repair and removal of vegetation. Careful consideration needs to be given as to the potential of making them subject to an Article 4 Direction. However in the first instance the issue should be discussed with the owners who are believed to be Thames Water. Ideally an incremental ongoing programme of maintenance repair and repainting needs agreeing.

Picture 51. Low railings less than 1m in height and thus unprotected from demolition within the Conservation Area. Potential candidates for formal protection by Article 4 Direction. Need to remove vegetation repair and repaint. In first instance need to discuss issue with Thames Water if indeed they are the owners.

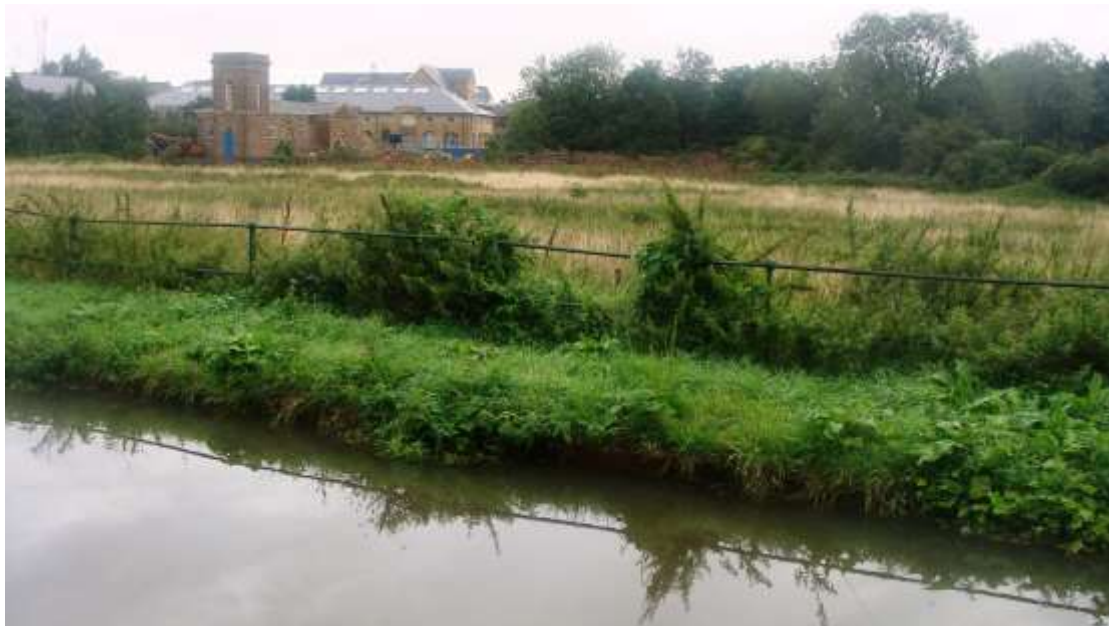
field can be regarded as a gateway to Ware in this location and is properly designated as Green Belt. It is bounded by a hedge and tree screen on Viaduct Road and by fencing and New River on London Road. It is not known if the field is subject to flooding. The area is surrounded by modern neutral development beyond the Conservation Area which heightens its importance as an open space that should remain as such.

Picture 52. Low lying field junction London Road/ Viaduct Road. It is most important this field remains as open land and its visual appearance improved. Public access would be a real bonus.

5.84. It would be of considerable benefit if the site could be improved and landscaped appropriately. Ideal if it could be made accessible for to the public. Resolution of this issue is regarded as being most important and discussions with the owners who are believed to be Thames Water would be an essential first step.

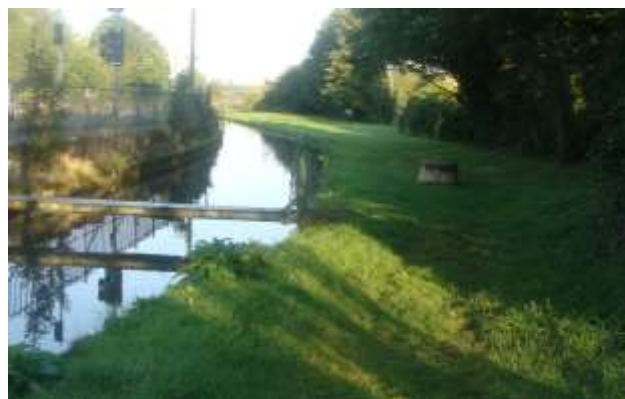
5.85. New River and parallel open space, north of Hertford Road and south of railway line. Important landscape feature called New River Path. Display board need cleaning.

Picture 53. New River Path, an important open space of considerable visual quality.

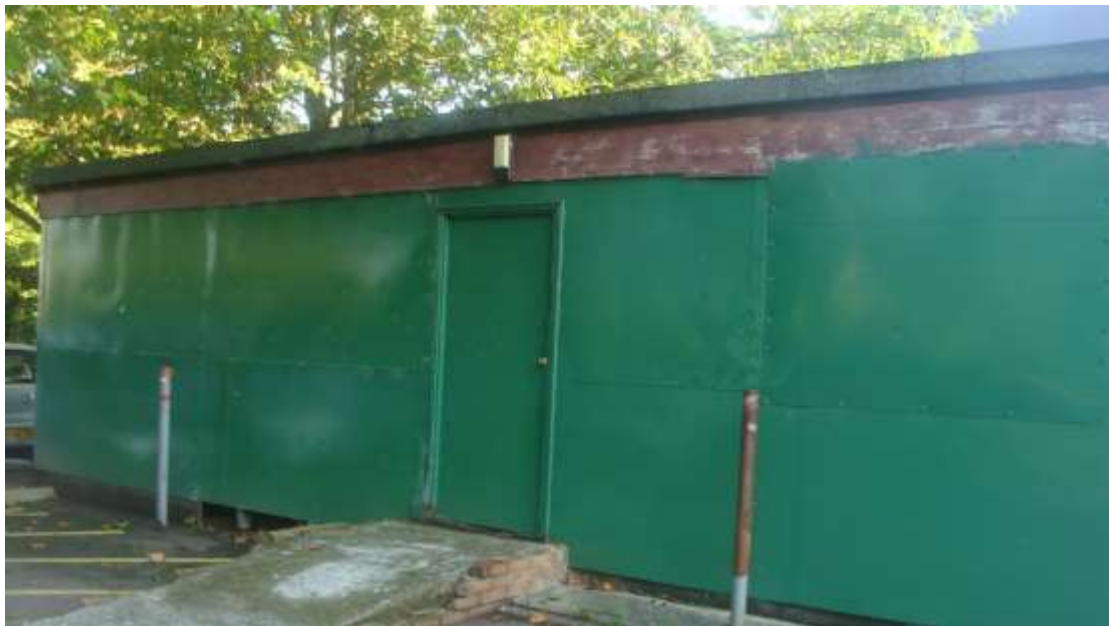
Picture 54. Temporary structure on EHDC car park Broadmeads which detracts. Should be removed or replaced. As a short term measure it needs repainting.

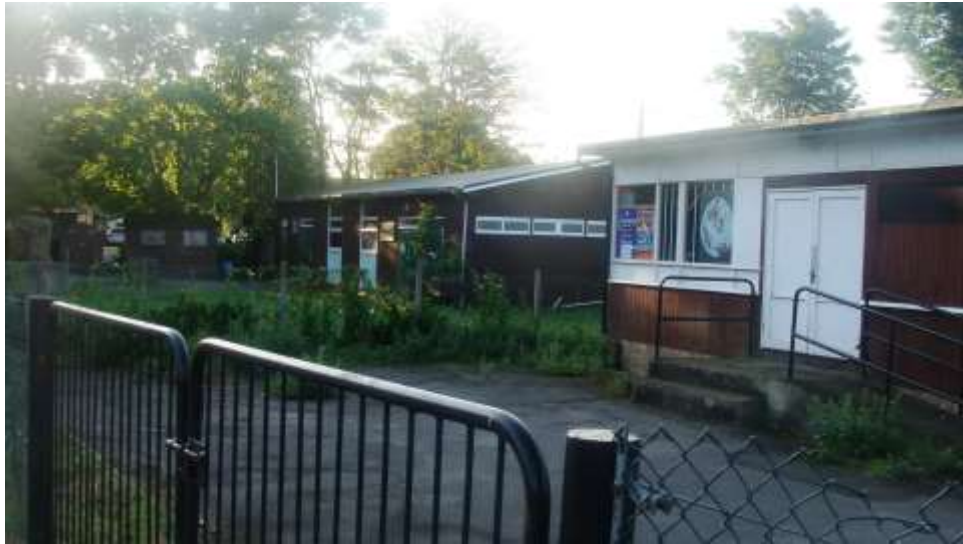
5.91. Prefabricated buildings for Scouts and Air Training Corps. This group of buildings both within and beyond the Conservation Area detracts from the quality of the area. The long term future of this site is unknown but it might represent a redevelopment opportunity.

Picture 55. Prefabricated buildings (Scouts and Air Training Corps) Broadmeads. This site detracts from the quality of the Conservation Area and needs improvement.

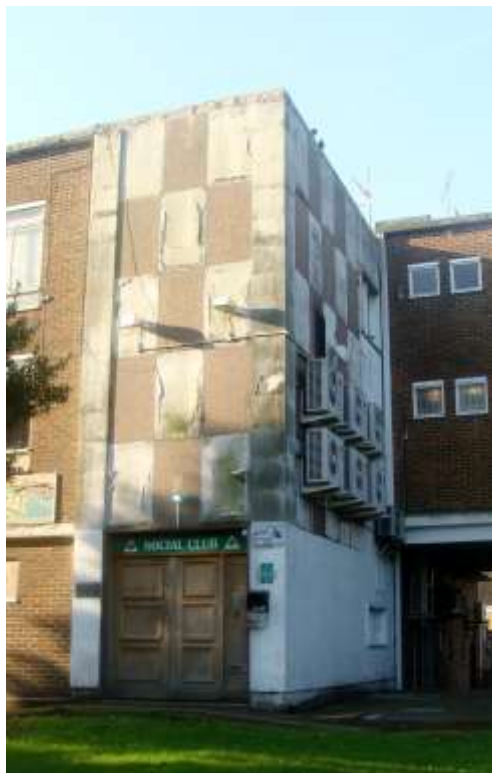
Picture 56. Poor quality building at strategic north western corner of Amwell End whose appearance seriously detracts from the Conservation Area.

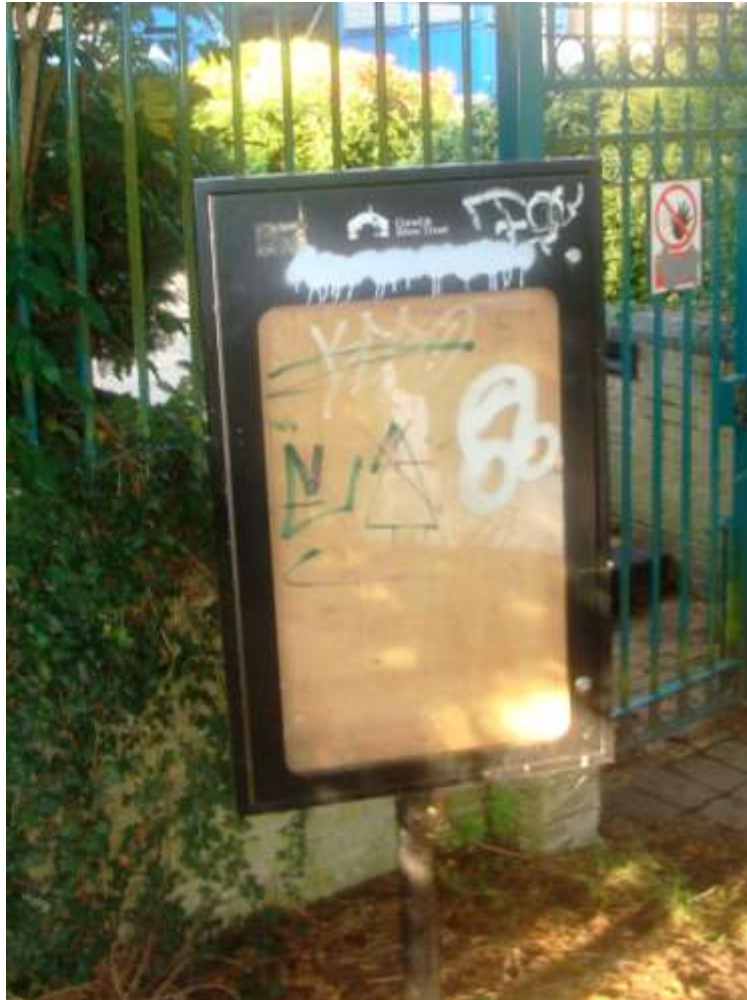
5.93. Information board relating to Gazebos. Corner of Amwell End/River Lea. This most informative and interesting information board was thought to be suffering from damp penetration but the Ware Society advise this is not moisture ingress but the effect of background shading of the main drawing.

Picture 57. Vandalised information Board that probably should be removed unless it is to be refurbished.

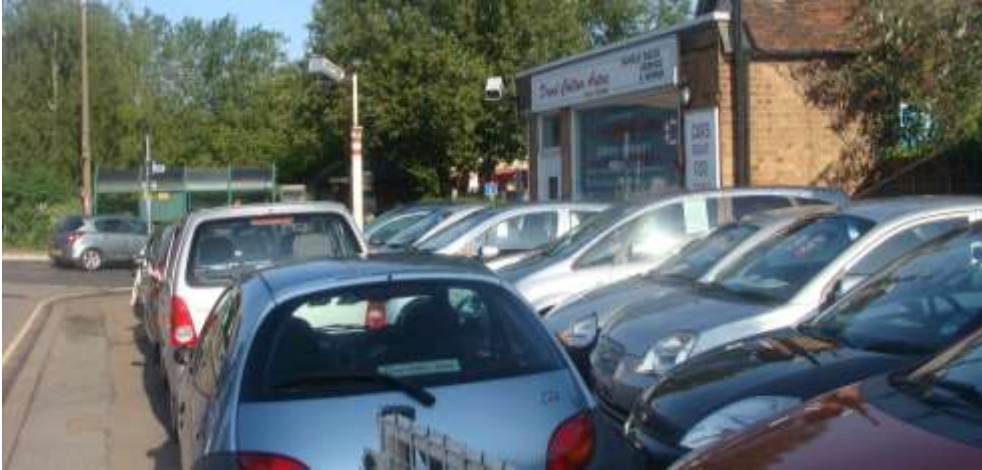
5.95. David Collier Autos - corner Amwell End/Station Road. A vehicle sales area where an accumulation of parked cars is visually disruptive. Do some of the parked vehicles intrude onto the highway?

Picture 58. David Collier Auto site. Does this site have a more visually acceptable long term alternative ? Are the cars intruding onto public highway space?

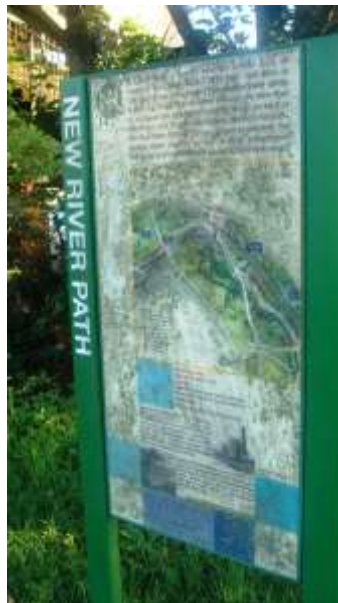
5.96. Display board at New River Path. Informative display board needs improvement/replacement. Damp penetration?

Picture 59. Information Board on New River Path in need of improvement/replacement.

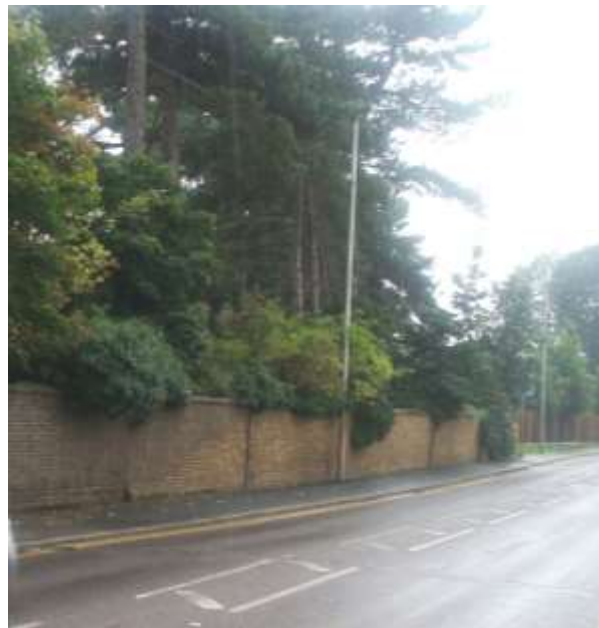
5.99. In Area 2 the Conservation Area has been extended to remove ambiguity relating to the status of the wall (i.e. is it currently in or beyond the Conservation Area) and to include an area of trees of conifer and other species between London Road and Grange Gardens. Both the boundary wall and trees to the south represent an important feature at this gateway entrance to Ware whose protection by Conservation Area status is justified.

Picture 60. Fine wall and trees now included within the Conservation Area at this London Road gateway entrance to the town.

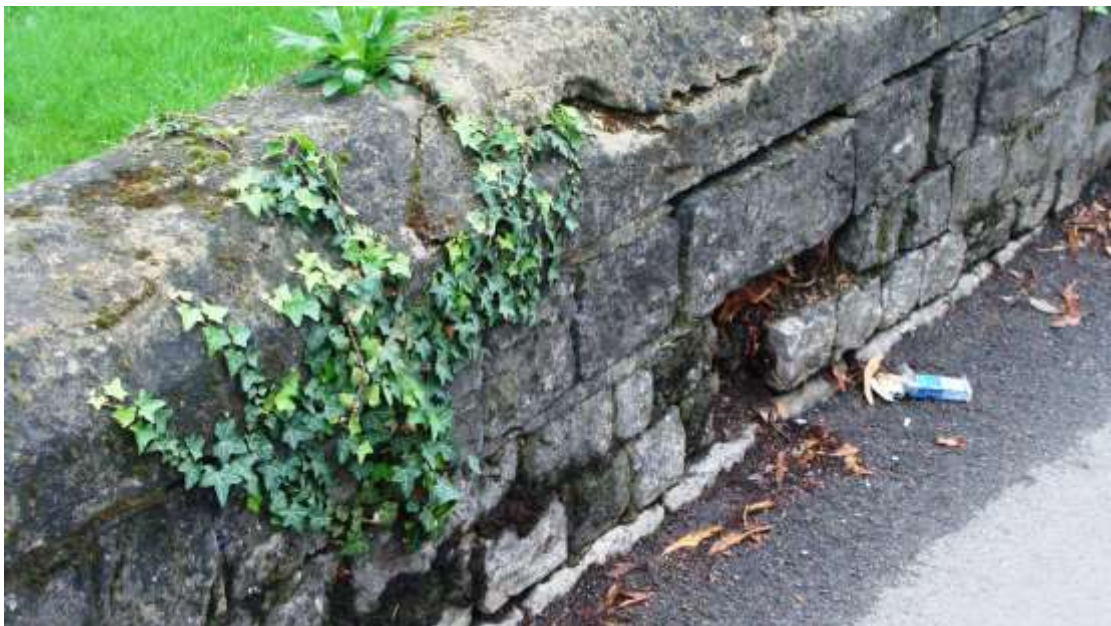
5.106. Boundary wall and gate to Christ Church, New Road - Grade II. Embattled and buttressed wall, with offset caps and splayed copings. 1858. Kentish ragstone. Sections of cast-iron railing originally filled embrasures, but were removed for salvage in World War II. In need of repair.

Picture 61. Mid 19th century boundary wall to Christ Church in need of repair.

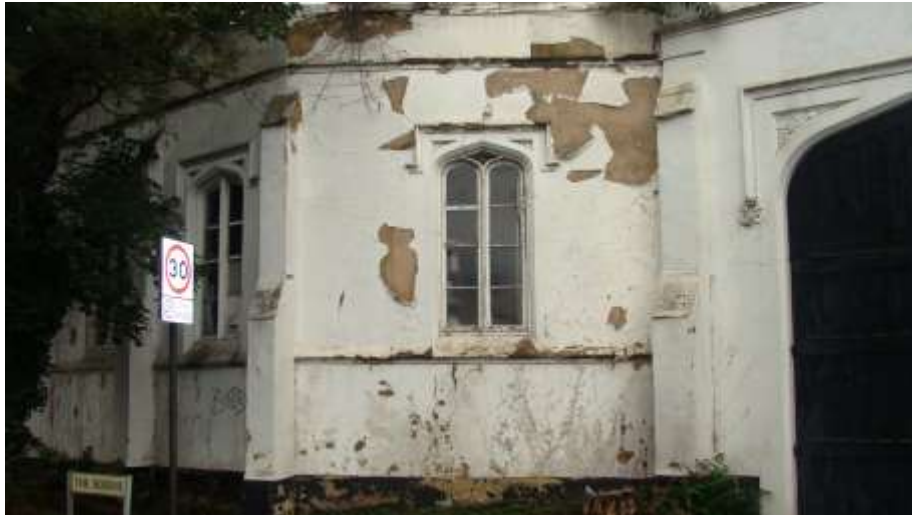
5.108. Thunder Hall and boundary wall, Wadesmill Road - Grade II. Late 17th century, extended later and converted to flats 1972. Architect John Snellgrove Associates for 1850-52 remodelling, George Godwin. Interior: Fireplace in south-east room on ground floor contains mid 19th century arched fireplace, with marble tablet inscribed 'This marble from the room in which the Emperor Napoleon died was brought from St Helena by Capt. Amb. Fred. Proctor, AD 1833'. Grounds and land to north altered by modern residential development of Thundercourt in early 1970s, extinguishing original road access from The Bourne. Boundary wall to Wadesmill Road partly in red and yellow Hitch patent brickwork, with Hitch coping bricks. *The exterior of the building appears in poor condition in several locations and in need of refurbishment. Vegetation should be removed from the listed wall.*

Picture 63. Thunder Hall, Wadesmill Road - a listed building in need of renovation. Recent improvements made and situation will be monitored.

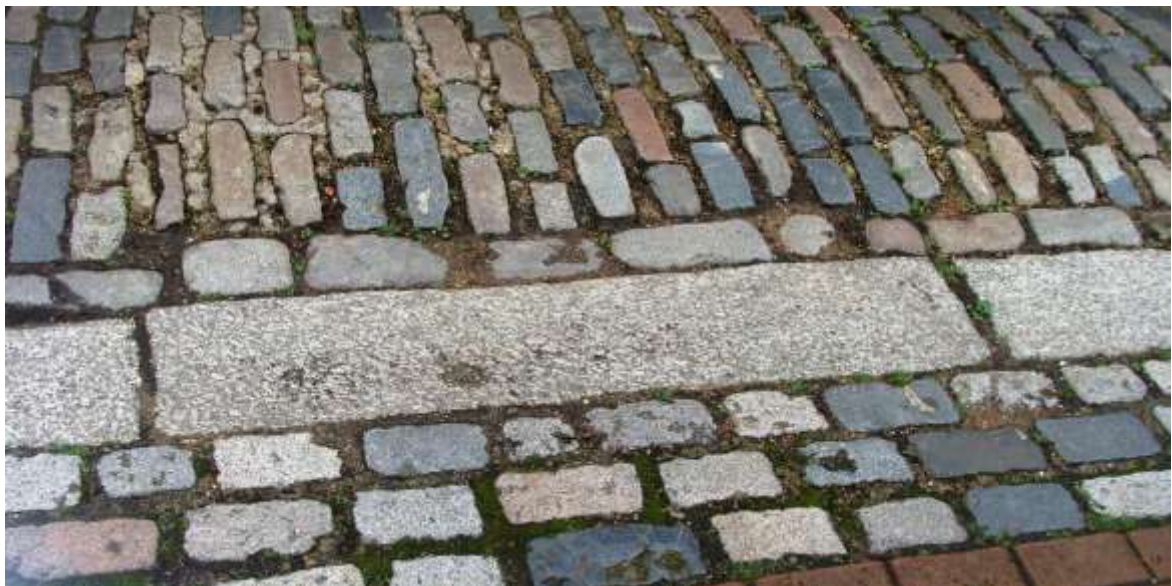
Picture 64. Original surface to Maltings access which is important to retain.

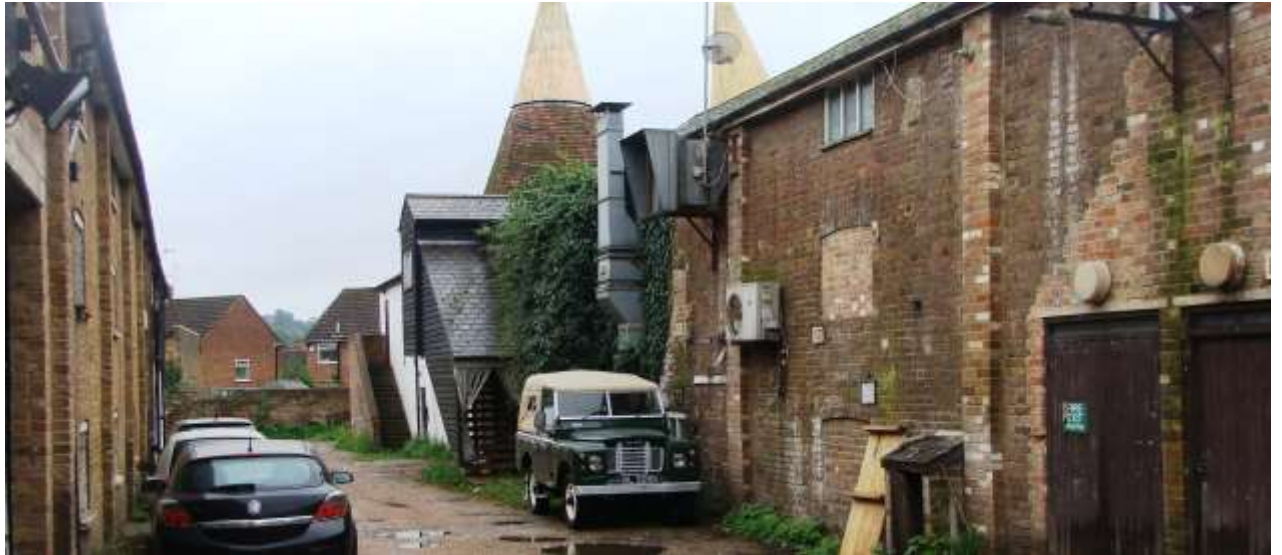
5.109. Maltings and Kibes Lane Art Centre, New Road - Grade II. Range of 3 large maltings. Early 19th century with modern alterations. Yellow-grey stock brickwork, Flemish bond, part colour washed and part rendered. Roof of corrugated asbestos to N and S range. 3 storeys. Each malting has 3 floors, and 3 double kilns, and malt stores at east end. The South range, converted to an art centre, has cast-iron circular tie plates, by 'Chas. Wells Ware'. *The north maltings has now been converted to residential use, the central building presently remains in commercial use and the south maltings is being marketed. The future use of the southern Maltings building is a matter of concern for some residents of the town. The fieldworker has not undertaken an internal inspection and cannot comment on its condition. However the illustration below shows its poor visual appearance when viewing its northern elevation.*

Picture 65. South Maltings building whose future use is a matter of concern to some residents. The visual appearance of the building and its surrounds are less than satisfactory. It is hoped an acceptable use can be found which results in its significantly enhanced visual appearance.

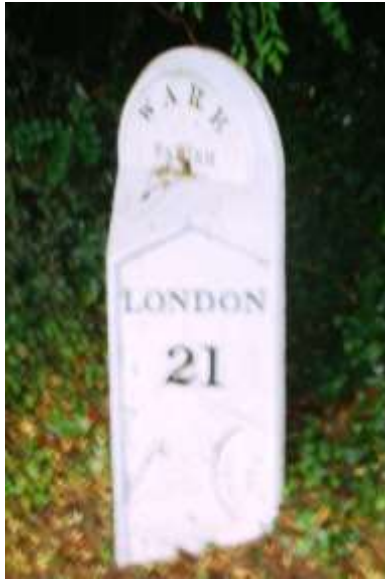
5.110. Milestone in verge east of Fire Station, Baldock Street - Grade II. Circa 1810-1820. Erected by Cheshunt Turnpike Trust. Cast-iron with semicircular top, and splayed faces. Raised lettering, 'Ware Parish', 'Wadesmill 2' 'London 21'. Appears to have been resited back from its original position in 1960's road widening. *This milestone marker is on the Council's Heritage at Risk Register and is in need of repair. The iron work of the top panel is punctured and rusty in part.*

Picture 67. 19th century milestone on Baldock Street that is of early transportation interest and in need of repair.

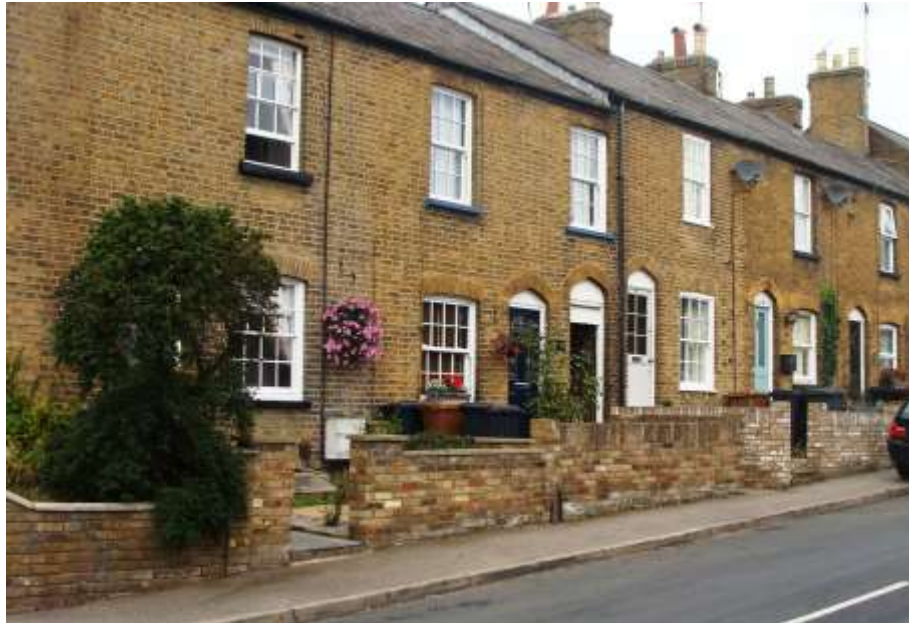
(e) Nos. 2-62 east side. A miscellany of 19th century buildings, principally residential, of varying quality and various design including terrace and semi detached two storey development. Some original features including bay window detailing and date plaque of 1894. Original chimney detailing and predominately original slate roofs. Includes the High Oak PH.

Picture 69. Typical terrace development at High Oak Road. The continuous slate roofs and repetitive chimneys particularly add character to this 19th century street despite inappropriate other alterations principally brought about by the exercise of Householder Permitted Development Rights.

5.117. An Article 4 Direction to provide protection for selected features in relation to the properties collectively described on High Oak Road may be appropriate subject to further consideration and notification.

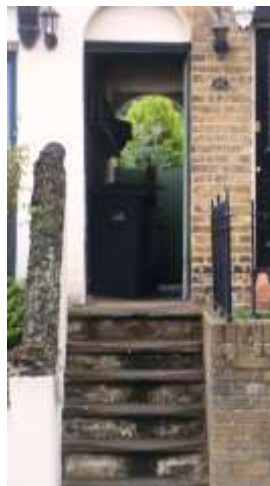
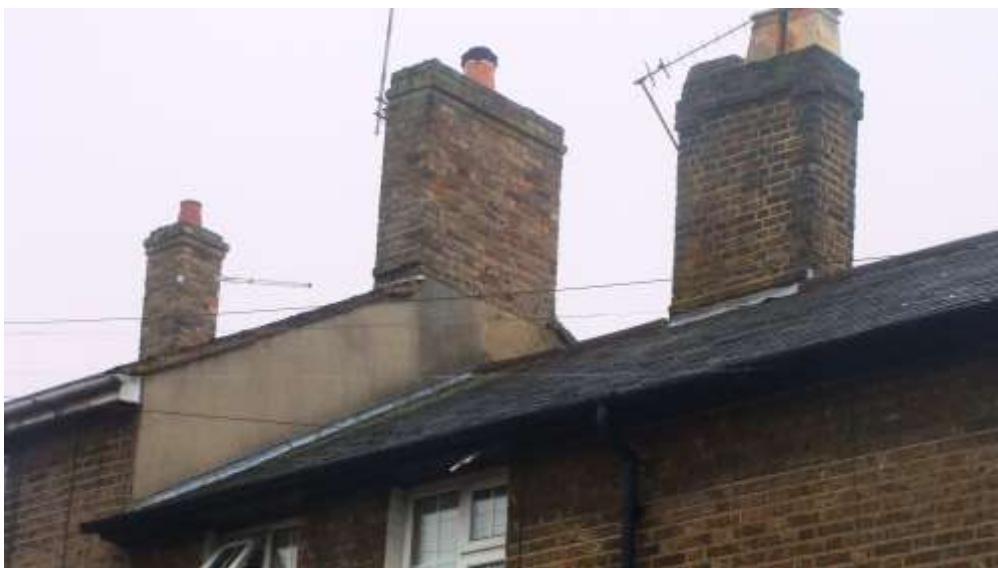
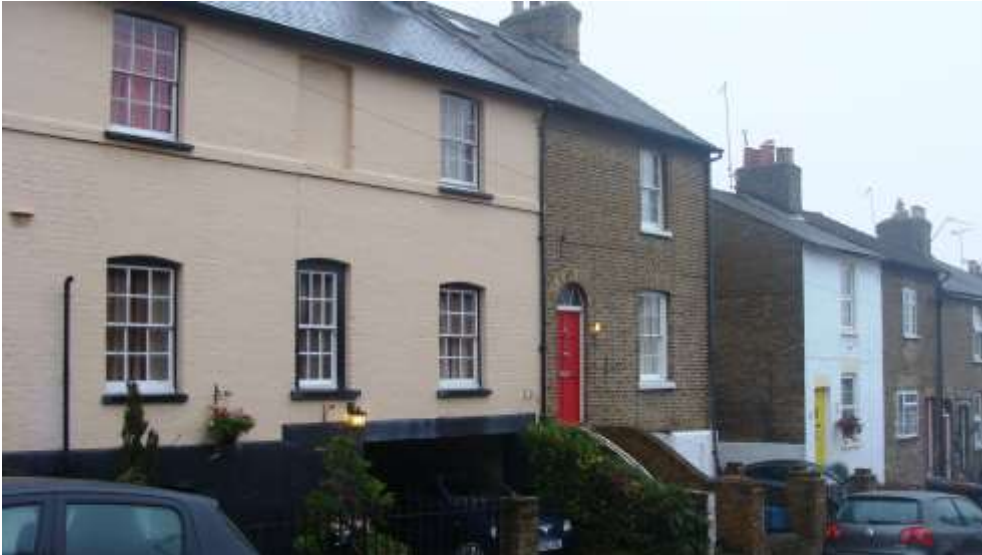
5.120. Nos. 1- 45 and Nos. 2- 56 Musley Hill (now included in an extended Conservation Area) - see below. A 19th century street consisting of two storey terraced housing generally of original brick and slate roofs. Although there are some later additions and façade treatments/ material changes and inappropriate window/door/porch changes the overall street scene is visually attractive particularly with long stretches of slate roofs and chimneys at regular intervals that results in a street scene that is pleasantly composed and seen as an architectural entity. Because of proximity of buildings to road there is limited off street car parking that can be so visually disruptive. The brick walls of various heights to frontages enclose the street scene although some have been modified. Date plaques Mount Ephraim erected 1849 and Skippers Row Constitution Hill erected AD 1850 noted. Early street sign. An Article 4 Direction to provide protection for selected features may be appropriate subject to further consideration and notification.

Pictures 71, 72 and 73. Musley Hill - a 19th century street with a number of original features that, despite changes, essentially remains a compact visual entity and is of historical importance in the later development of the town. Pictures 71 -72 show interesting steps and access detail and the importance of chimneys in the street scene respectively.

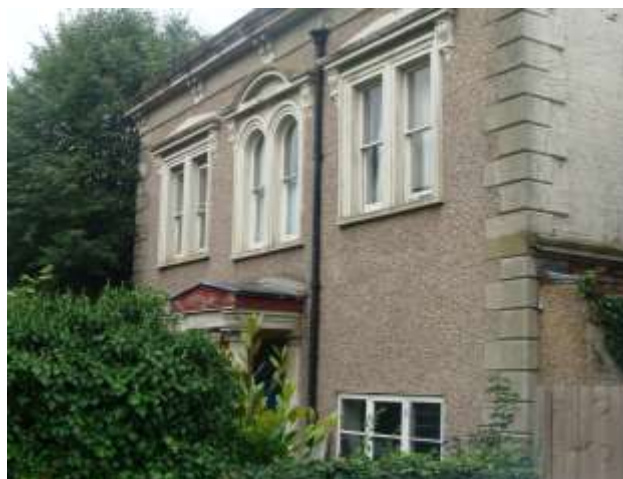
5.129. Nos. 93- 95 New Road - late 19th century. No. 93 inaccessible at time of survey, constructed of yellow brick with red brick banding; tiled roof and chimney. No. 95 has pebble dash frontage with fine window and stone quoin detailing. Central porch entrance with classical columns. An Article 4 Direction to provide protection for selected features may be appropriate subject to further consideration and notification.

Picture 78. Fine architecture detailing no. 95 New Road.

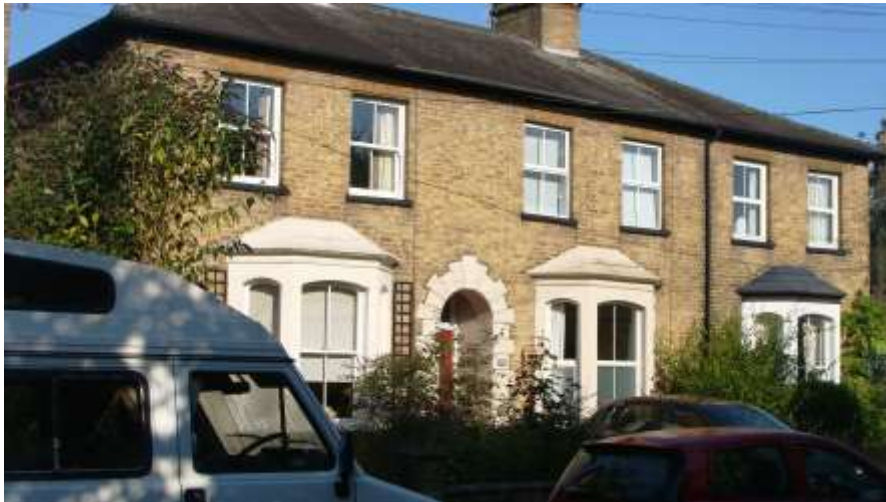
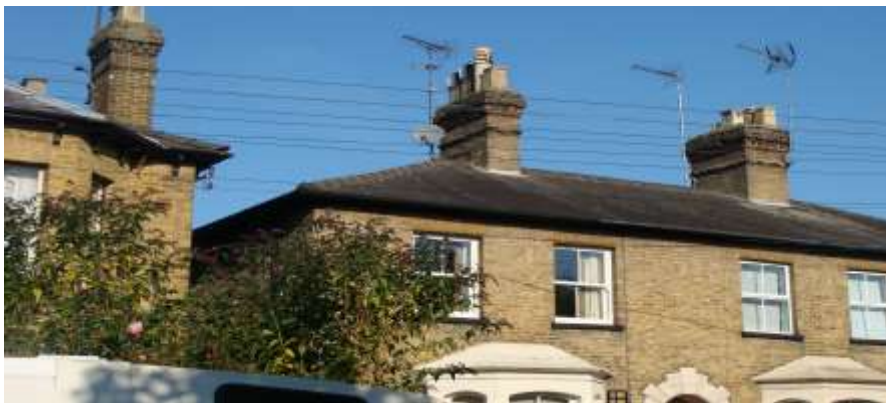
5.134. Nos. 73 and 75/77/79 New Road. Group of 19th century dwellings. Of yellow brick construction with hipped slate roofs. Nos. 75/79 have bay windows to ground floor and recessed central entrance. Rubbed brick window detailing. No. 73 similar with bay windows to both floors and metal finials on roof. An Article 4 Direction to provide protection for selected features may be appropriate subject to further consideration and notification.

Pictures 80-81. Attractive 19th century residences with detailed features worthy of additional protection. Lower picture demonstrates the important visual role chimneys play in adding character and interest to the roofscape, not only here but also in many other streets elsewhere in the Conservation Area.
