WARE CONSERVATION AREA APPRAISAL AND MANAGEMENT PLAN

ADOPTED JULY 2016

East Herts District Council
Pegs Lane, Hertford, SG13 8EQ

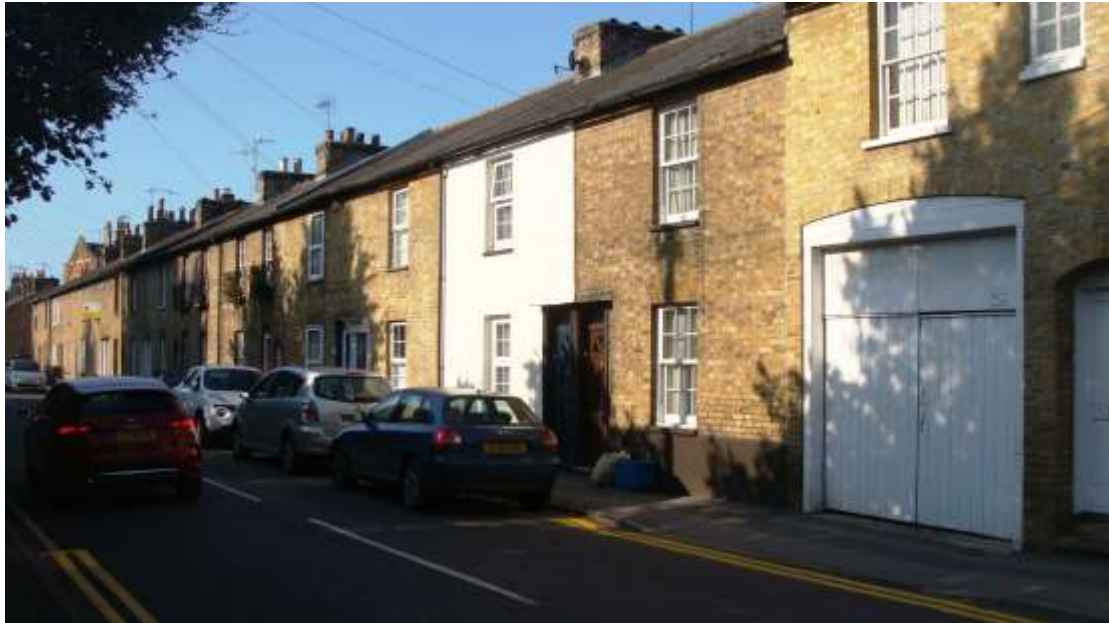
5.136. Nos. 31-59 New Road. A 19th century terrace of yellow brick construction, principally with slate roofs and chimneys. Rubbed brick

lintels. Many original details replaced including doors and windows, occasional replacement roofing materials and painting of brickwork. Nevertheless the terrace makes a positive contribution to the street scene and certain original features notably the slate roofing and chimneys are candidates for additional protection. An Article 4 Direction to provide additional protection to these features may be appropriate subject to further consideration and notification.

Picture 82. Nos. 31-59 New Road make a positive and worthwhile contribution to the street scene despite many detailed features having been altered.

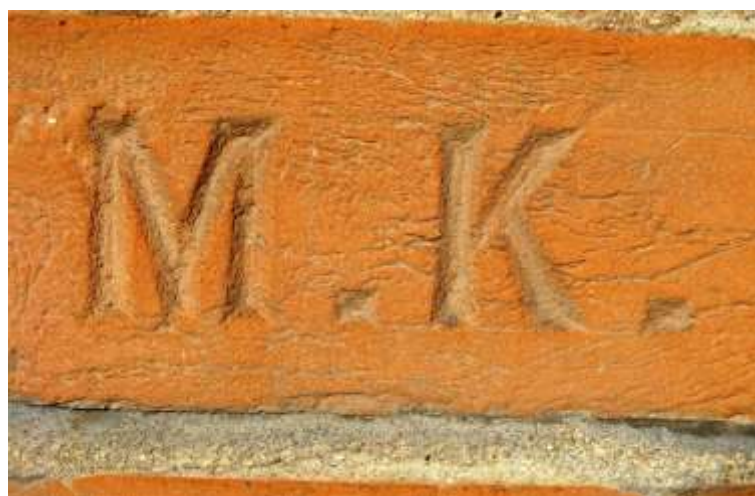
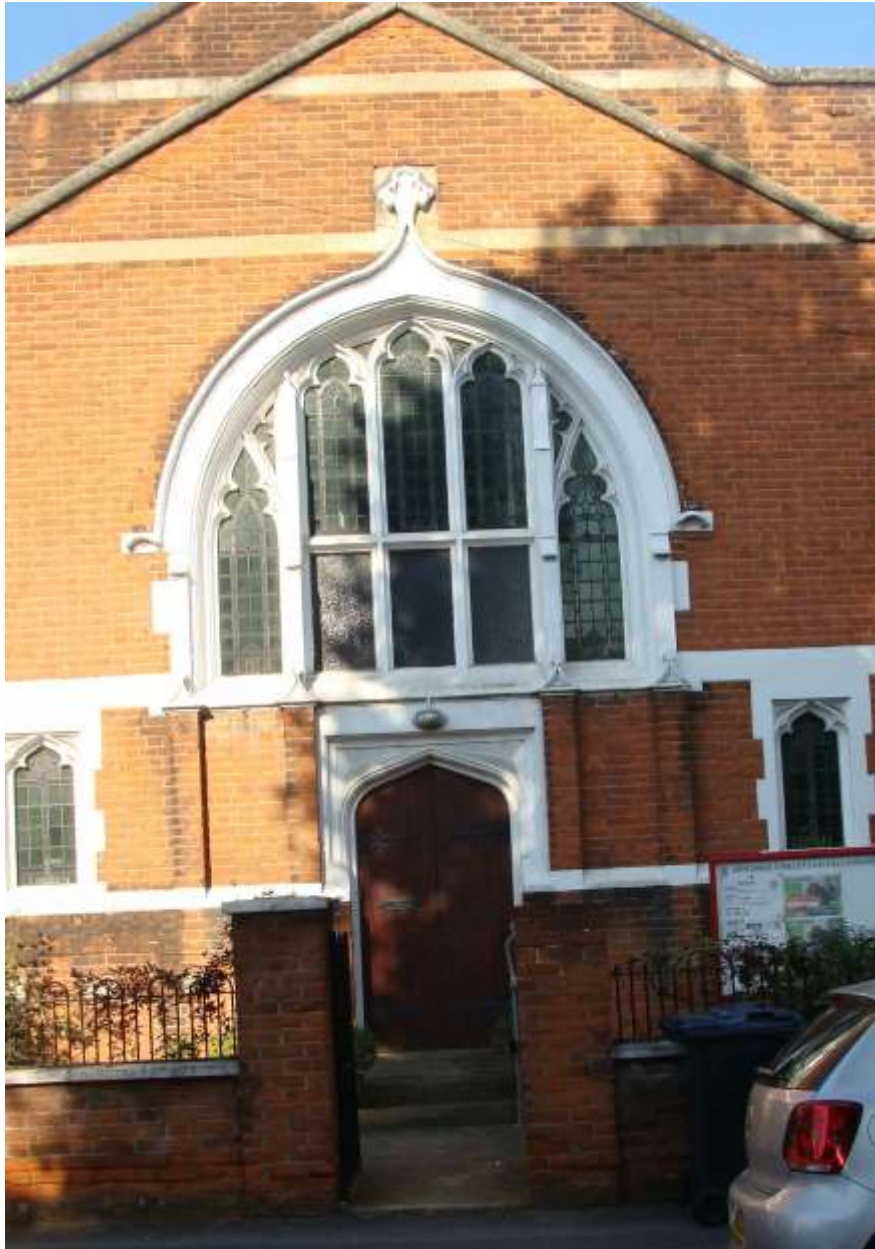
5.137. Springs Christian Fellowship and hall to rear. Shows on 19th century mapping as a Methodist Chapel. Constructed of red brick with central entrance and fine window detailing above, this building makes a significant contribution to the street scene. Would appear to have original window glass. Interesting initialled bricks presumably commemorating patrons.

Picture 83-84. Springs Christian Fellowship building south end of New Street. It makes a significant contribution to the street scene. Upper picture shows interesting inscribed brick.

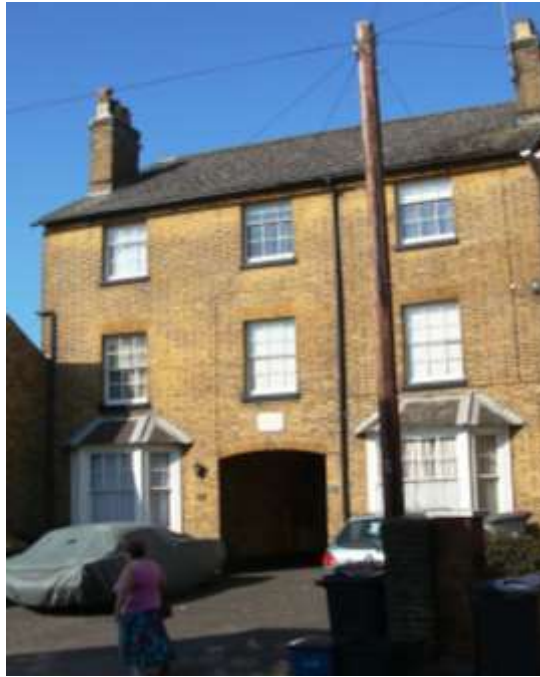
5.138. Nos. 27 - 29 New Road. Fine late 19th century three storey building of yellow brick construction with slate roof and 2 no. chimney pots. Central carriage entrance with plaque above reading *Christ Church School House 1884*. Good quality bay windows to ground floor. Above two ranges of 3 No. vertical sliding sash windows. An Article 4 Direction to provide protection for selected features may be appropriate subject to further consideration and notification.

Picture 85. Nos. 27 - 29 New Road an imposing three storey building set back from the road with central carriage entrance.

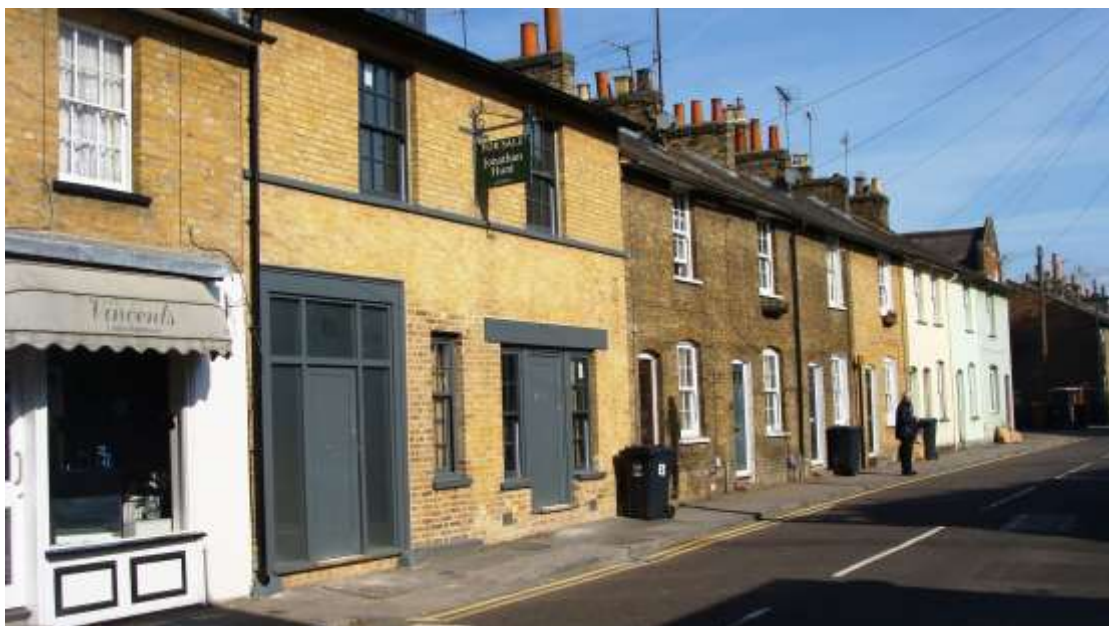
5.139. Nos. 9 - 25 New Road. A 19th century terrace of two storey buildings principally residential in use. Of yellow brick construction generally with slate roofs and good chimney detailing. Despite some exercise of Permitted Development Rights the terrace and its general mass and roofscape makes a positive contribution to the Conservation Area. Thus an Article 4 Direction to provide protection for selected features on residential properties may be appropriate subject to further consideration and notification.

Picture 86. Nos. 9 - 25 New Road an attractive 19th century terrace where the exercise of Permitted Development Rights has been more restrained than other examples elsewhere.

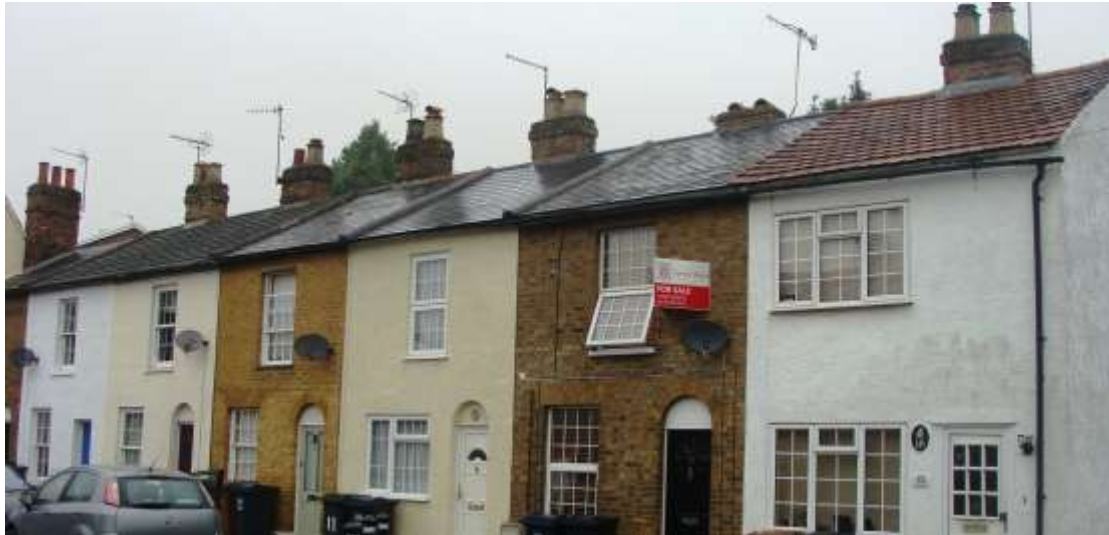
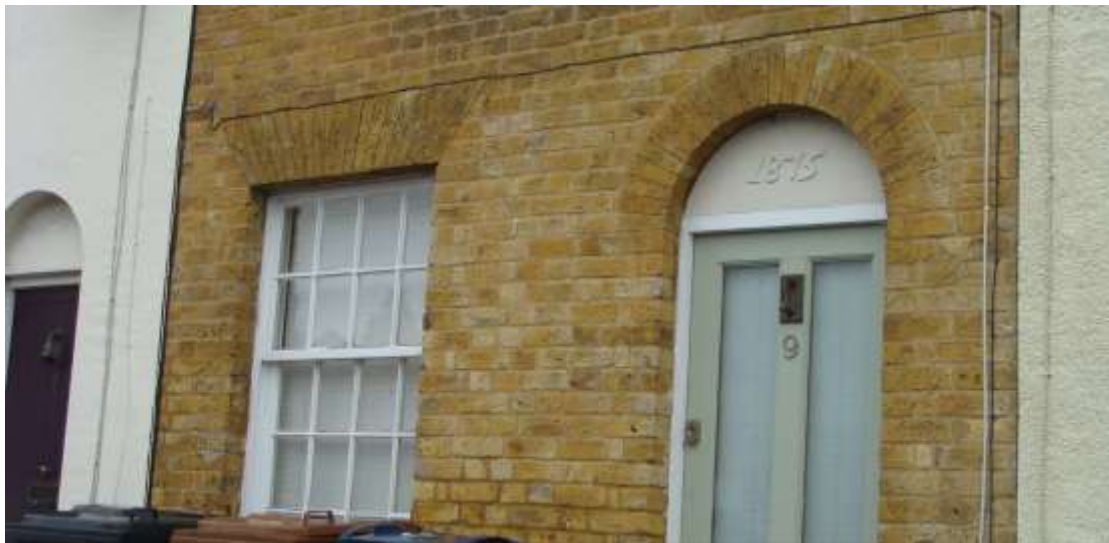
5.140. Nos. 3-15 Collett Road. A 19th century terrace of seven where the original unity and architectural cohesion has been compromised by the exercise of Householder Permitted Development Rights. These include application of render, different roofing materials and various windows and doors. Satellite dishes also detract. Nevertheless the buildings are worthy of retention and represent part of the historical development of the town.

Pictures 87-88. Nos 3-15 Collett Road. Upper shows the impact of individual householders' exercise of Permitted Development Rights. Lower photo shows quality of original brickwork detailing.

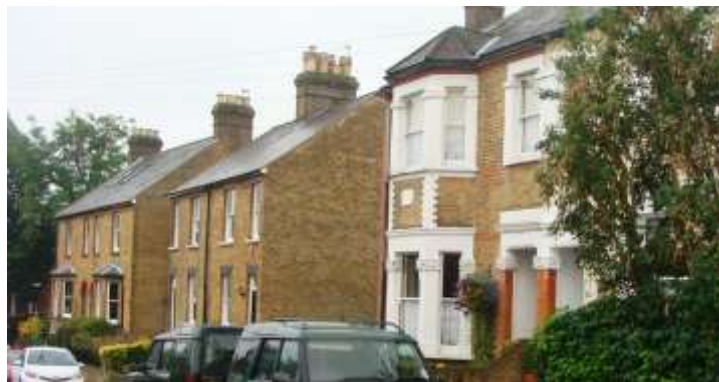
5.145. Nos. 9-19 Milton Road. Three pairs of late 19th/early 20th century dwellings. Constructed of yellow brick with slate roofs and chimneys with pots. Nos. 9-11 and 17-19 have recessed entrances. Nos. 17-19 have decorative bay windows to both floors; Nos. 9-11 have bay windows to ground floors. An Article 4 Direction to provide protection for selected features may be appropriate subject to further consideration and notification.

Picture 89. Nos. 9-19 Milton Road, pleasantly proportioned late 19th and early 20th century properties which are visually pleasing and historically important.

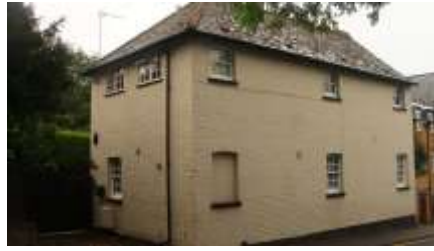
5.146. No. 62 Baldock Street. Two storey painted brickwork with hipped slate roof. Probably dates from late 19th century and surviving building of dense grouping at that time, now all replaced. Its simple historic design adds to the quality of the street scene in this immediate location.

Picture 90. No 62 Baldock Street, solitary historic building remaining in this immediate part of the street.

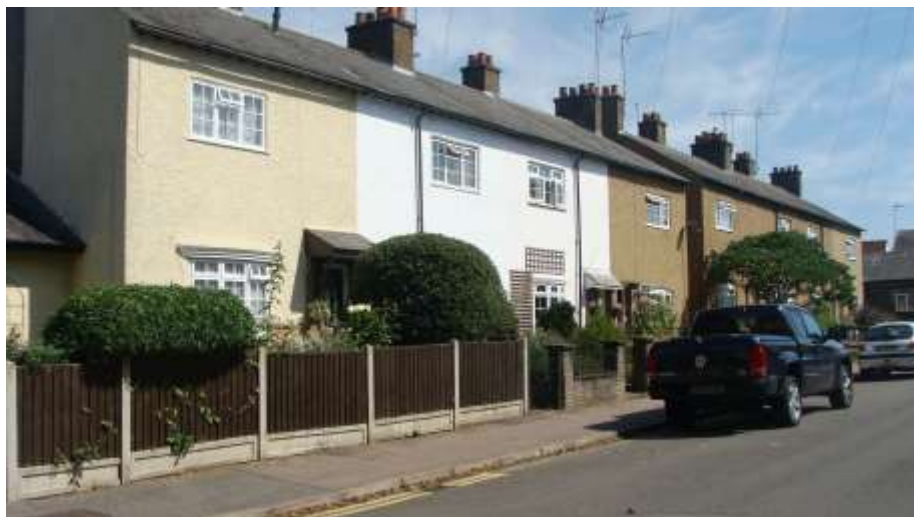
5.149. Nos. 1- 6 Century Road and Nos. 1- 10 and Nos. 11- 22 Coronation Road. Three groups of simply designed early 20th century pebble dashed properties all with slate roofs and repetitive chimneys with pots. Despite some modern windows and doors and render/painted surfaces their simplicity and uniformity and historical interest make them most worthy of retention. An Article 4 Direction to provide protection for selected features may be appropriate subject to further consideration and notification.

Picture 91. Typical early 20th century terrace properties at Century Road and Coronation Road whose simplicity form and roofscape add to the quality of the environment despite the exercise of some Permitted Development rights.

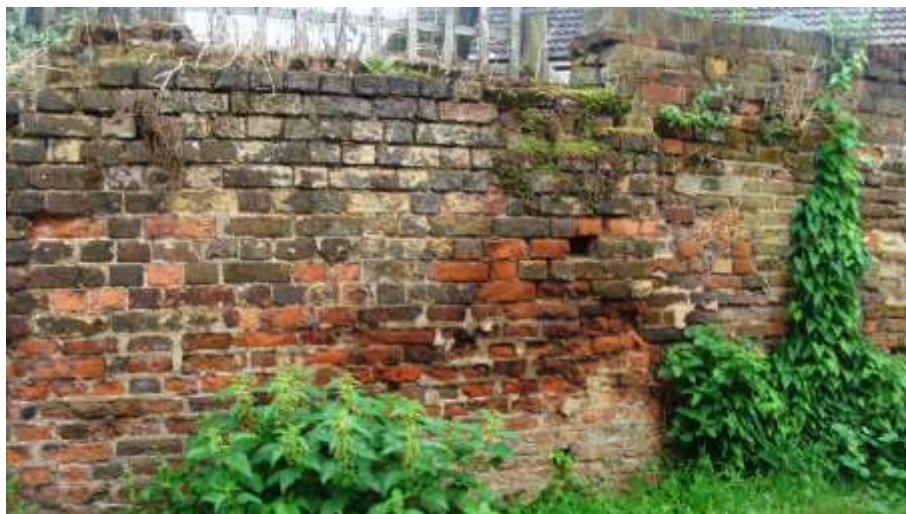
Picture 92. Wall in deteriorating condition to be retained; to rear of South Maltings, New Road.

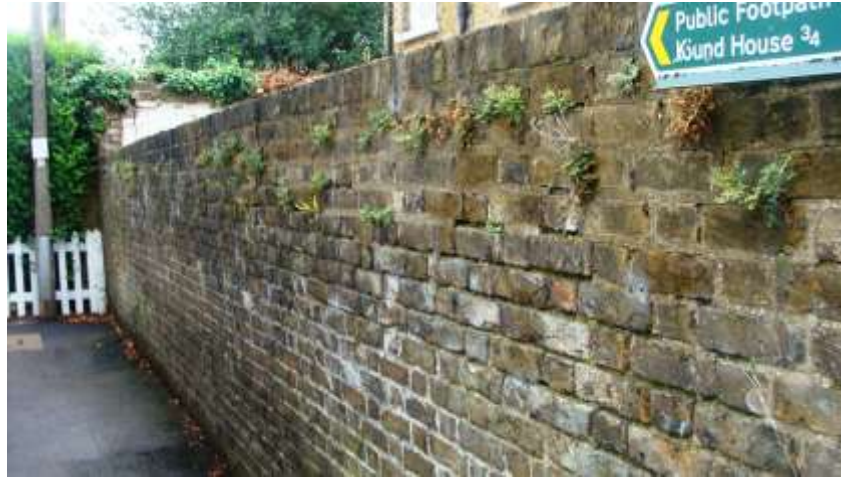
5.159. Wall adjacent to public footpath 5 - Little Horse Lane. Probably of late 19th/early 20th century date. A short but visually important length of wall adjacent to a public footpath and thus protected as it exceeds 1m. Careful removal of vegetation would be beneficial.

Picture 93. A short but important length of wall adjacent to footpath 5 Little Horse Lane, most worthy of retention.

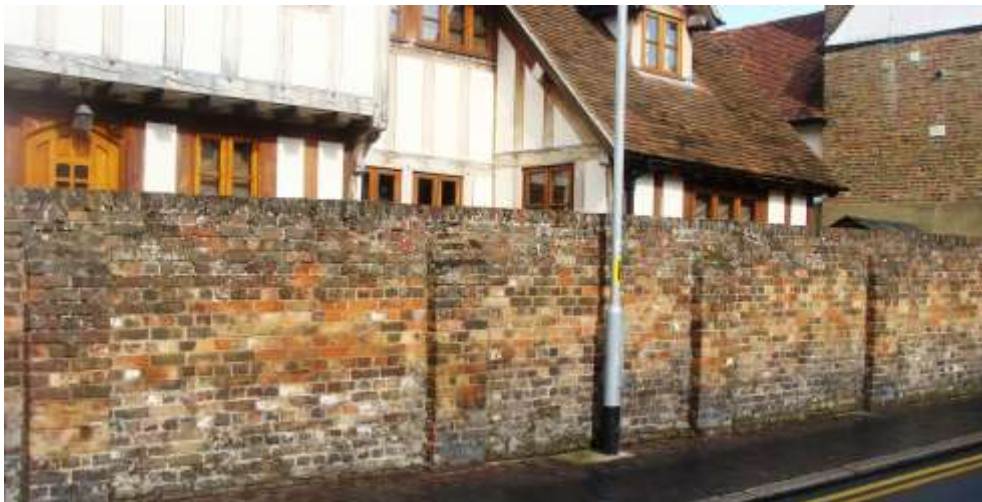
5.161. Wall to front of no. 21 Crib Street. Of red brick construction up to 2m in height and visually prominent in the street scene.

Picture 94. Restored and prominent wall which adds visual interest to this part of Crib Street.

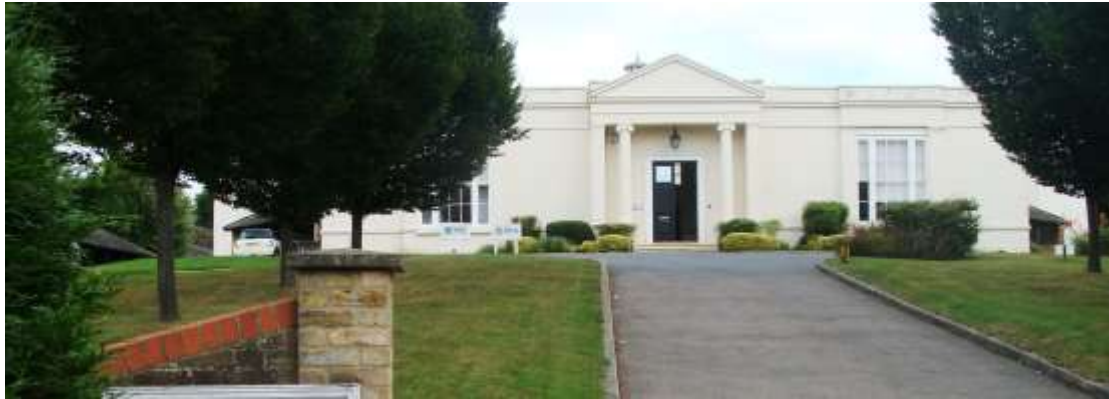
5.165. Open space to front of The Old Boardroom and The Octagon. A small but important open space that provides a fine setting for the listed building and a much needed 'breathing space' in this dense urban area.

Picture 95. Open space and formal tree planting provides a fine setting for the listed building and a 'breathing space' in this dense part of town.

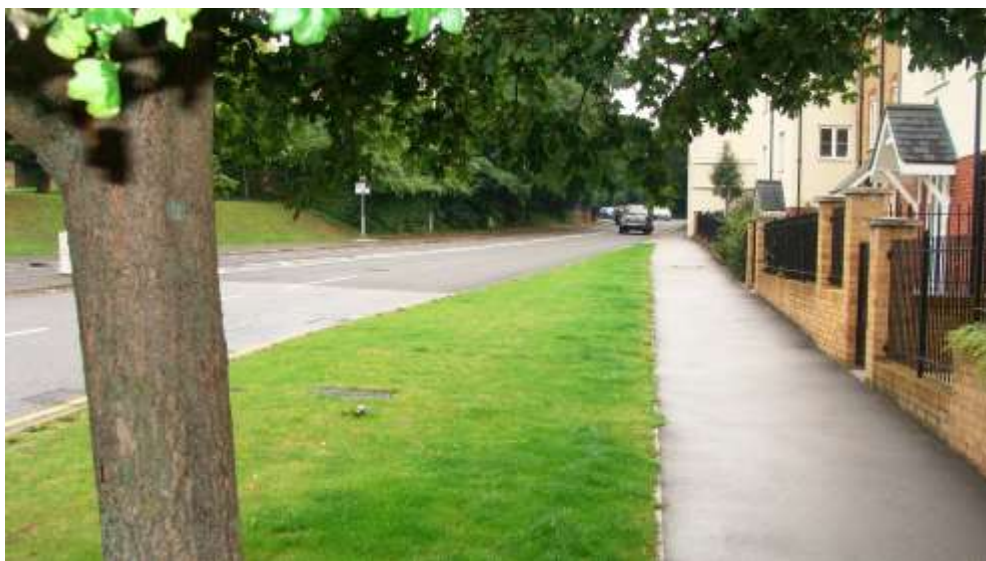
5.166. Open space to front of Fire Station, Baldock Street. An elevated open space with trees that makes an important contribution to the street scene in this location. Also narrow triangle of open space opposite Fire Station site, east side of Baldock Street.

Picture 96. Narrow triangle of open space Baldock Street, is there opportunity to plant a few additional trees?

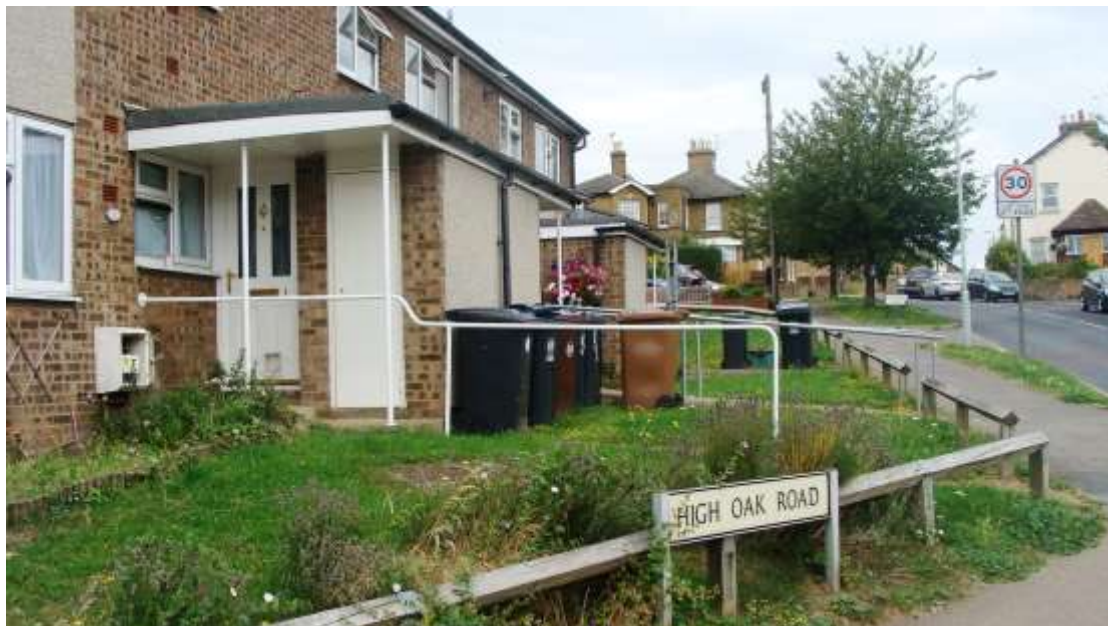
5.169. Elements out of character with the Conservation Area. Area around Goldstone Close. Mid/late 20th century housing that does little to contribute to the quality of the Conservation Area. Wooden fences and small gardens to front of Nos. 1-5 capable of being enhanced by hedge planting.

Picture 97. Housing corner of High Oak Road where hedge planting would significantly improve the general quality of the Conservation Area in this location. Is this possible?

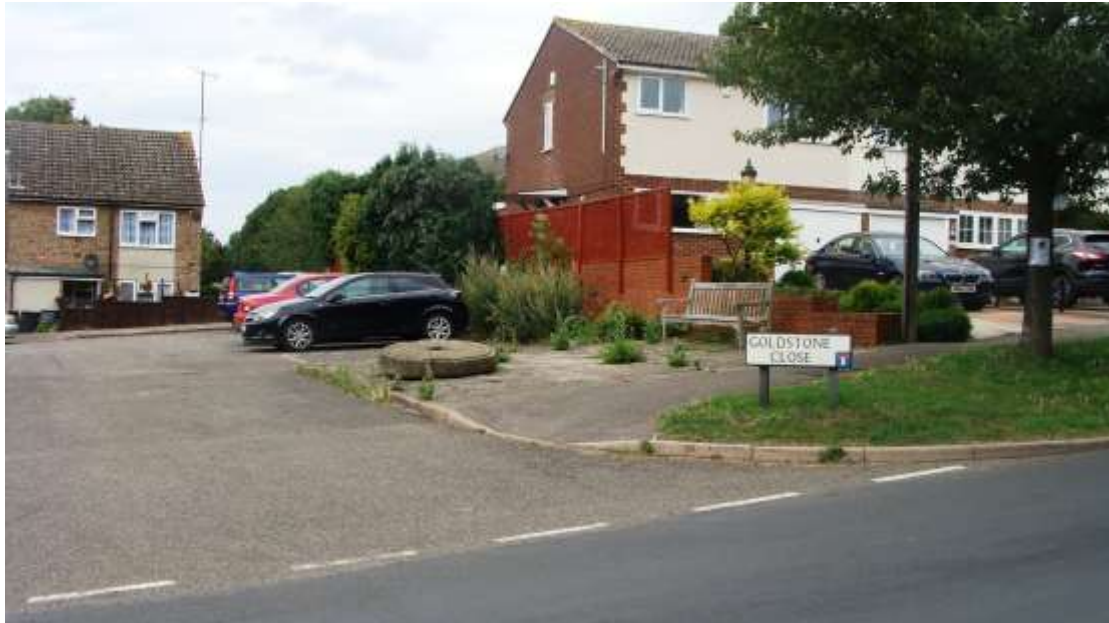
5.170. Also in the same general area there is a small communal sitting area that is shabby and weed infested and uncared for. Self set sycamores are establishing and these need removing before they become established. An old millstone feature has been displaced from its original position. The whole area represents an opportunity for improvement.

Picture 98. Communal sitting area at Goldstone Close in real need of improvement.

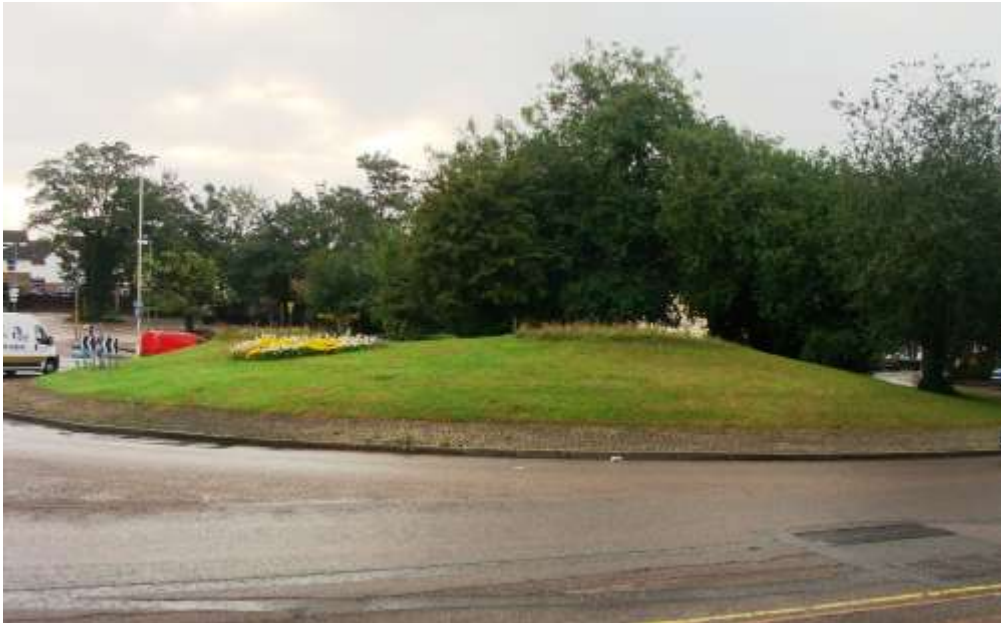
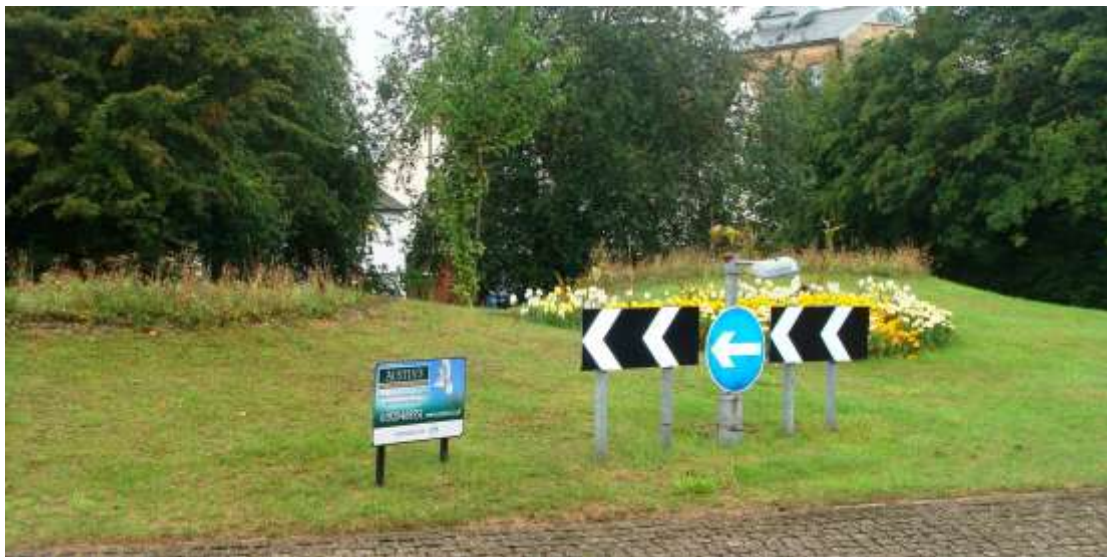
5.171. Roundabout at junction of Watton Road/Baldock Street. This roundabout is a key entrance point to the historic town. It is a large open space rather desolate in appearance, planted with various flower beds and consisting of grass with some centrally located trees. Roundabouts are difficult areas to satisfactorily landscape and high quality design solutions are the exception but not impossible to attain. However in this key location it is considered worthwhile to explore the potential of making significant improvements and this Appraisal recommends, if there is support for the idea, that a landscape consultancy be appointed to prepare an uplifting design worthy for this important entrance to a most important historic town. Solutions noted elsewhere in the country range from sensitively designed low maintenance soft landscape treatment to hard landscape solutions and other schemes involving sculpture of either a traditional or contemporary nature.

Pictures 99-100. The roundabout at Watton Road/ Baldock Street is a key entrance point to the historic town and would benefit from the preparation and implementation of a landscape uplift worthy of the historic qualities of Ware.

5.173. Opportunities to secure improvements. Consider appointing an experienced consultancy to prepare an uplifting landscape solution for the Watton Road/ Baldock Street roundabout, a key entrance point to the historic town. Repair frontage wall to Christ Church, New Road. Undertake refurbishment to Thunder Hall, a listed building; also remove vegetation from attached listed wall. Consider hedge planting, corner of High Oak Road. Initiate improvements to sitting area at Goldstone Close. Seek to remove vegetation from wall adjacent to footpath 5 Little Horse Lane. Consider the potential of additional tree planting, triangle of open

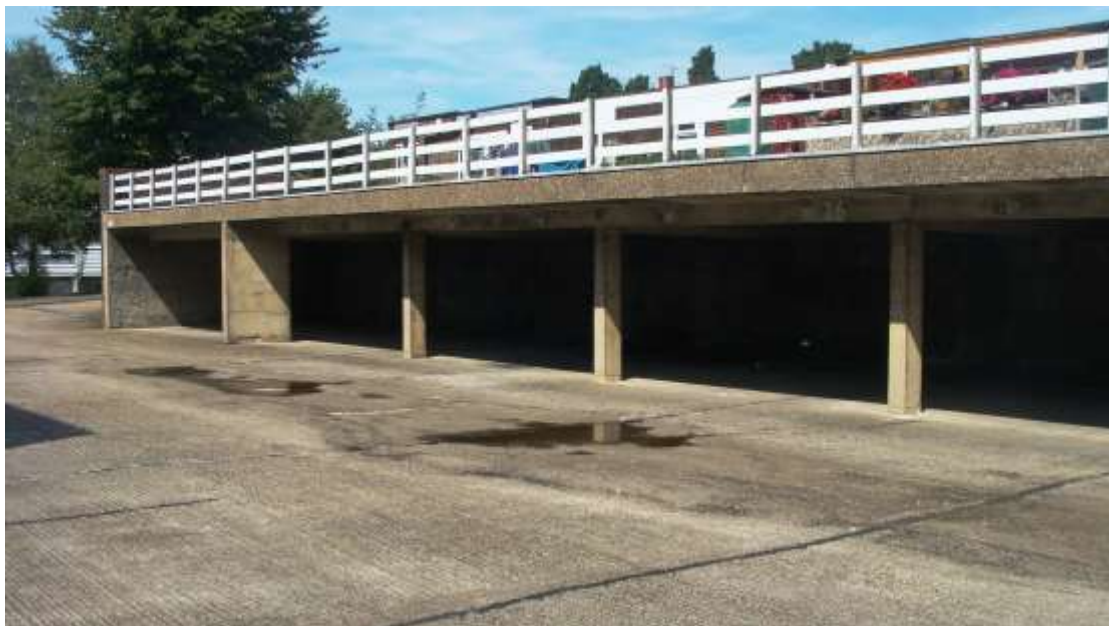
5.175. Within this area there is a large desolate parking area that the fieldworker considers to be underused. Nearby the concentration of parked cars on the road may be an issue of highway safety concern. It is advertised as being run by PCM (UK) Ltd and assumed to have been provided for the residents nearby.

Picture 101. Large desolate car parking area off Crib Street. What options, if any, are there to make improvements here?

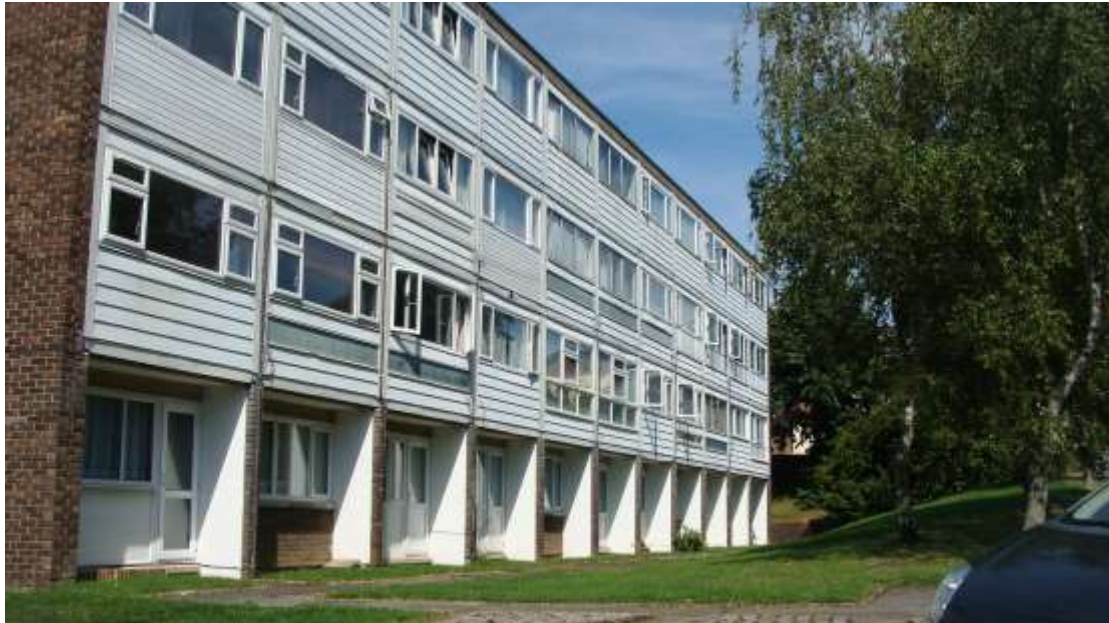
5.176. The whole area contains some trees but there may be opportunity to provide additional ones. Perhaps the opportunity exists to plant additional trees within highway areas subject to consent from the Highway Authority or there may be other opportunities to improve the environment by planting in private front gardens to improve the setting (e.g. front gardens to Nos.14-32 The Bourne).

Picture 102. Large scale development off Crib Street. Here it would seem there is opportunity to plant additional trees, subject to services.

5.177. It is therefore suggested this area is identified for further consideration by the three councils to identify opportunities to improve the general environment. In this respect surface improvements and tree planting may be options.

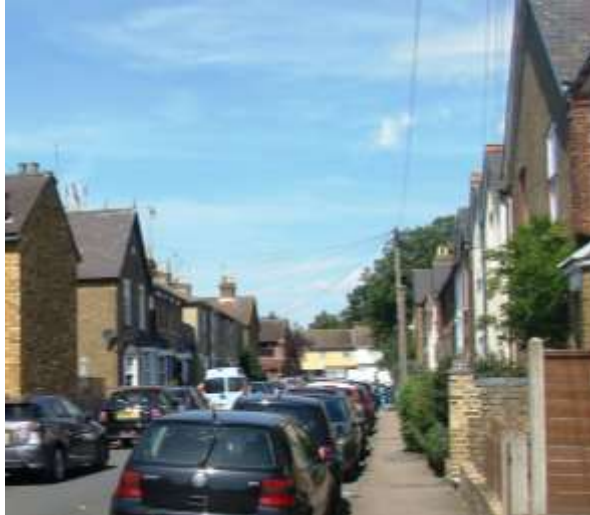
5.197. Nos. 1 - 18 and Nos. 21 - 33/33a/34/34a Gladstone Road. Interesting late 19th century properties located in a street part of which is now included within the Conservation Area. Properties are generally two storeys and of yellow brick construction with slate roofs and chimneys with pots. Many windows and doors and the occasional replacement of roofing material has occurred. Despite this the overall visual and historic importance of the street remains largely intact. The Royal British Legion is an interesting building with curved (asbestos?) roof. Some properties have original bay window detailing and some successful modern development has taken place at the southern end of the street. An Article 4 Direction to provide protection for selected features on historic buildings may be appropriate subject to further consideration and notification.

Picture 103. The Conservation Area has been extended to include some of Gladstone Road, a late 19th century street whose overall visual and historic importance remains largely intact. Note successful modern development on bottom left of picture.

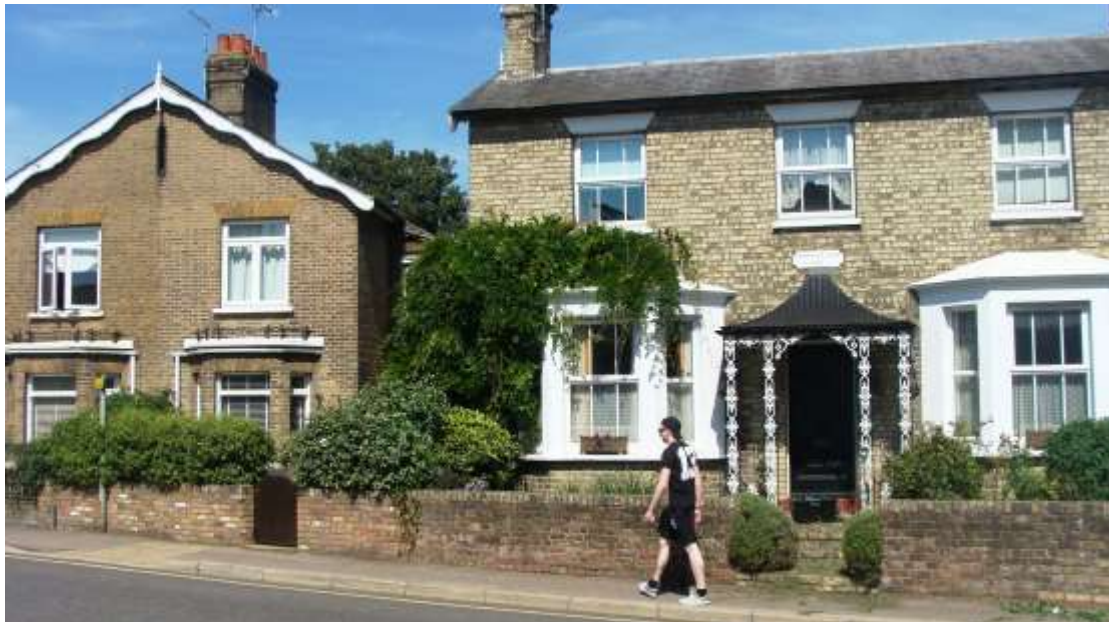
5.198. No. 4 and Nos. 6- 8 Watton Road. No.4, Cambridge Villa - two storey yellow brick with slate roof and 2 no. chimneys with pots; bay windows to ground floor. Decorative canopy to ground floor entrance. Wooden barge board detailing with finials. Plaque reads Cambridge Villa 1880. Nos.6- 8 of similar late 19th century date. This property has prominent barge boarding detail, a central chimney with pots and bay windows to ground floor. An Article 4 Direction to provide protection for selected features on both may be appropriate subject to further consideration and notification.

Picture 104. No.4 and Nos. 6 - 8 Watton Road. Late 19th century houses with good quality architectural detailing.

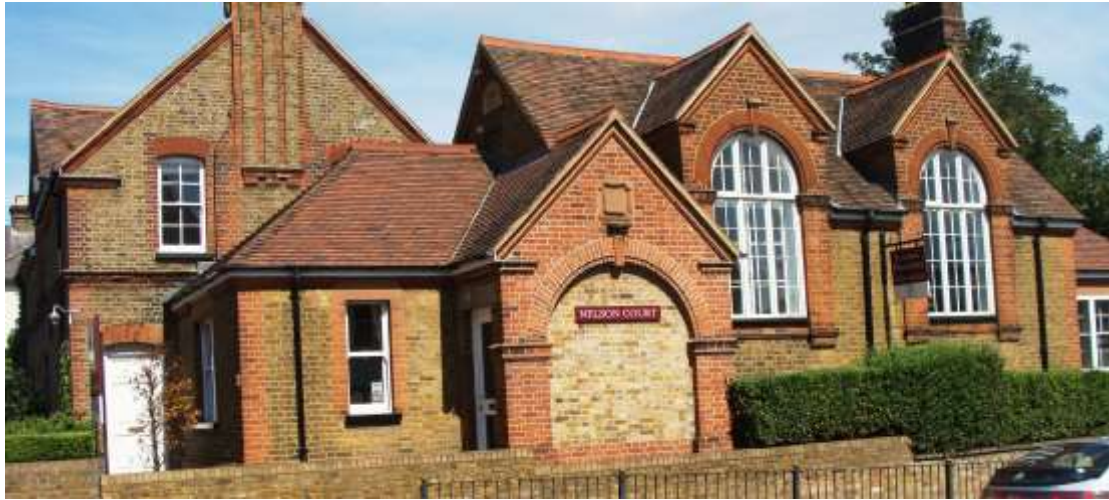
5.199. Nelson Court, Watton Road several commercial activities occupy. East corner of Watton Road/Gladstone Road. Fine late 19th century building that shows as Police Station (?) on 1897-1898 mapping. Of brick construction with tiled roof. Semi circular rubbed brick and other good quality brick detailing. Finely detailed chimneys with pots. Many features worthy of retention including tall window detailing and governed by existing planning controls.

Picture 105. Nelson Court, a fine group of late 19th century buildings with architectural features most worthy of retention, interpreted as originally having been a Police Station.

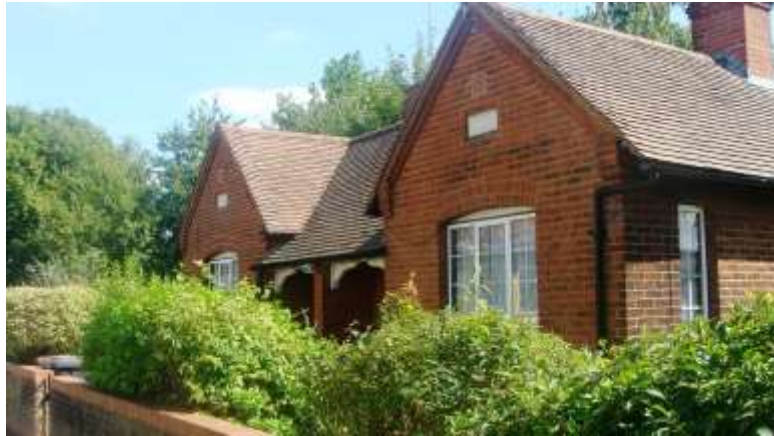
5.201. Nos. 45 - 47 Park Road. Pair of early 20th century single storey brick and tiled cottages. Recessed entrances with original wooden detailing above. 2 no. chimneys. Plaques read Harrison Bequest; erected AD 1908. Despite modern windows a charming pair and good representatives of their type and period. An Article 4 Direction to provide protection for selected features on both may be appropriate subject to further consideration and notification.

Picture106. Nos. 45-47 Park Road. Pair of single storey charming early 20th century bungalows retaining many original features.

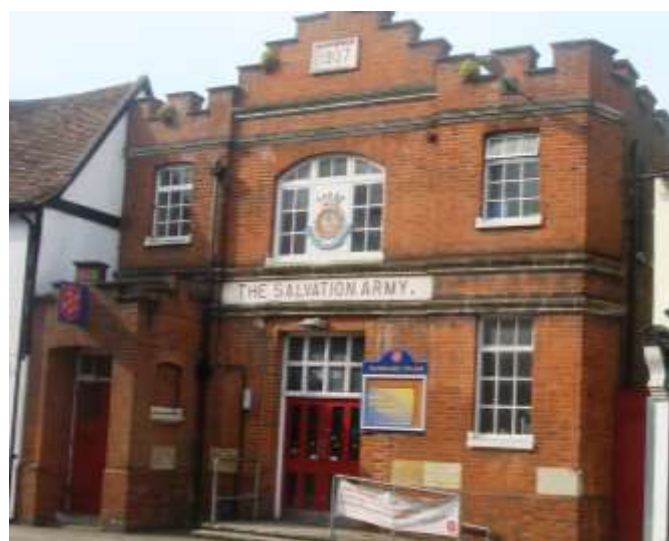
5.203. Salvation Army Hall, west side Baldock Street. Two storey red brick construction with unusual parapet detailing. Dating from the early 20th century with plaque of 1907. An unusual building that adds variety to the street scene and which should be retained. Identified on 1920-24 mapping as S.A. Hall. Detail protected by existing planning control.

Picture 107. Early 20th century Salvation Army Hall of architectural and historic interest that adds variety to the street scene.

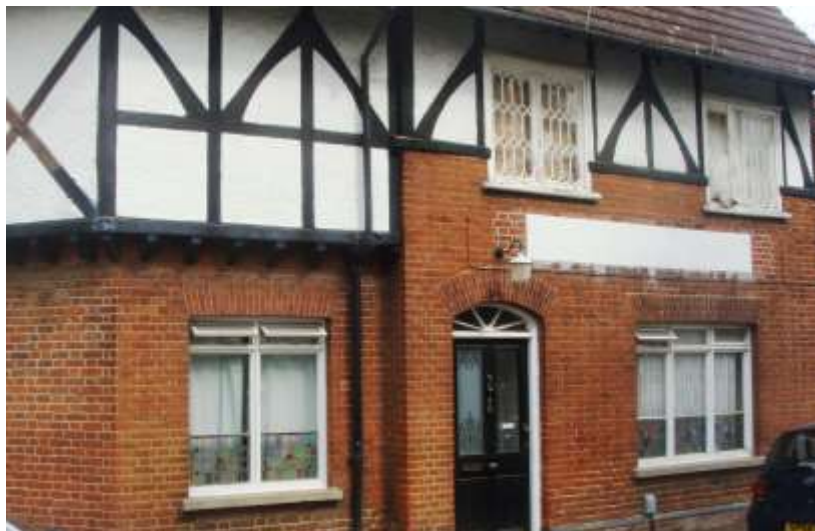
5.206. No. 46 Priory Street. Interesting late 19th century building of brick with decorative timber detailing to first floor. Also cast iron Arts and Crafts windows to first floor. An Article 4 Direction to provide protection for selected features on both may be appropriate subject to further consideration and notification.

Picture 108. No. 46 Priory Street, interesting late 19th century building.

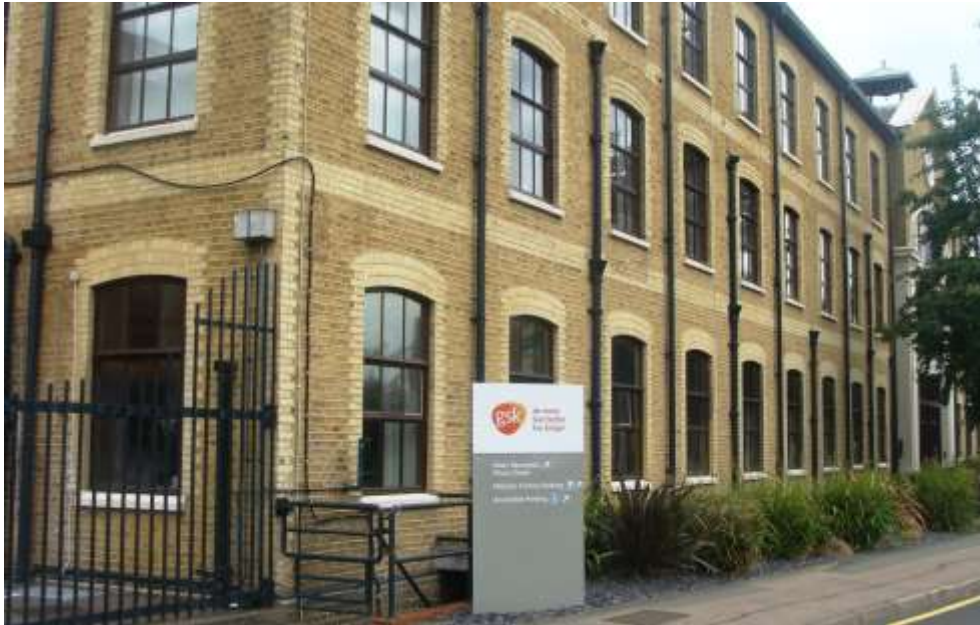
5.208. Long range of industrial building three storeys in height constructed of yellow brick, now occupied by GSK, north side of Priory Street. Fine entrance detail includes clock and date plaque 1911. Part of building complex shown on 1920-24 mapping as *Ware Mills (Food & Drugs)*. Detail protected by existing planning control.

Picture 109. A most satisfactory adaptation of an earlier industrial building of fine proportions.

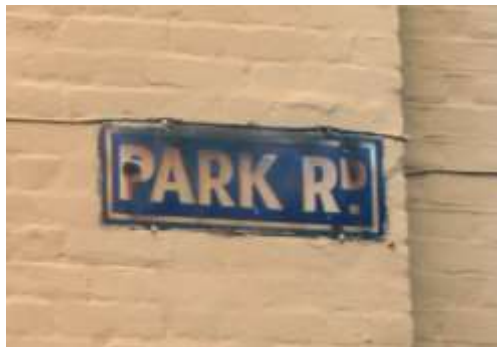
5.211. Early street signs. Several of these have been noted and it is important they are retained and where appropriate restored. The one illustrated below is attached to a listed building and in need of restoration.

Picture 110. Early Street sign. One of several. This one located on the Worppell PH.

redundant items.
Historic street name plates.	Various. Two noted Park Rd and Musley Hill.	Identify candidates and discuss with owners potential for restoration. If there is owner interest officers draft schedule of restoration.
Boundary railings.	North boundary to Buryfield Recreation Ground.	Undertake their repainting.
Deteriorating Listed Building and untidy site.	No. 19 Church Street.	Contact owner and discuss options. Potentially eligible for grant assistance (also see below).
Deteriorating front elevation of prominent commercial building.	No. 92 High Street - Wok u Like.	Contact owner and discuss options for improvements.
Deteriorating rear elevation of commercial listed buildings.	Nos. 96 - 96A and No.77 and No. 79 High Street.	Contact owner and discuss options for improvements.
Modern telephone kiosk, vandalised.	Corner Kibes Lane/ New Street.	Contact BT - repair/restore or consider its removal.

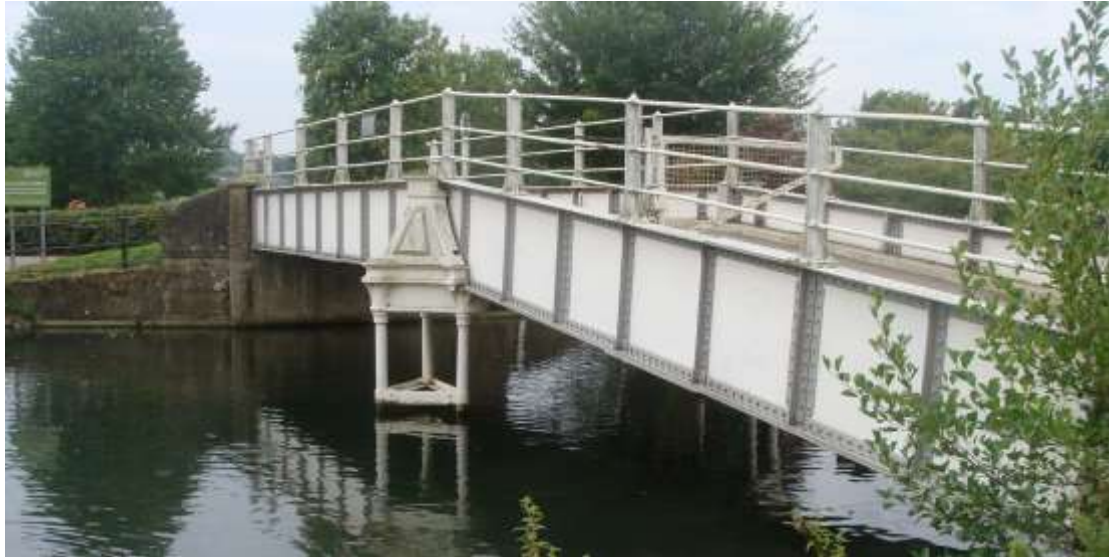
5.212. Bridge over River Lea. Date unknown to the writer without research but probably from the 19th century. Metal bridge with handrails and decorative triangular central supports. Certainly a bridge appears in this position on 1874-1894 mapping.

Picture 111. Bridge over the River Lea, a fine feature of considerable interest. Is there any knowledge regarding the date of its construction?

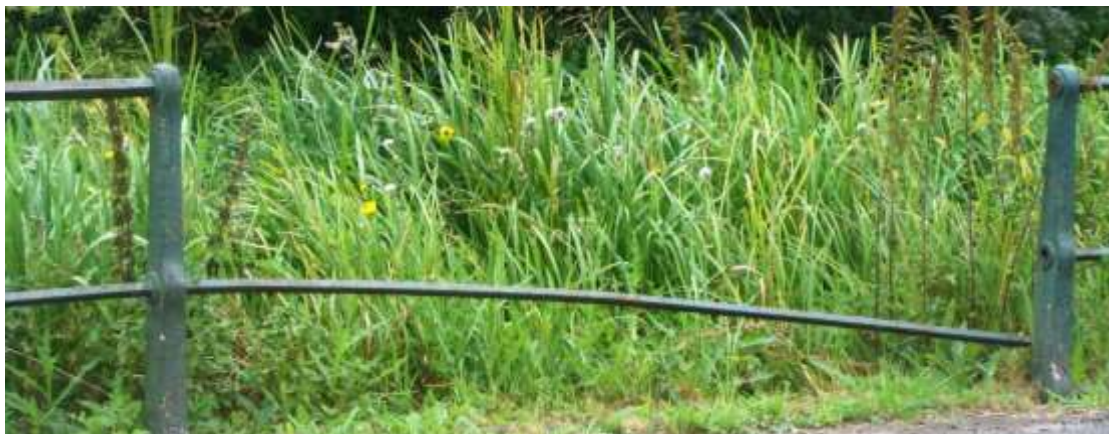
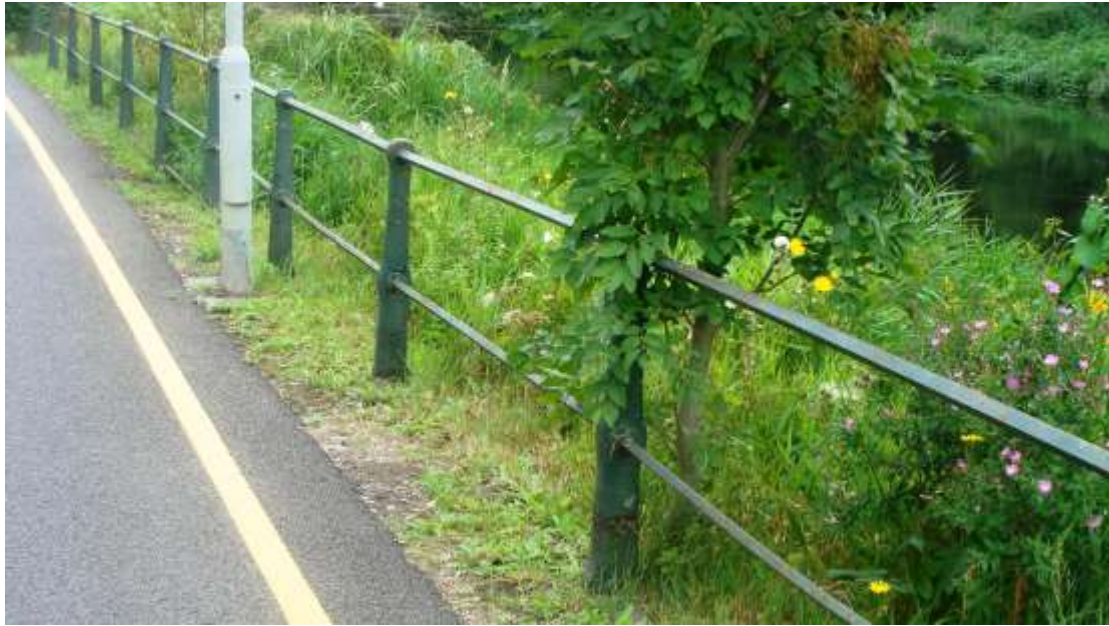
Pictures 112-113. Quality railings of historic importance contribute to the street scene; some sections are in need of repair.

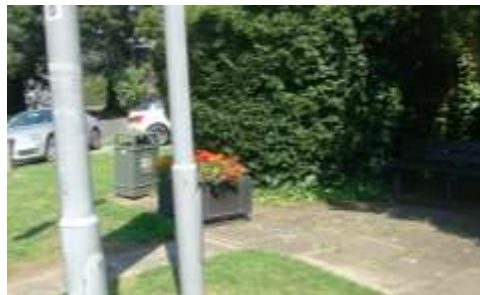
5.214. Important Open Spaces. Small but strategically located green with sitting area, Watton Road, west of Gladstone Road. This small sitting area houses various street furniture including litter receptacles, signage, flower box and seat. In parts concrete slab surface uneven. Some minor rationalisation/ improvements would be beneficial.

Picture 114. Sitting area Watton Road where some improvements and or rationalisation could be carried out.

5.227. Opportunities to secure improvements. Consider improvements/ rationalisation of street furniture on small sitting area on Watton Road to west of Gladstone Road. Repaint railings north boundary to Buryfield Recreation Ground.

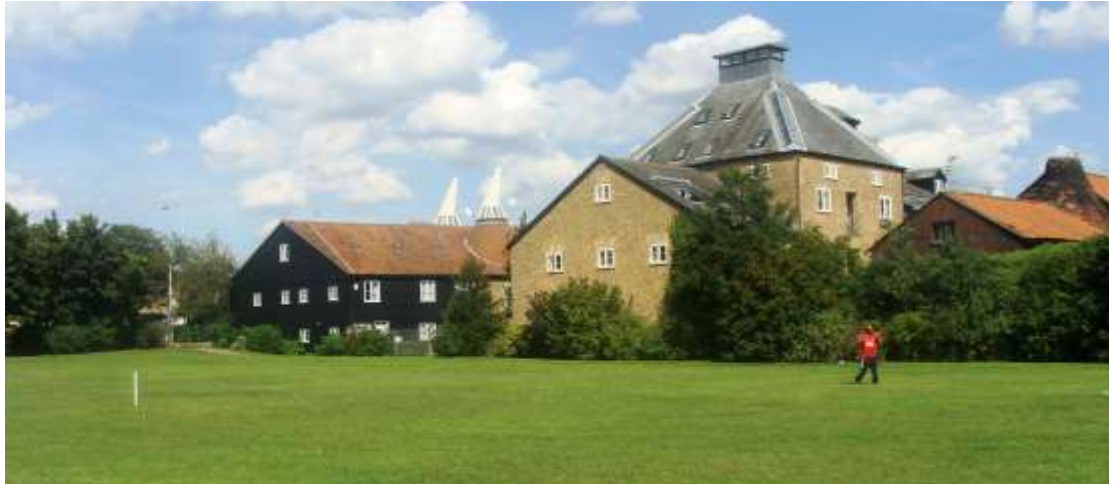
5.215. The Buryfield Recreation Ground. An extremely important open space well used for walking sitting and sports activities. Located in a key location and surrounded/contained in part by former Maltings buildings and with views across to the church. Its essential quality is its openness which should not be compromised. At the northern end of the site there is a raised display illustrating a brief Roman history and finds from the adjacent GSK site. Metal railings would benefit from repainting. Litter bins could perhaps be sited so as to be less visually intrusive.

Picture 115. Buryfield Recreation Ground. Its open nature and views it provides must not be compromised.
