WARE CONSERVATION AREA APPRAISAL AND MANAGEMENT PLAN

ADOPTED JULY 2016

East Herts District Council
Pegs Lane, Hertford, SG13 8EQ

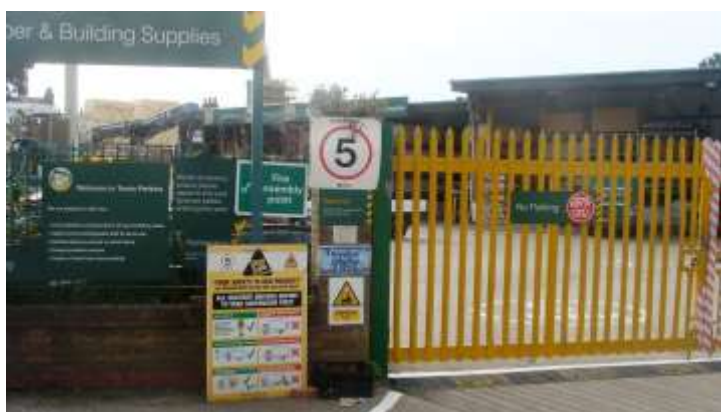
5.225. **Elements out of character with the Conservation Area.** Travis Perkins site, south of Watton Road. This industrial complex hemmed in by two important groupings of listed buildings could be a candidate for appropriate future redevelopment.

Picture 118. Travis Perkins site, contained by two groups of listed buildings this site could be a candidate for appropriate future development.

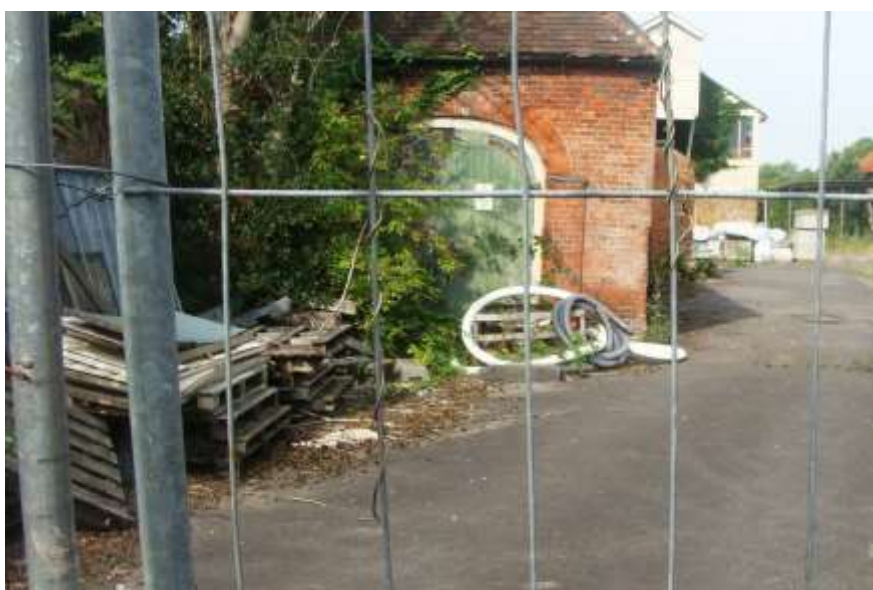
5.226. **Crook Brothers site.** Adjacent to Travis Perkins site. Potential candidate for future redevelopment. Contains one single storey brick building with pyramidal tiled roof and good quality circular arched rubbed brick detailing. This building may be worthy of retention subject to further investigation (access to site not available on day of survey).

Picture 119. Crook Brothers site. Potential site for appropriate redevelopment. The building with the arched entrance may be worthy of retention subject to further consideration.
