WESTMILL CONSERVATION AREA APPRAISAL AND MANAGEMENT PLAN

ADOPTED DECEMBER 2017

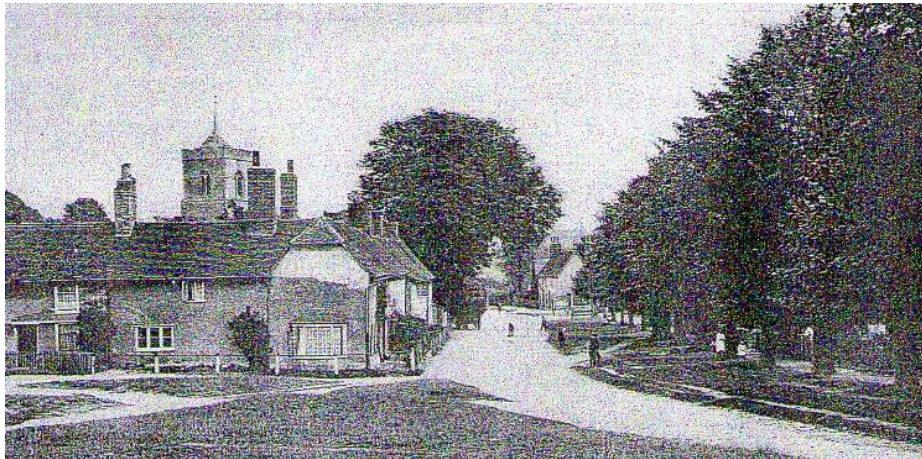
Picture 1. Westmill - photo probably from the late 19th century. Not a great deal has changed. Reproduced courtesy of Hertfordshire Archives and Local Studies (HALS).

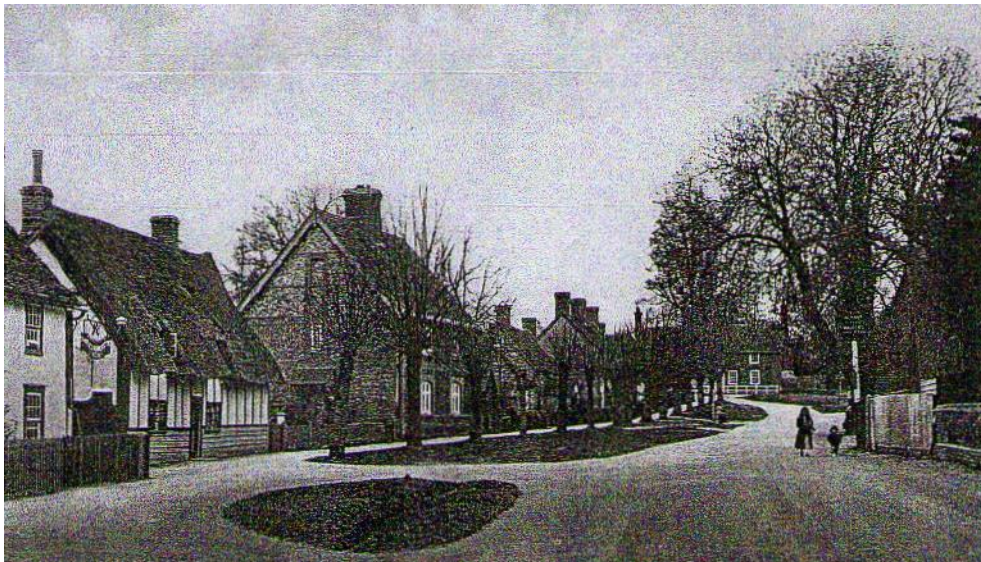
Picture 2. Line of original lime trees probably taken late 19th century. Reproduced courtesy of Hertfordshire Archives and Local Studies (HALS).

3.10. Mapping from 1874 -1894 (Plan 1) identifies the location of some of the activities listed above. It shows the railway line, station and associated goods yard east of the river, The Sword in Hand PH and a formal line of trees on the south side of the road opposite and west of the PH (on the alignment of the

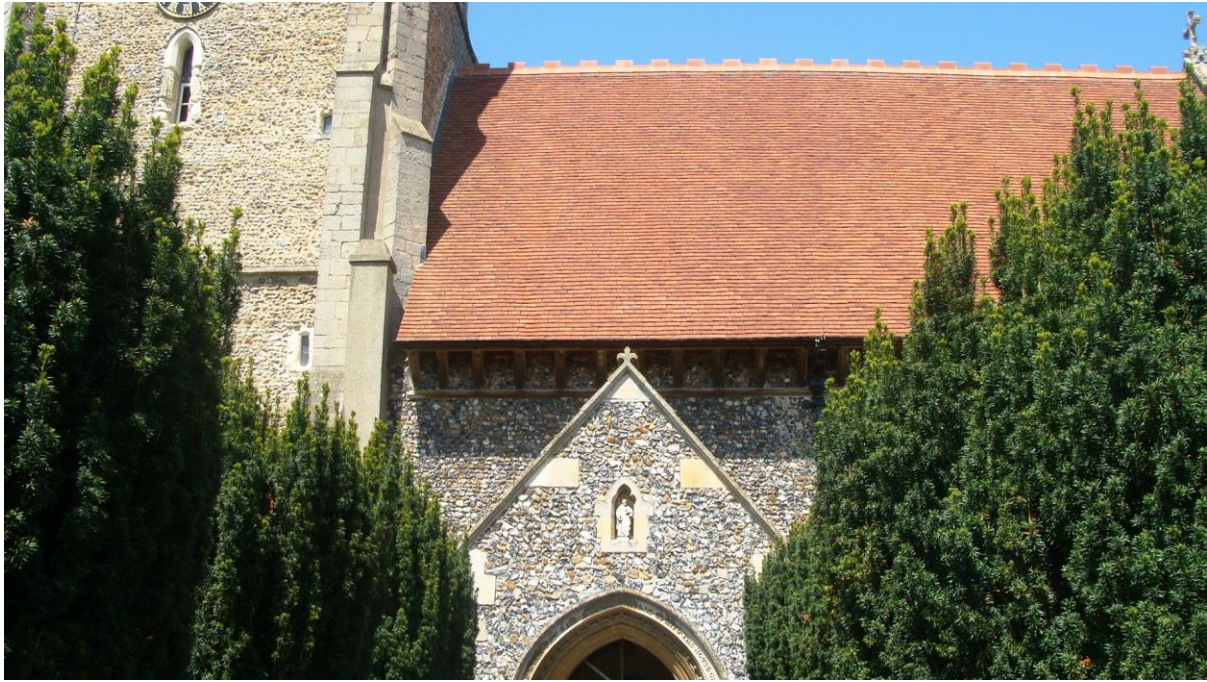
5.8. Parish Church of St Mary the Virgin - Grade II*. Parish church. Eleventh century nave, 12th century aisle, 13th century chancel, 15th century tower and nave roof. South porch rebuilt and church restored 1876. Flint rubble with coursed flint facing and limestone dressings. Steep red tile roofs. Small leaded Hertfordshire spire and vane on pyramidal slated base behind crenulated parapet of tower. Essentially a 2-cell pre-conquest church with unusually wide (and therefore important) nave. Gargoyles in middle of each face below parapet and deep moulded string around base. 15th century scissor-braced collar-purlin nave roof. 13th century memorial slab to Nicol de Leuknore, octagonal late 15th clunch font, 15th century benches with buttressed ends. *The roof has recently been restored with the assistance of grant aid at a cost of £160,000 the fieldworker was advised. The lych gate was also being repaired at time of survey.*

Picture 3. St Mary's church, a grade II* building with its recently restored roof.

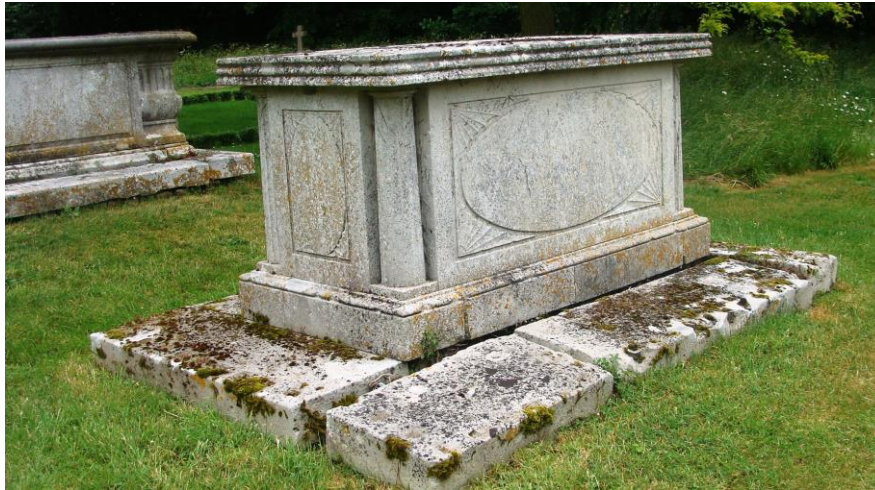
5.9. Tomb in St Mary's churchyard - Grade II. Tomb chest. 18th century. Inscription worn (possibly to William Prisimer). Limestone with grey stone top slab. A rectangular tomb chest. Raised curb and moulded splayed base. Recessed gadrooned baluster corners. Rectangular stone panels on each face with raised and fielded panel. Moulded edge to overhanging top slab with primary inscription. *This structure is included on the Council's Heritage at Risk Register and is thus potentially eligible for grant assistance.*

5.10. Enever Monument in St Mary's churchyard - Grade II. Tomb chest. Early 19th century. To Judith Enever died 1811, William Enever died 1838, and his 2nd wife. Limestone. Rectangular tomb chest on raised curb. Moulded base. Rectangular panel on each face with inscribed oval and fan pattern in each spandrel. Inset fluted Greek Doric column at each corner. Rectangular projecting top slab with reeded edges. *This structure is included on the Council's Heritage at Risk Register and is thus potentially eligible for grant assistance.*

Picture 4. Listed chest tomb within St Mary's churchyard, one of two in need of repair and restoration and both, without prejudice, potentially eligible for EHDC financial assistance.

5.66. Opportunities to secure improvements. Repair 2 No. chest tombs to front of St Mary's churchyard that, without prejudice, are candidates for grant assistance from EHDC. Improve the appearance and reduce impact of agricultural storage area when viewed from the public realm; being open land to the east of River Rib (site of former railway station). Initiate minor selected repairs to wall fronting and to east side of St. Mary's churchyard. Consider potential for improving directional signage on central green. Consider if there is a better solution to the existing notice board on wall near central green. (Some improvements to the latter two items have now been undertaken). Undertake repairs to curtilage listed wall Dial House.

| Detracting element. | Location. | Proposed Action. |
|---|--|--|
| 2 No. listed chest tombstones in need of repair. | To front of St. Mary's churchyard. | Without prejudice consider making application to EHDC to execute appropriate repairs. |

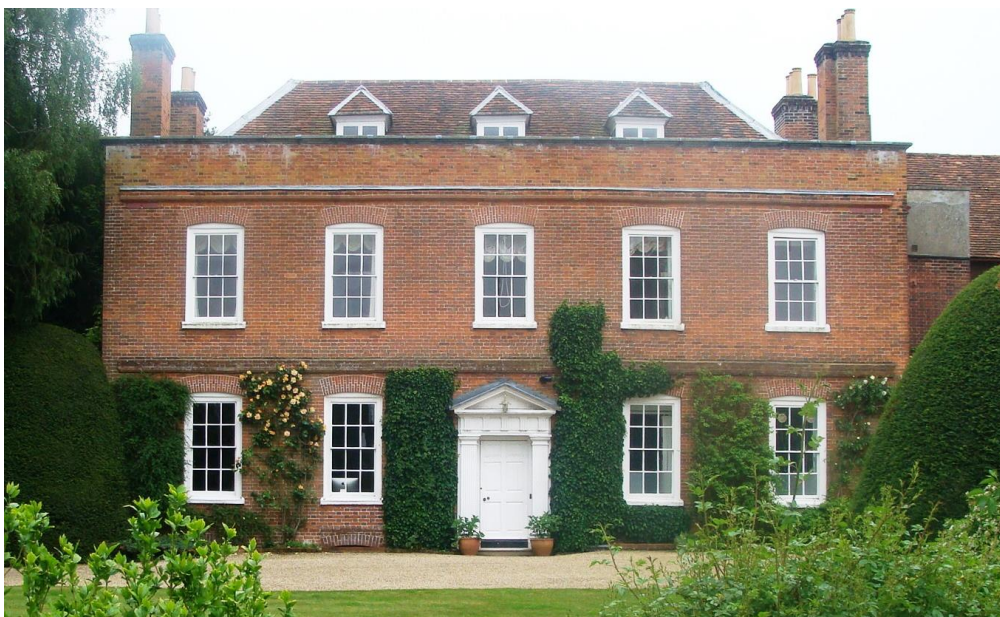
5.11. Westmill Bury - Grade II*. Early 18th century. Red brick with old red tile roof. Double-pile plan main block of 2 storeys, cellar and attics, 5 windows wide, facing north and south. Symmetrical north and south fronts each with central doorway and slightly recessed box sash windows. North front has a pilastered Tuscan doorcase with full entablature and triangular pediment. South front to garden has a fanlight and a Doric doorcase with fluted pilasters.

Picture 5. Westmill Bury a fine Grade II* listed house dating from the early 18th century.

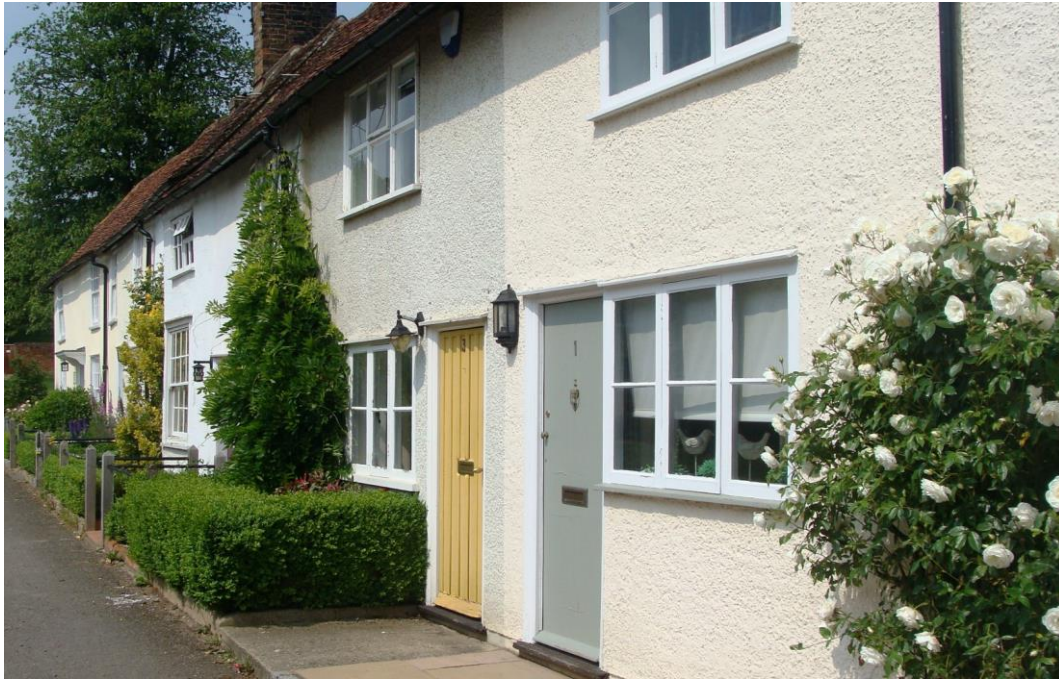
5.12. Pilgrims Row - grade II. Block of houses. Early 18th century for Samuel Pilgrim, altered early 19th century. Timber frame roughcast with steep old red tile roofs. Slate lean-to at rear. Central chimneys upper parts in stock brick. A 2-storeys continuous row. A picturesque group with Pilgrims House, next the village inn.

Picture 6. Pilgrims Row - a picturesque group of listed cottages in the centre of the village; quintessentially English is character.

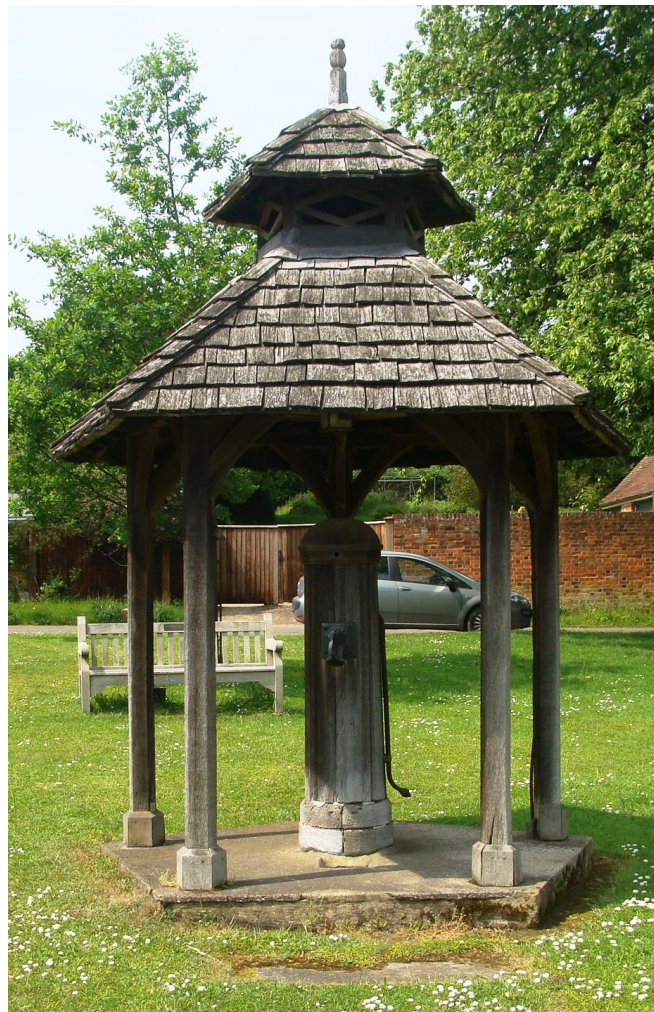
5.17. Village Pump and Canopy - Grade II. Pump and canopy. About 1900, restored 1975. Cylindrical and domed oak to pump mechanism with fluted and spurred cast bronze spout enclosure and acorn finial. Oak hexagonal canopy on 5 posts with shingled roof in 2 stages with carved finial. Arts and Crafts Style carved decoration to tapering cylindrical casing with double chamfered base, vertical fluted and moulded sections, moulded capital and domed top carved with overlapping pointed leaves. Inscribed around capital 'TRAVERSE THE DESERT AND THEN YOU CAN TELL WHAT TREASURE EXISTS IN THE COOL DEEP WELL'. Oak posts with curved braces to wall plate and brackets supporting boarded soffit. Centrepiece of picturesque village green.

Picture 7. Picturesque Arts and Crafts style pump and canopy believed to date from about 1900.

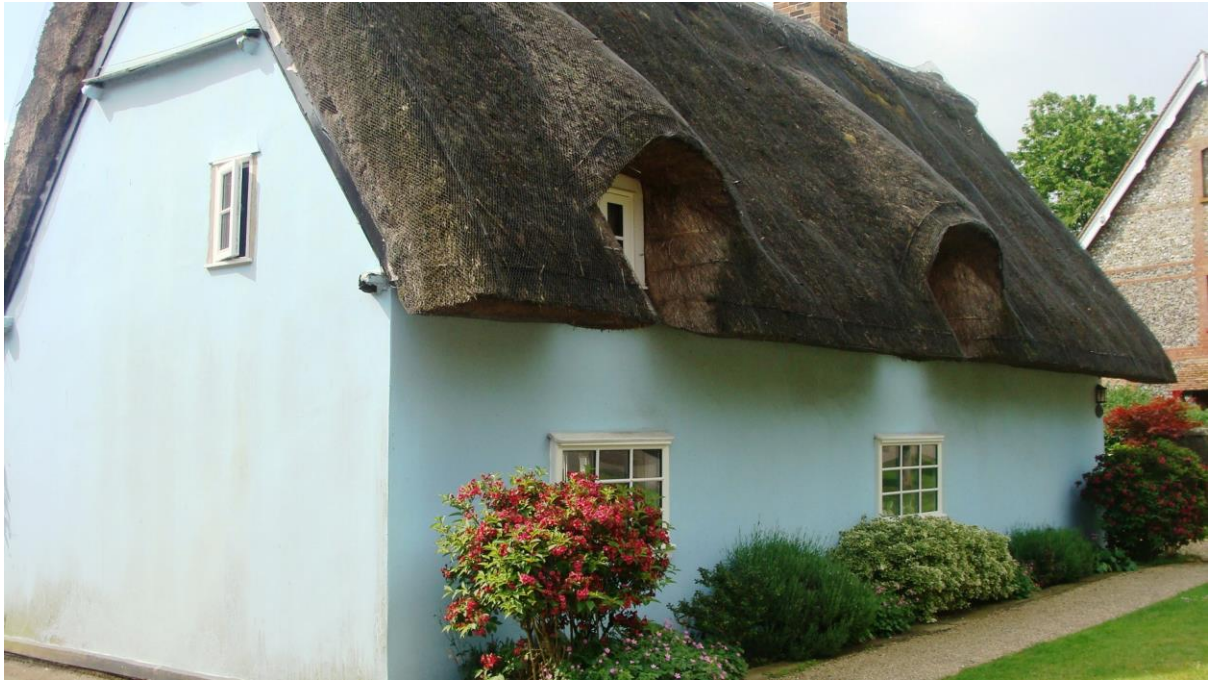
5.18. Woolpack Croft - Grade II. 17th century or earlier. Timber frame plastered with steep thatched roof. Eyebrow dormers with 2-light casement windows at eaves. *There are several thatched properties in Westmill that add significantly to the character and diversity of the conservation area.*

Picture 8 Woolpack Croft - a delightful thatched property listed grade II with typical eyebrow dormers.

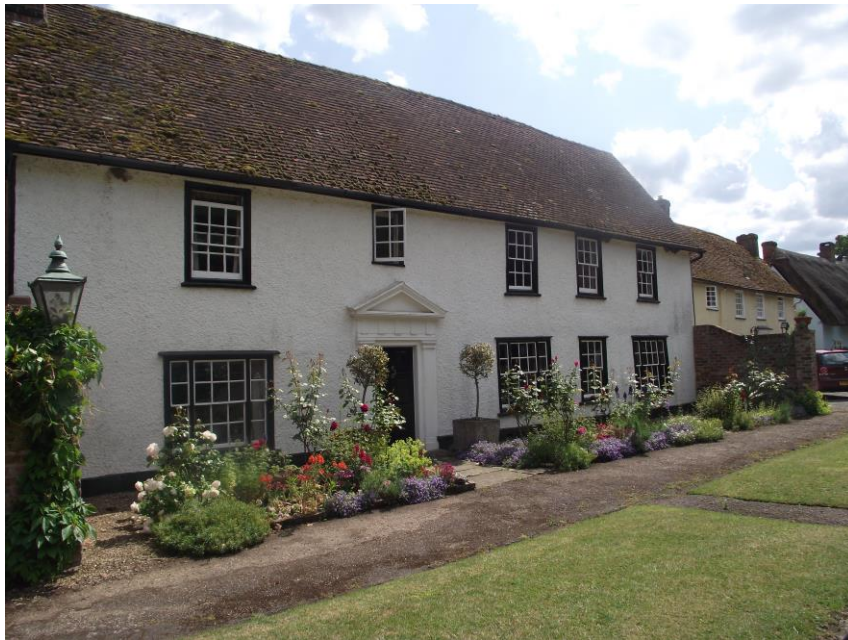
5.19. Church House – Grade II. 16th century south wing, early 17th century front block with rest *later*. Timber frame roughcast with steep old red tile roofs. Bellcast and plastered soffit to front eaves. Doric doorcase with fluted pilasters and triangular pediment with triglyph frieze.

Picture 9. Church House dating from the 16th century, listed grade II. Photo reproduced courtesy of owner, David Mills.

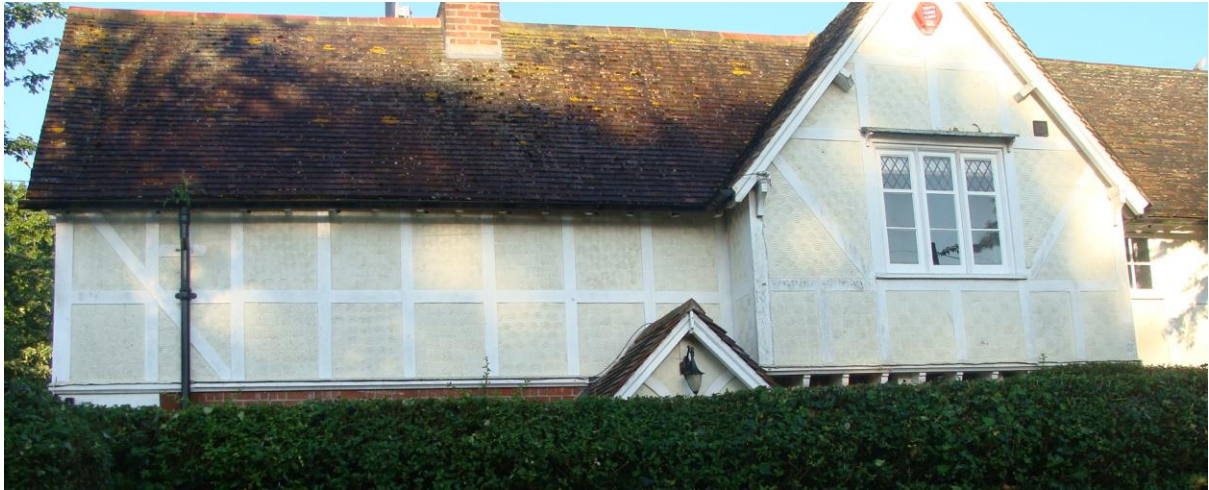
5.26. Gaylors Cottage. Located on prominent corner site and dating from late 19th/early 20th century. Brick to ground floor with render and decorative painted timber detailing to first floor. Tiled roof and chimney. Timber bargeboarding and eaves detailing. An Article 4 Direction to provide protection for selected features may be appropriate subject to further consideration and notification.

Picture 10. Gaylors Cottage - a late 19th/early 20th century house considered to be worthy of retention and additional protection. Prominent tiled roof adds quality to the conservation area in this location.

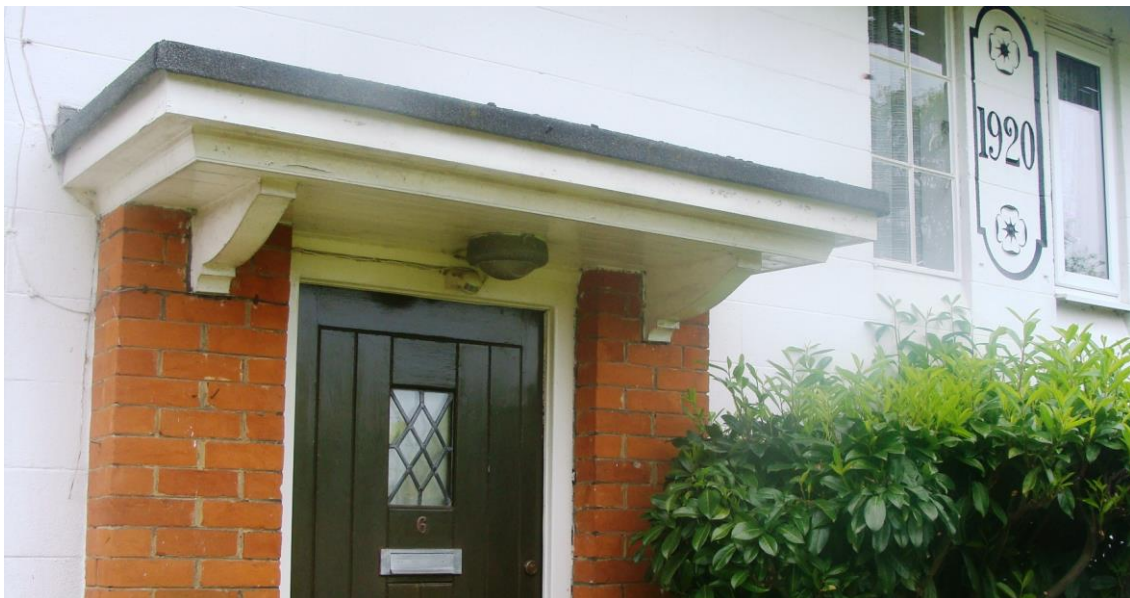
5.27. Nos. 1-6 The Terrace. Three pairs of single storey dwellings dating from 1920. Of blockwork and brick construction with pyramidal tiled roofs and chimneys. Original canopies. No. 6 retains original Crittall metal windows but others are replacements. Despite this the grouping retains much of its original unusual character. An Article 4 Direction to provide protection for selected features may be appropriate subject to further consideration and notification.

Picture 11. Unusual early 20th century council properties with original plaque and canopy detailing. Mostly original detail worthy of retention and protection.

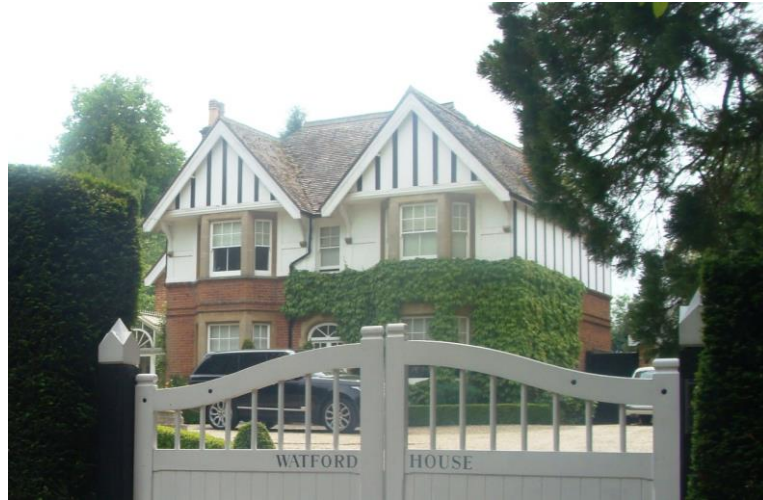
5.28. Watford House. Dates from the early 20th century. Large detached residence of brick to ground floor and render to first floor with wooden decorative detailing. Bay windows to both floors and centrally located entrance to front elevation. Tiled roof

and chimneys. An Article 4 Direction to provide protection for selected features may be appropriate subject to further consideration and notification.

Picture12. Watford House. Large detached property dating from the early 20th century, typical of its type and period.

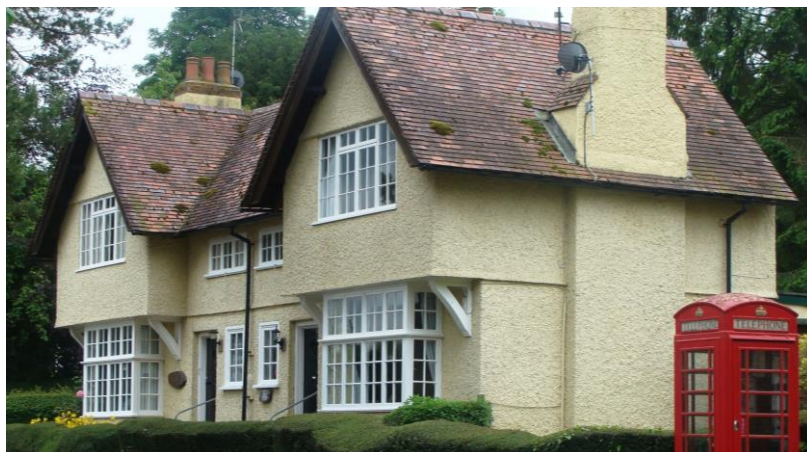
5.30. School Cottages. Dating from the late 19th/early 20th century. Prominent in the street scene. Of rough render with tiled roof and two large chimneys. Boxed windows to ground floor; upper floor protrudes. Some simple decorative wooden detailing; sympathetic window detailing common to frontages of both properties. An Article 4 Direction to provide protection for selected features may be appropriate subject to further consideration and notification.

Picture 13. School Cottages - a fine pair prominent in the street scene with features of architectural interest most worthy of retention and additional protection.

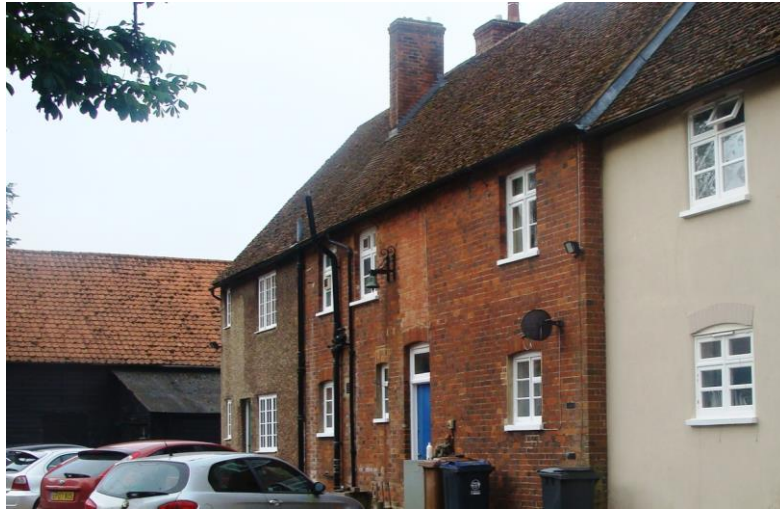
5.31. Residential accommodation at Westmill Bury Farm. Late 19th century of brick and render with steeply sloping tiled roof with chimneys. Modern window detailing detracts. Nevertheless worthy of retention and additional protection. An Article 4 Direction to provide protection for selected features may be appropriate subject to further consideration and notification.

Picture 14. Residential accommodation at Westmill Bury Farm of brick construction with steeply sloping roof of historical and architectural merit worthy of retention.

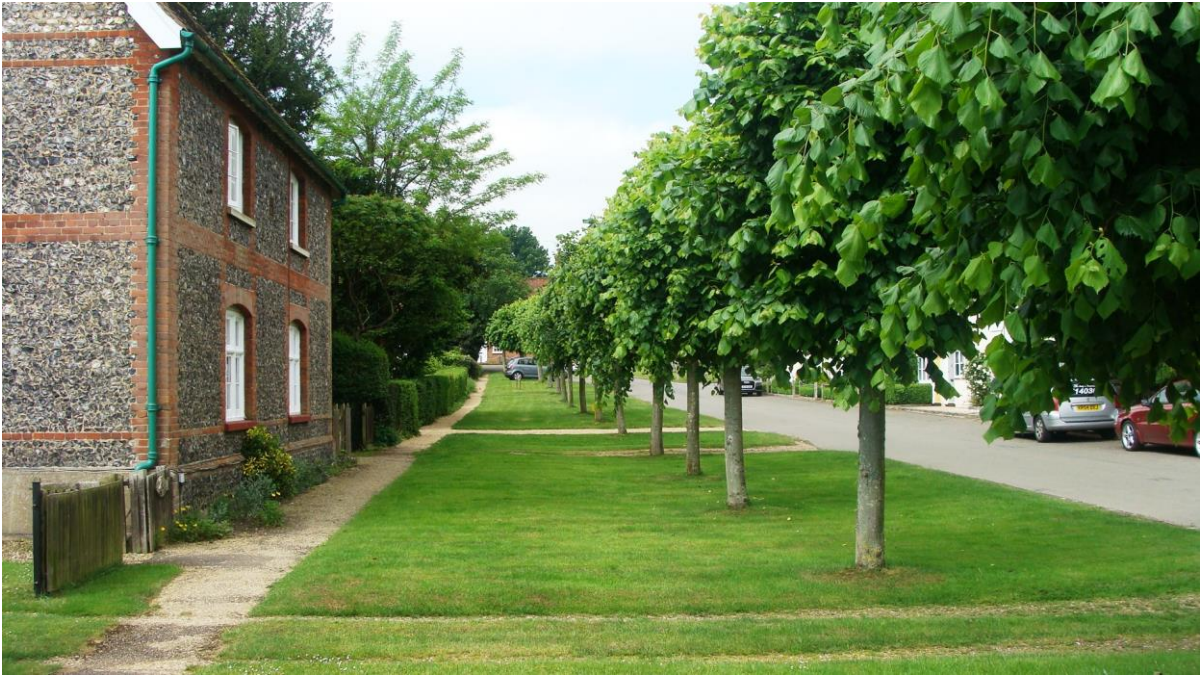
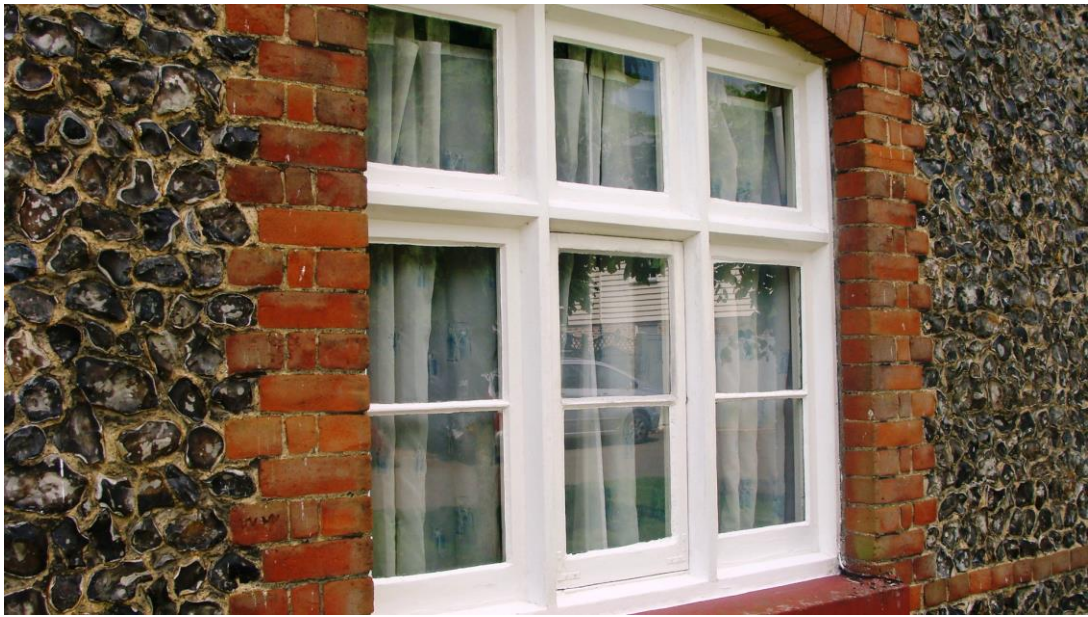
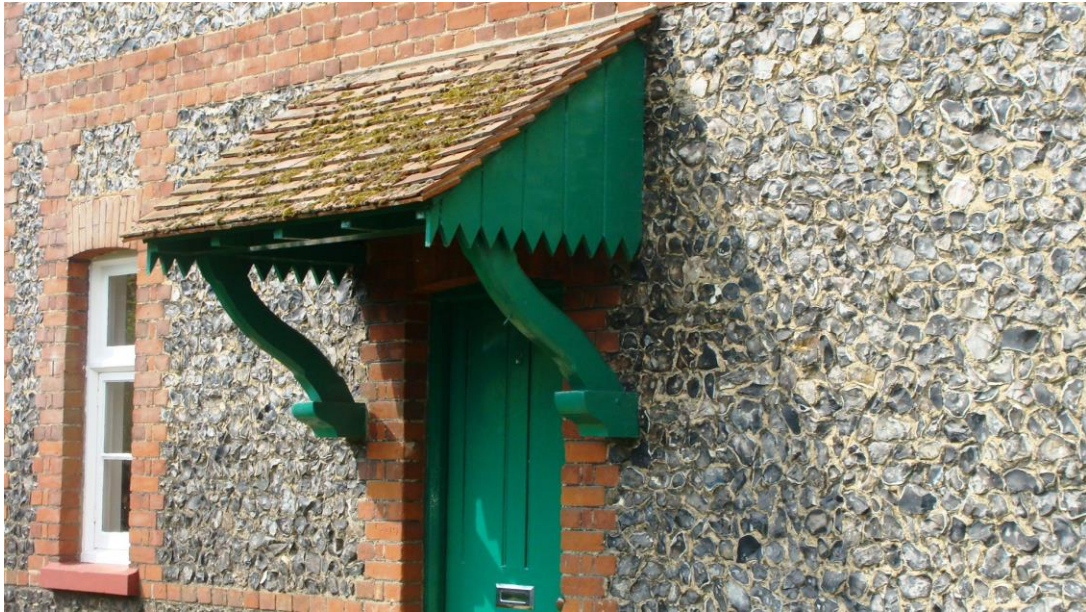
5.32. Flint Cottages, opposite Sword in Hand PH. A finely detailed pair probably of early 20th century date of flint construction with horizontal brick banding and window surround detailing. Tiled roof and central chimney. Early/sympathetic windows and high quality original canopy detailing to each end. An Article 4 Direction to provide protection for selected features may be appropriate subject to further consideration and notification.

Pictures 15-17. Flint Cottages. Particularly fine flint and brick cottages probably dating from the early 20th century, unspoilt with many good quality features.

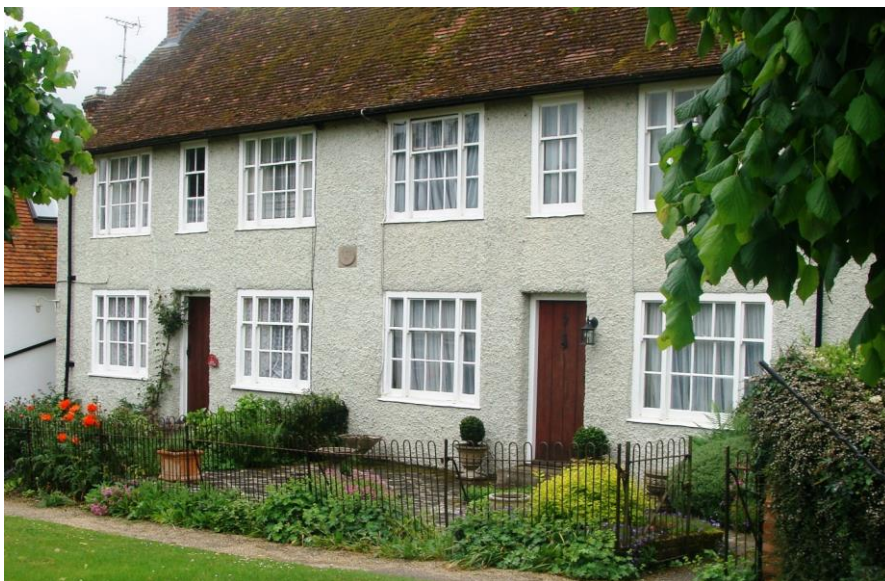
5.33. Nos. 1-2 Hope Cottages. Terrace of two prominent in the local street scene and dating from the early 20th century. Rough render with steeply sloping tiled roof and 3 No. prominent chimneys. Common early/sympathetic window detailing; central plaque inscribed TTG 1911. An Article 4 Direction to provide protection for selected features may be appropriate subject to further consideration and notification.

Picture 18. Hope Cottages - a prominent group with attractive detailing dating from the early 20th century most worthy of retention and additional protection.

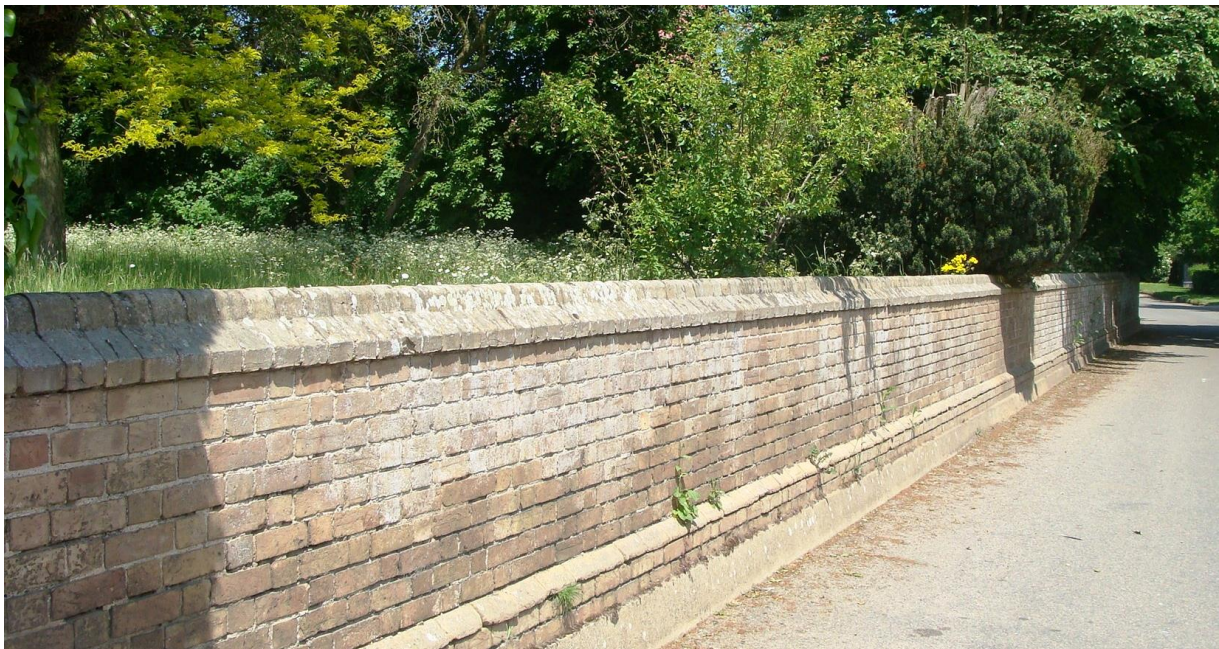
5.35. Wall to front and to east side of St Mary's churchyard. Of brick construction with distinctive capping detailing. Prominent and important in the street scene. Relatively minor repair works needed to selected sections.

Picture 19. Wall to front of St Mary's churchyard prominent and important in the street scene.

| Detracting element. | Location. | Proposed Action. |
|---|--|--|
| Wall in need of minor repairs. | To frontage and east side of St. Mary's churchyard. | Consider undertaking necessary repair works. |

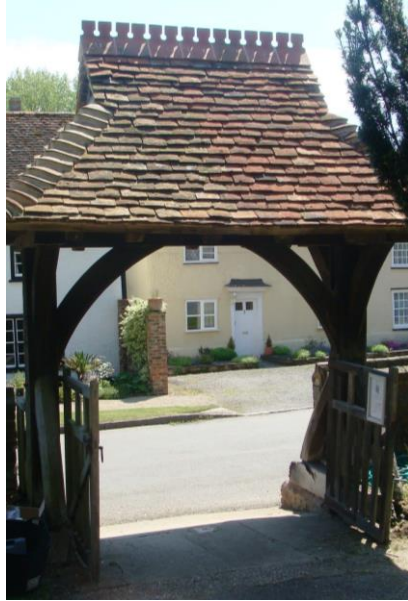
5.36. Lych gate to front of St Mary's church. Of timber construction with decorative tiled roof. Recently repaired.

Picture 20. Recently repaired lych gate to St Mary's church.

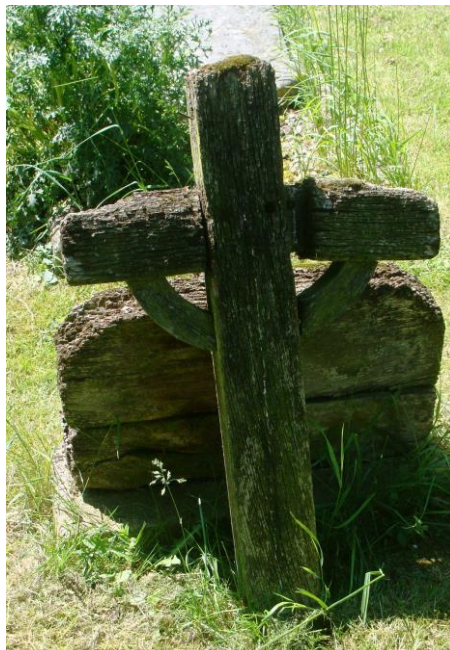
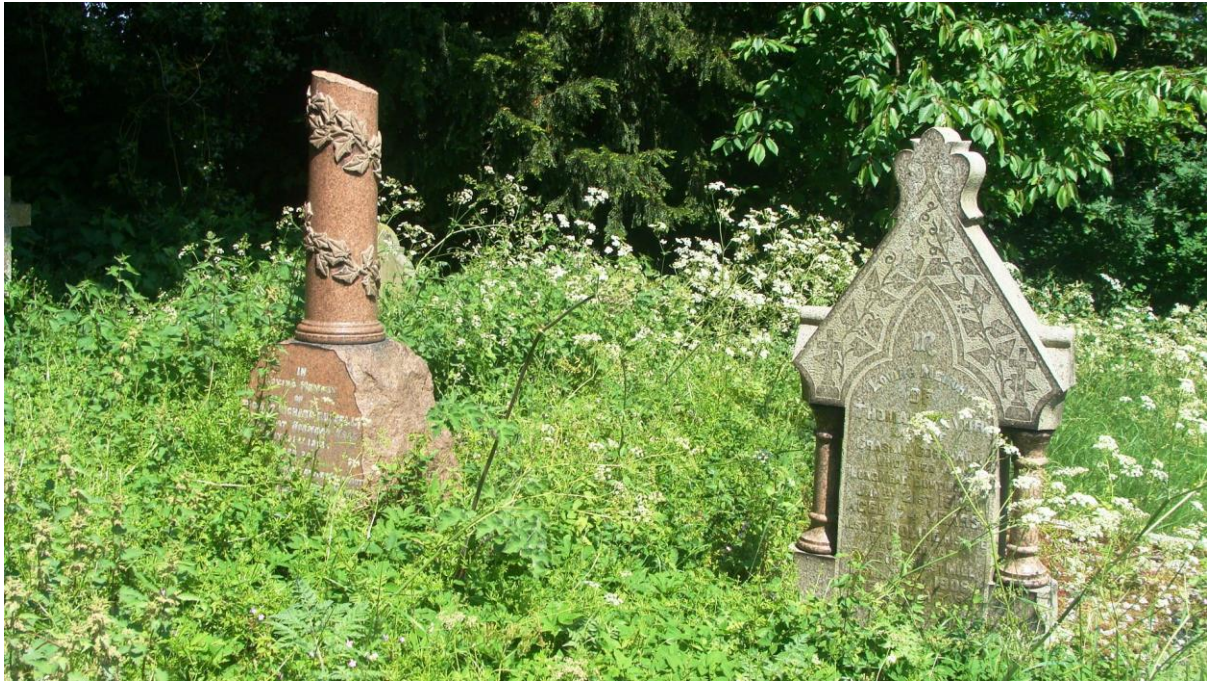
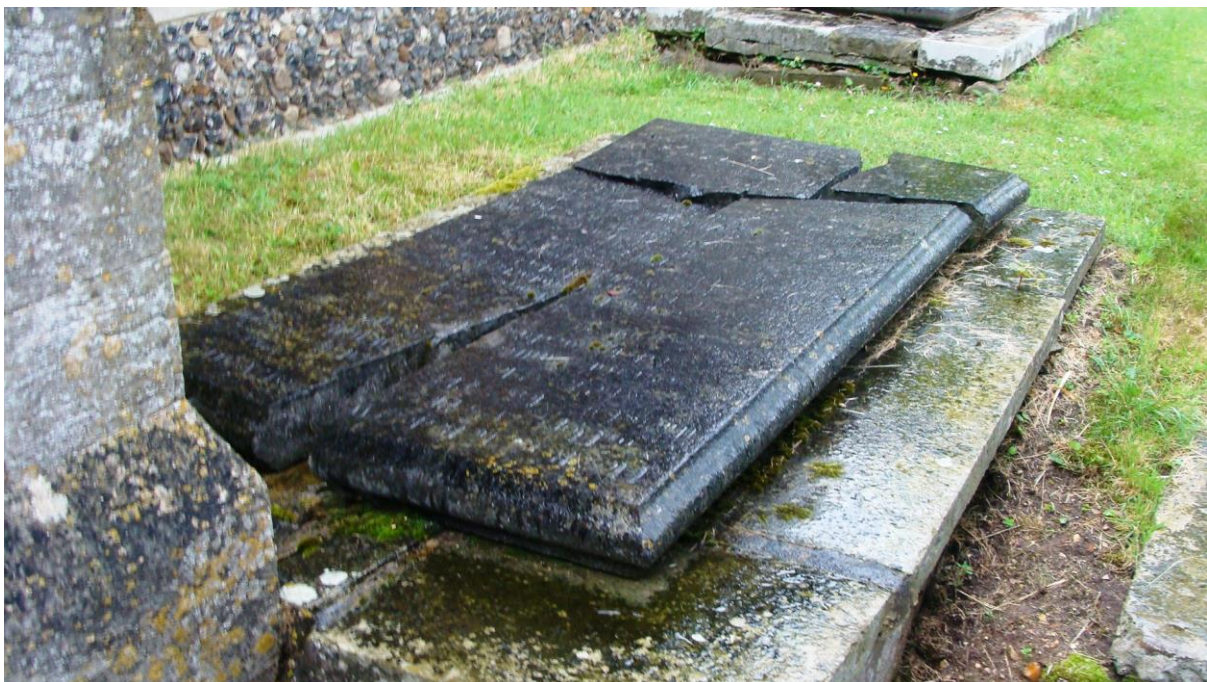
5.37. Range of tombstones in St Mary's churchyard. Of various types and ages. Some in need of repair. Two wooden structures noticed.

Pictures 21-23. Various details of tombstones in the churchyard. The lower one is in need of repair. The middle illustration shows fine early 20th century design. Is there local knowledge of the first illustration of the wooden cross etc?

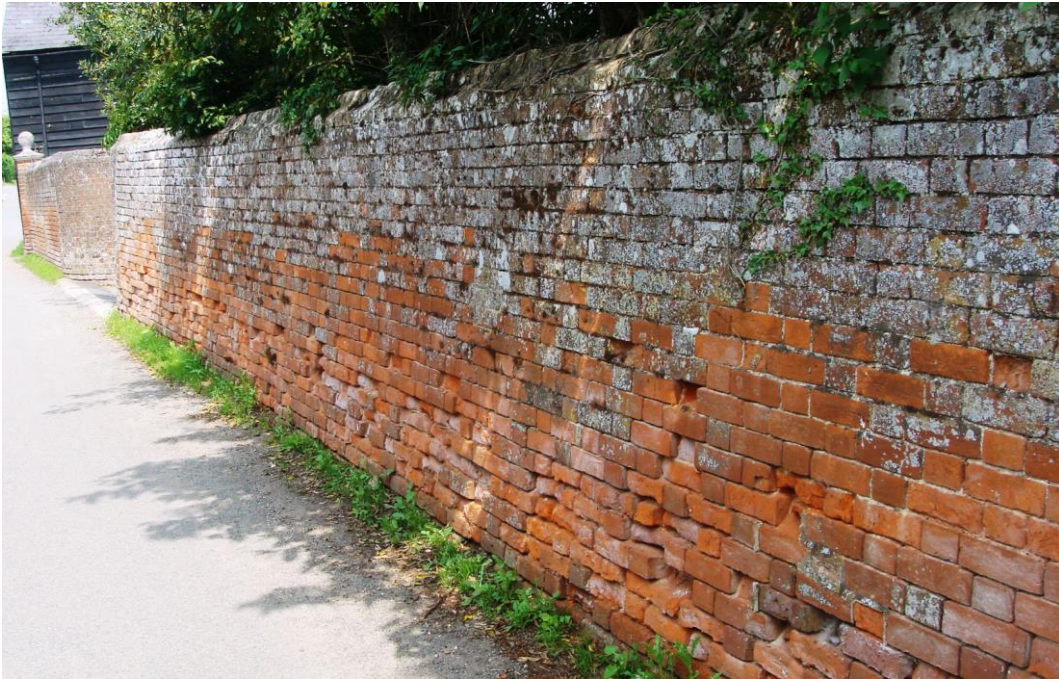
finial detailing. Some spalled brickwork in need of repair. The potential of grant assistance from EHDC exists.

Picture 24. Frontage wall to Dial House. A prominent feature in a key location and in need of repair.

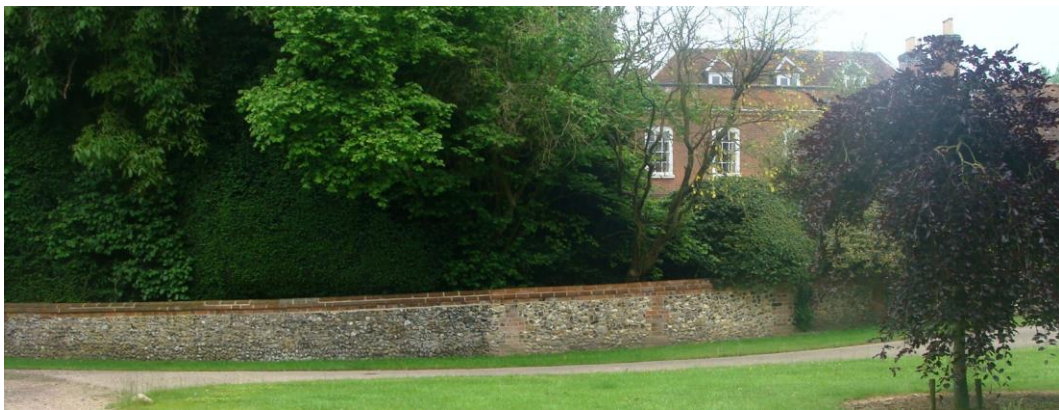
5.40. Brick and flint wall to front of Westmill Bury. Height varies. Owner advises recently repaired.

Picture 25. Brick and flint wall recently repaired, important to the setting of Westmill Bury.

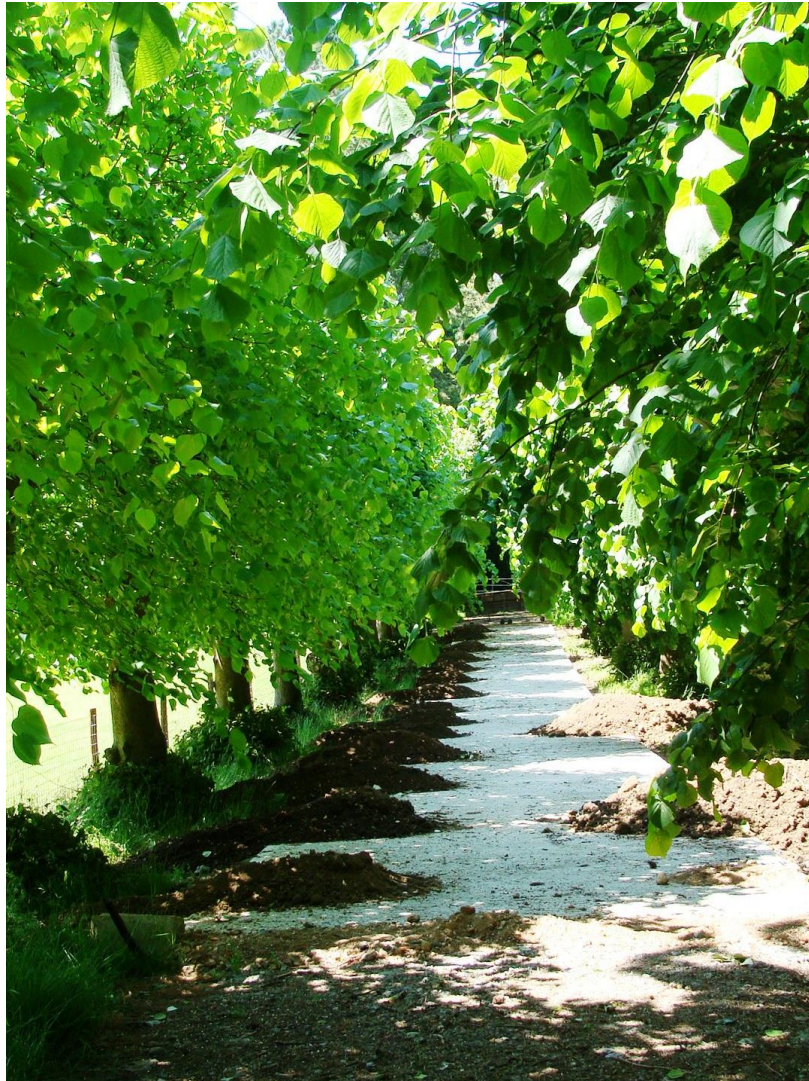
5.43. Small scale pasture with sheep grazing, south of road and to east of Westmill Bury. A small scale and enclosed pasture which together with adjacent lime-tree avenue represents a high quality open space forming an important part of, and setting to, the conservation area.

Picture 26. Fine avenue of lime trees providing an access point to Westmill Bury. The avenue also separates two small scale open spaces important to the setting of the conservation area.

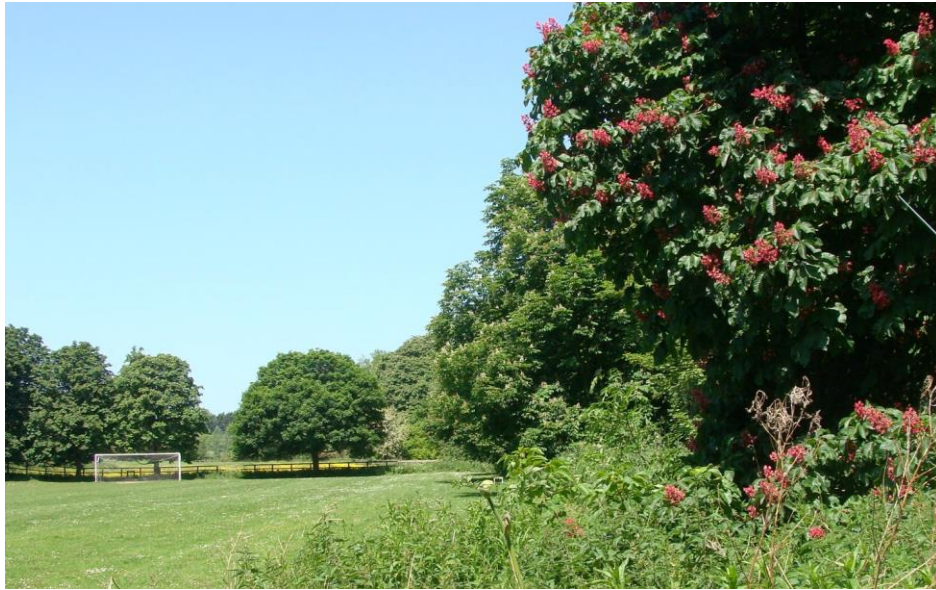
5.44. Football Ground. Consists of area of open land to the west of the River Rib. It is enclosed to varying degrees on all sides and contains a football pitch, a pavilion and some limited seating. Together with the river, trees and its enclosed nature it forms part of the important open character of the conservation area.

Picture 27. The football field. Its relationship with the River Rib and its fine mature boundary trees represents a small scale open space of quality important to the visual qualities of the conservation area.

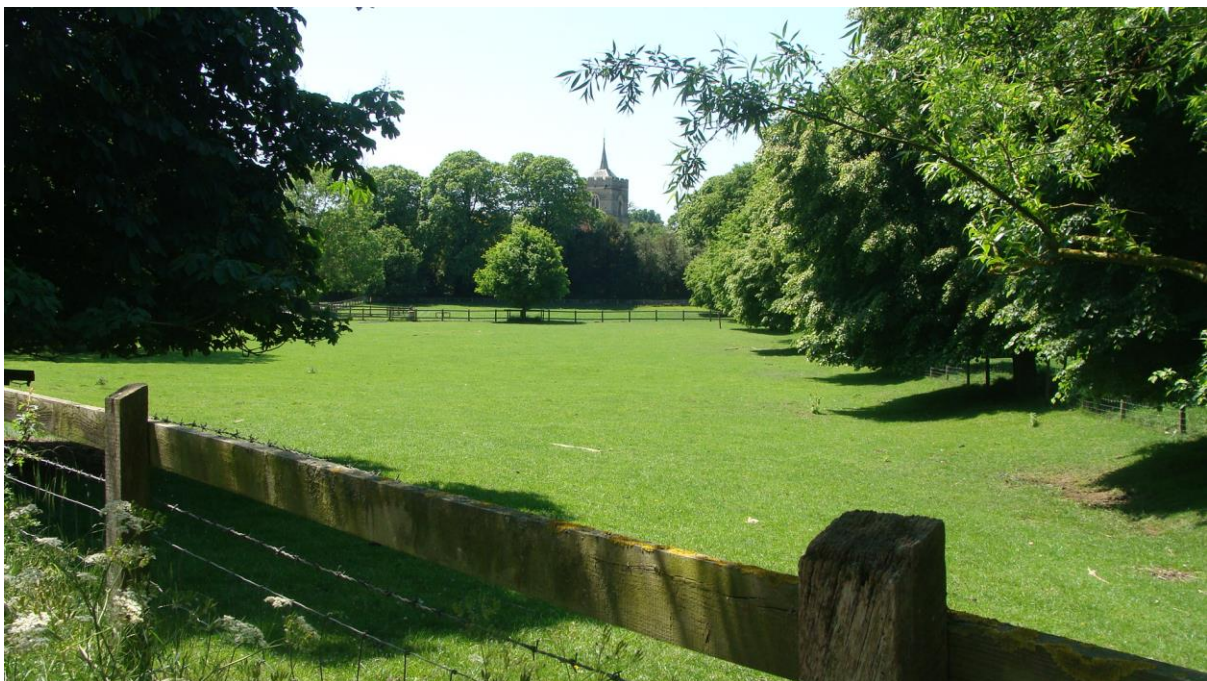
5.45. Small scale pasture land north of the High Street and east of St Mary's church. This pasture land is most important in the context of the setting of the conservation area. The row of mature lime trees on its northern boundary are visually prominent and form part of the setting of the church and distant views of its spire. The land is distinct from the open countryside to its north.

Picture 28. High quality pasture land a key small scale landscape feature to this part of the conservation area which provides a long distance view of the grade II* listed church.

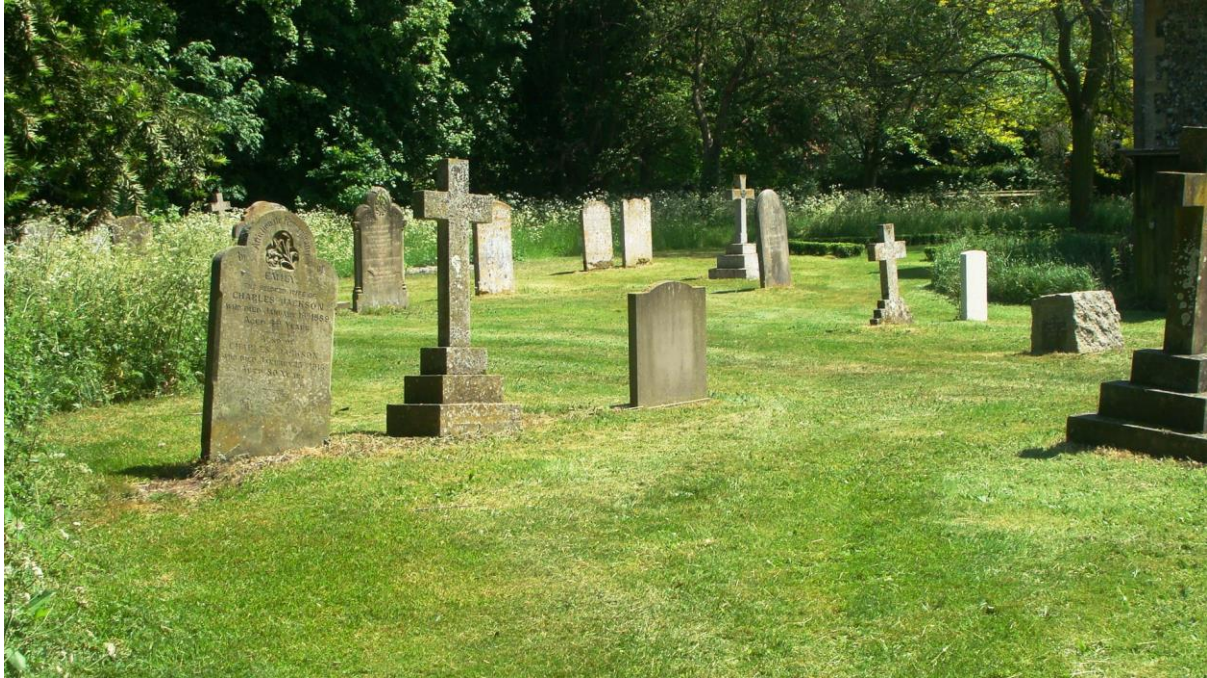
5.46. St. Mary's churchyard. Well kept with a variety of tombstones, two individually listed, at risk and previously referred to. Contains range of traditional churchyard trees including an Irish yew avenue approach. Contained by wall to front.

Picture 29. Well kept St Mary's churchyard with interesting range of tombs of various dates.

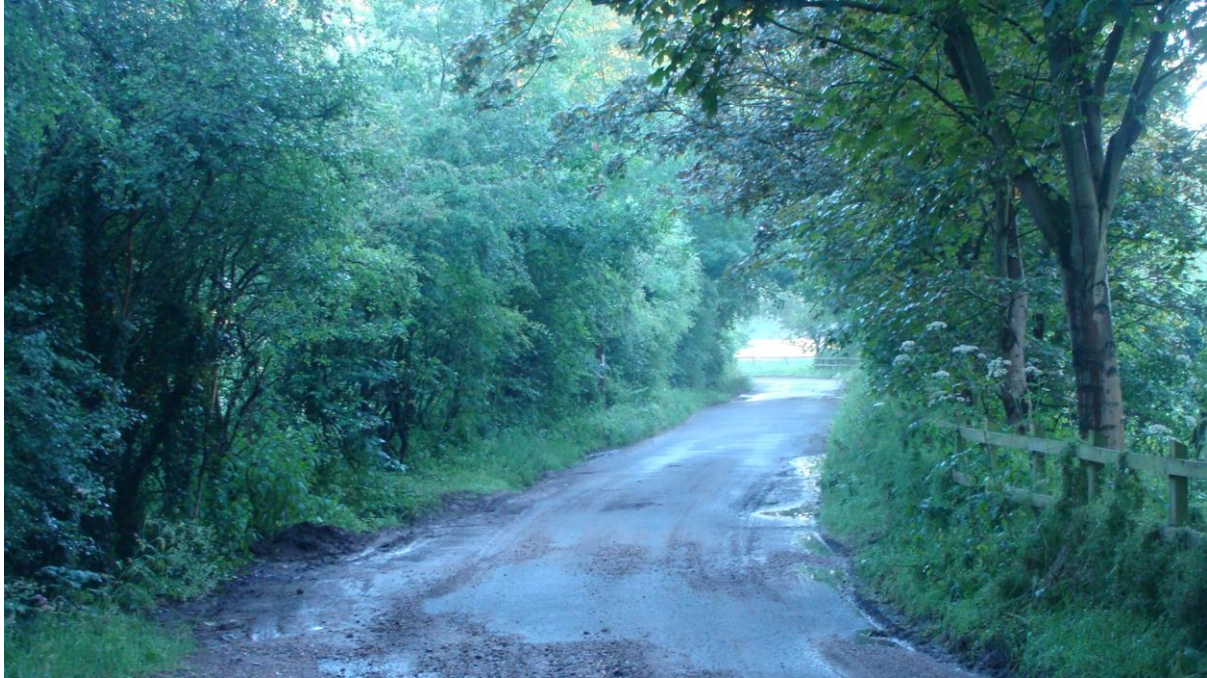
5.51. Linear strip that is unused and overgrown east of Westmill Bury Farm and on opposite side of road to the Football Ground. Its small scale and roadside hedgerow and trees within the site are important components in this location and on this approach to the village.

Picture 30. Linear strip of unused land, heavily treed and visually important as a village approach.
