WESTMILL CONSERVATION AREA APPRAISAL AND MANAGEMENT PLAN

ADOPTED DECEMBER 2017

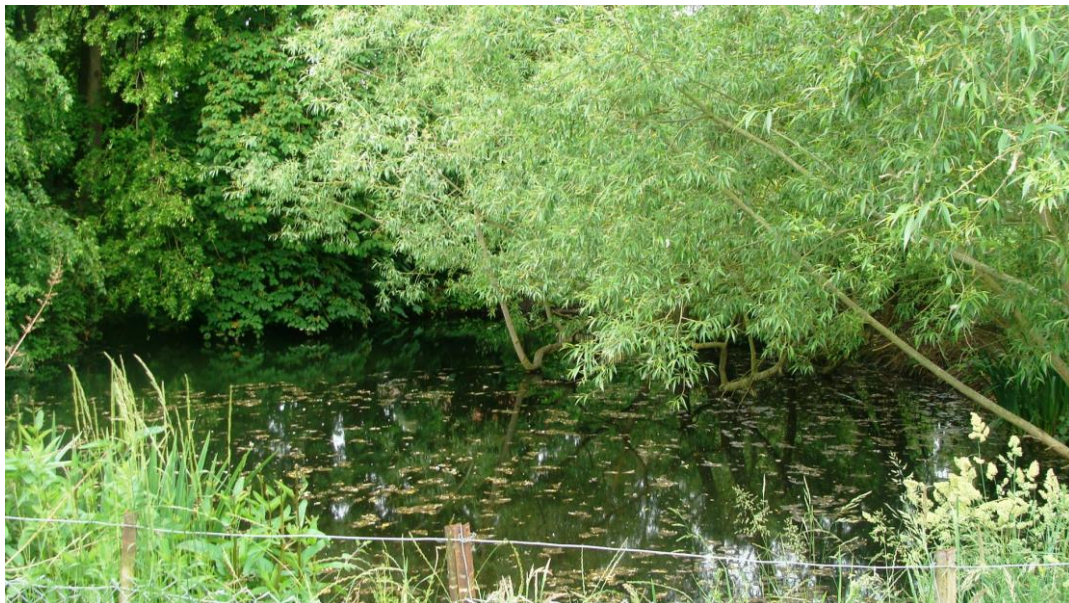
5.52. Small pasture and pond to west of approach access to Westmill Bury. This open space contributes to the spatial quality and diversity of the conservation area in this key location in proximity to a number of high quality listed buildings.

Picture 31. Pond and open space adds to the spatial quality and diversity of the conservation area in this location.

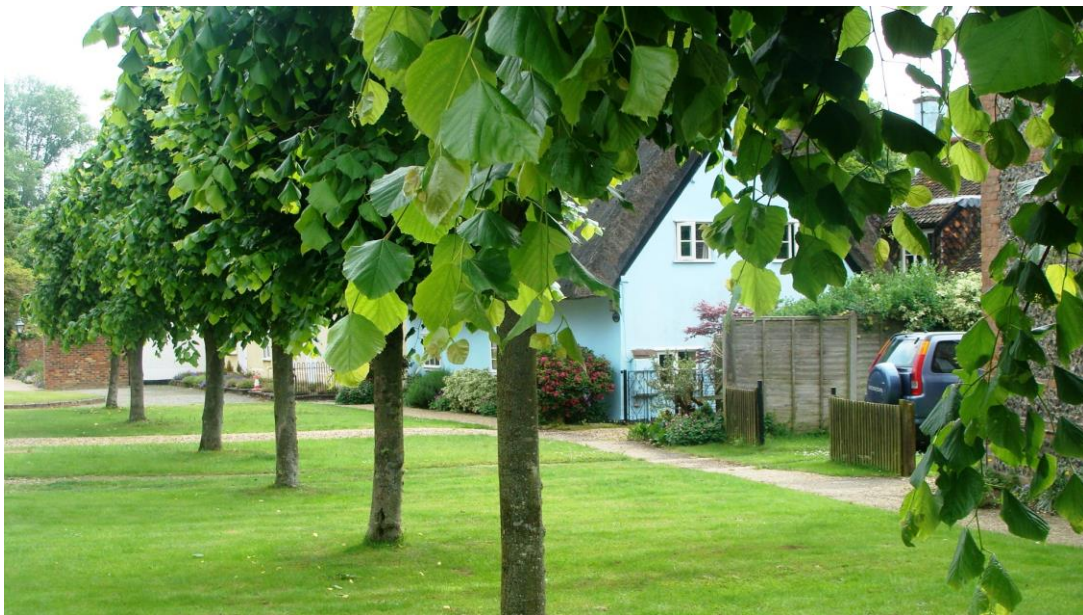
5.57. Throughout the conservation area trees play a very important role in adding quality to the environment generally and enhancing the historic built form. In this respect an avenue of lime trees are particularly important. The presence of trees was an important component showing up on late 19th century mapping including the row in the High Street in the illustration below.

Picture 32. The Lime tree row on village green south side of High Street is visually most important and would appear to replace similar planting identified on the late 19th century mapping.

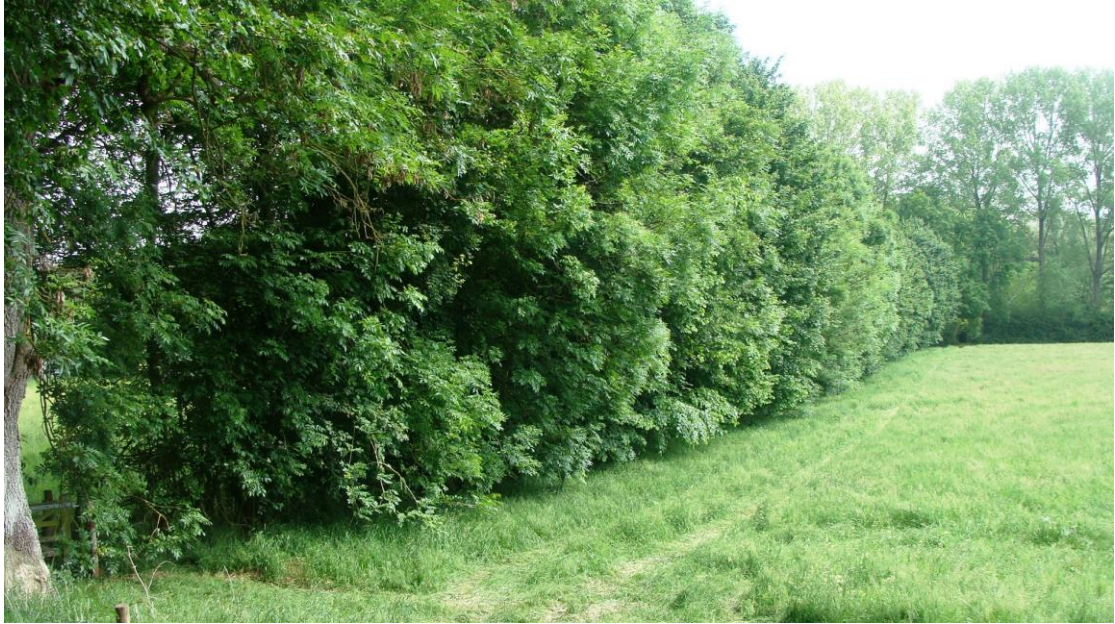
5.58. Particularly strong tree boundary on southern edge of the conservation area opposite Watford House is a clear demarcation between small scale pasture land and the open countryside beyond. The conservation area has been drawn to the south of this physical boundary and follows no feature on the ground, presumably originally drawn in this manner to ensure protection of the fine trees in this location.

Picture 33. The strong field boundary that delineates open countryside from enclosed pasture and horse paddock land to the north.

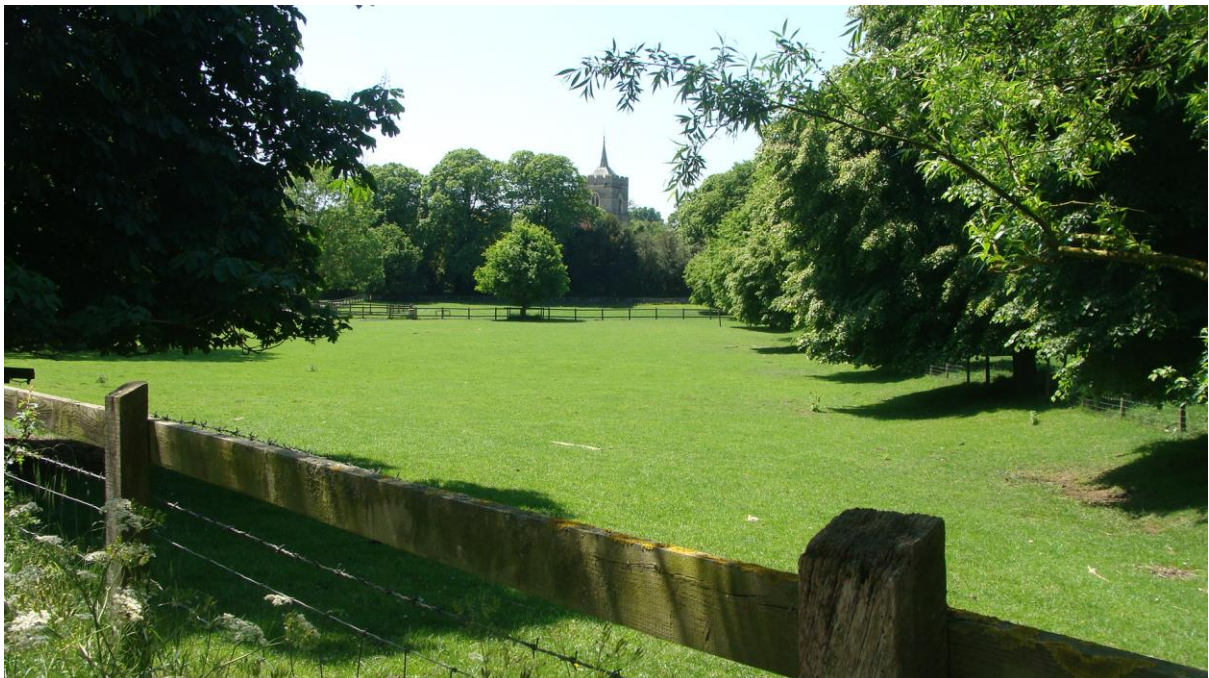
5.59. The role trees play in defining the character of the conservation area and in framing and providing views of important historic buildings is demonstrated in the picture below.

Picture 34. Trees alongside historic boundaries are extremely important in defining the high quality of the conservation area.

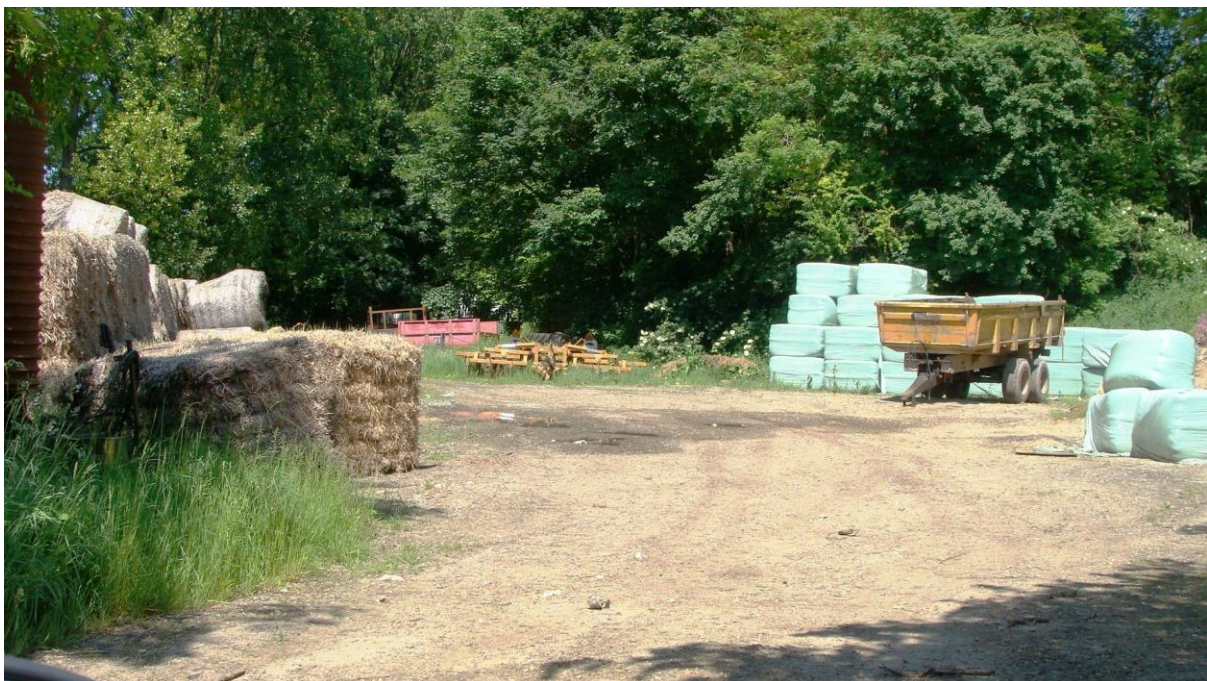
5.61. Elements out of character with the Conservation Area. The area forming the eastern extremity of the conservation area is a large open storage area containing agricultural machinery and equipment, some obsolete. The site is untidy and can be viewed from the road and public realm that forms its southern boundary. It is the former site of the railway station. It is accepted the area is part of a working farm but the fieldworker considers that minor improvements such as doubling up additional frontage planting and removal of obsolete machinery and a general tidy up would be beneficial. Elsewhere the River Rib forms an appropriate eastern boundary and on balance it is considered this area can be removed from the conservation area.

Picture 35. View of open agricultural storage area from public domain. It is recognised this area is very much part of an active working farm but any improvements to reduce its visual impact would be beneficial and appreciated.

5.66. Opportunities to secure improvements. Repair 2 No. chest tombs to front of St Mary's churchyard that, without prejudice, are candidates for grant assistance from EHDC. Improve the appearance and reduce impact of agricultural storage area when viewed from the public realm; being open land to the east of River Rib (site of former railway station). Initiate minor selected repairs to wall fronting and to east side of St. Mary's churchyard. Consider potential for improving directional signage on central green. Consider if there is a better solution to the existing notice board on wall near central green. (Some improvements to the latter two items have now been undertaken). Undertake repairs to curtilage listed wall Dial House.

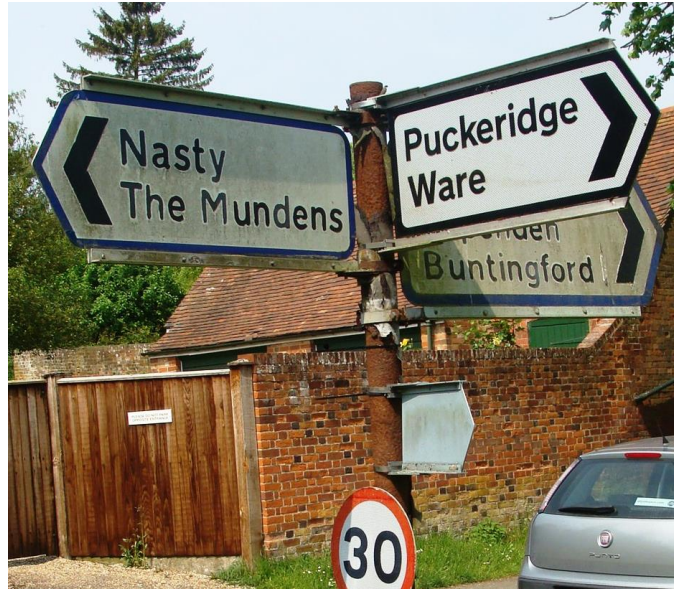
5.62. Directional post signage on the green in the centre of the village. The signage is mounted on a rusting pole which at the least needs repainting. Detracts to a degree from the high quality of this important central space. The Parish Council has now initiated improvements.

Picture 36. Directional sign post needing repainting.

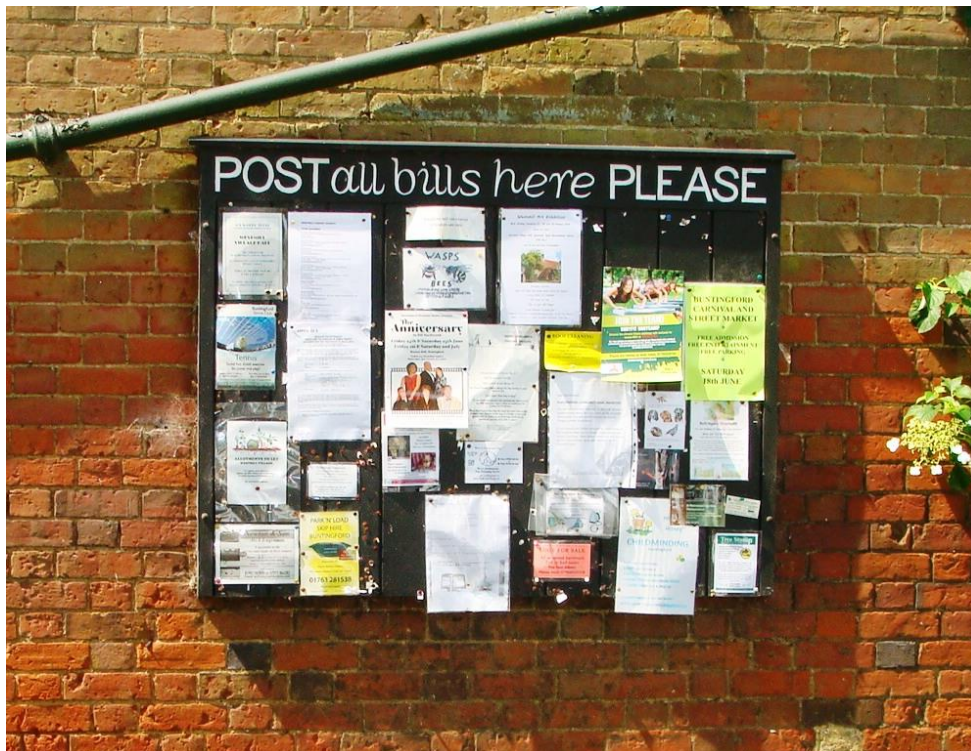
5.63. Parish notice board. This clearly performs an important community function but nevertheless is untidy and visually detracts. Is there a more acceptable solution? Following consultation the PC have undertaken some improvements.

Picture 37. Is there a more acceptable solution (and or location) to disseminate community information?

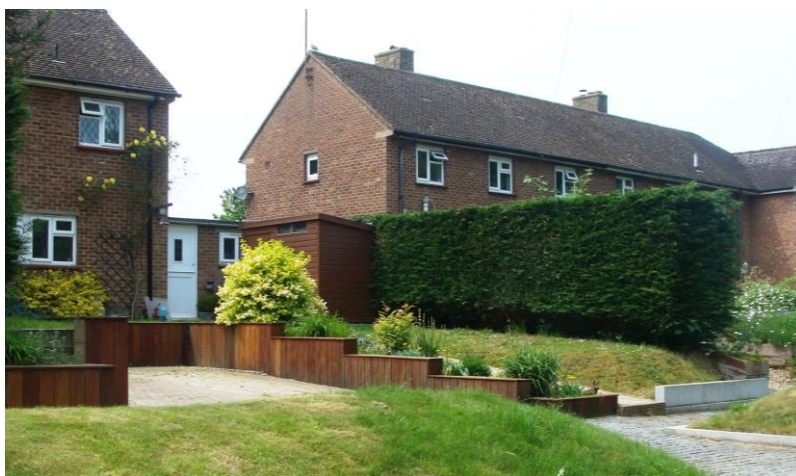
5.68. Also exclude 1-4 Wilstone (also known as Wilstone Cottages), east side of Aspenden road. Mid later 20th century terrace housing of no architectural or historic interest with variety of uncoordinated frontage boundary treatments. However retain mature tree to frontage as this fine specimen (along with trees opposite) is important to this entrance point to the village.

Picture 38. Nos. 1-4 Wilstone (Wilstone Cottages) are proposed to be excluded from the conservation area.

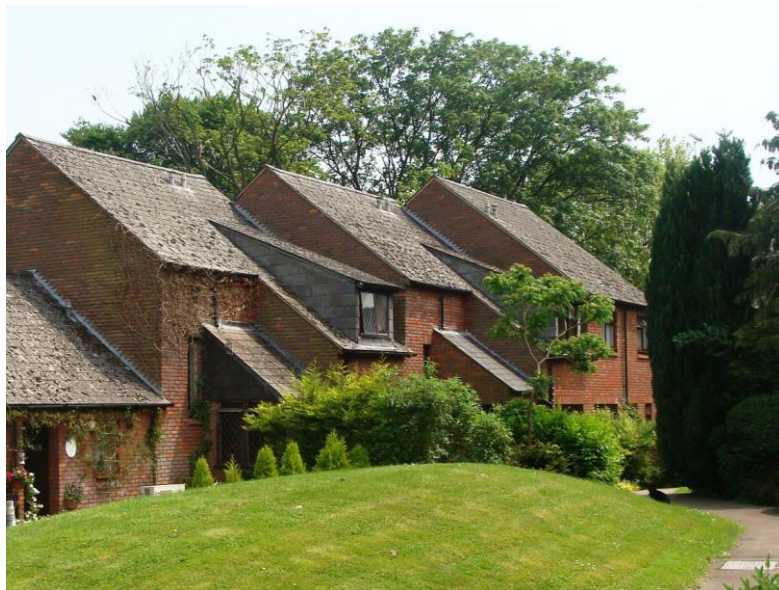
5.70. Explanation concerning retaining The Rookery and environs within the conservation area. Whilst The Rookery is a later 20th century development it is of a pleasant and cohesive design that has remained largely unaltered. The trees to the immediate north are important and worthy of retention as is a small pasture land adjacent and to the west. On balance and for these reasons it is considered appropriate for The Rookery and environs to remain within the conservation area.

Picture 39. The Rookery- a council development dating from the later part of the 20th century is of a pleasant and cohesive design which, on balance should remain within the conservation area.
