ARDELEY PARISH CONSERVATION AREA APPRAISAL AND MANAGEMENT PLANS, INCORPORATING THE THREE CONSERVATION AREAS OF ARDELEY, MOOR GREEN AND WOOD END.

ADOPTED MAY 2018

East Herts. District Council, Pegs Lane, Hertford, SG13 8EQ

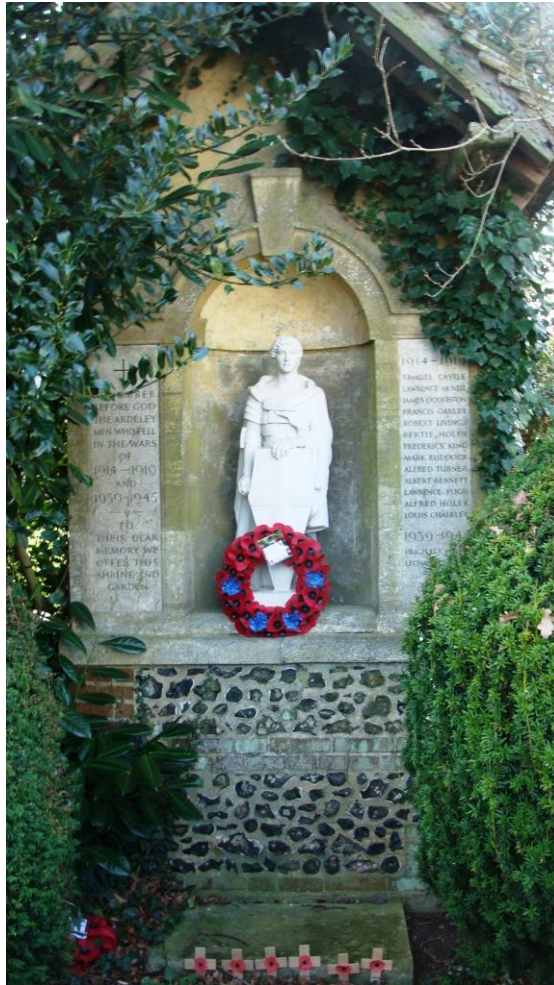
5.8. War Memorial - Grade II. Circa 1919. Possibly by F. C. Eden. Stucco with limestone dressings, inscribed Portland stone panels, battered knapped flint base with red brick banding and quoins, and a projecting steep old red tile gabled roof. Tall gabled memorial in the form of a wayside shrine with a half-size standing figure of St George in a large round-headed niche. Iron cross on gable. *Local sources advise the figure of St George is a replacement following the theft of the original. Removal of ivy and selected vegetation would be advantageous.*

Picture3. War Memorial- a most unusual design. Removal of selected vegetation would be advantageous. The fieldworker was advised the central figure of St George is a replacement following theft of the original.

5.39. Opportunities to secure improvements. Remove selected vegetation from War Memorial. Initiate repairs to village pump and well house. Consider possibility of repairing distinctive wooden grave markers in churchyard. Consider minor improvements to church notice board. Consider improving signage corner of School Lane and removal of two utility poles on School Lane. Improve signage etc entrance to Church Farm.

Detracting element.	Location.	Proposed Action.
ARDELEY		
Invasive vegetation.	War Memorial.	Judicial pruning and removal of ivy to expose to view for greater public appreciation would be beneficial.
Signage etc.	Entrance to Church Farm.	Discuss with owners the potential for improvements.
Render in need of replacement on listed structure.	Village pump and well house on village green.	Undertake selected necessary repairs.
Wooden grave markers and other gravestones in need of repair.	Church of St Lawrence graveyard.	Consider potential for executing simple and inexpensive necessary repairs. Most important for their continued survival.
Road and other signs.	Corner of School Lane.	Consider rationalisation/improvements.
Particularly intrusive utility poles.	Two on School Lane.	In first instance contact utility company to seek their cooperation in removing/reducing impact.

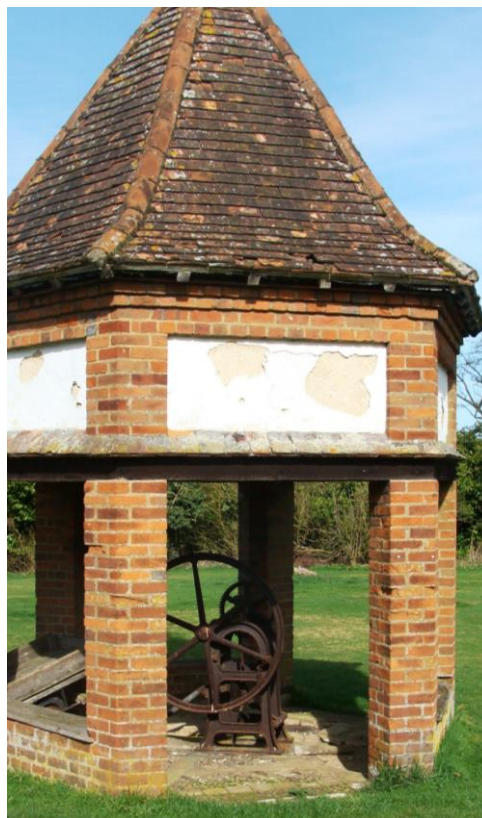
5.14. Village Pump and Wellhouse - Grade II. Circa 1917 by F. C. Eden for John Howard Carter of The Bury. Cast iron pump with large flywheel. Red brick well house with plastered panels and hexagonal old red tile cap with gilded vane and bellcast eaves. Centrepiece of picturesque Blaise Hamlet type scheme at The Green.

Picture 4. Village pump and well house. Simple repair works at modest cost would result in significant improvements. Without prejudice financial assistance may be available.

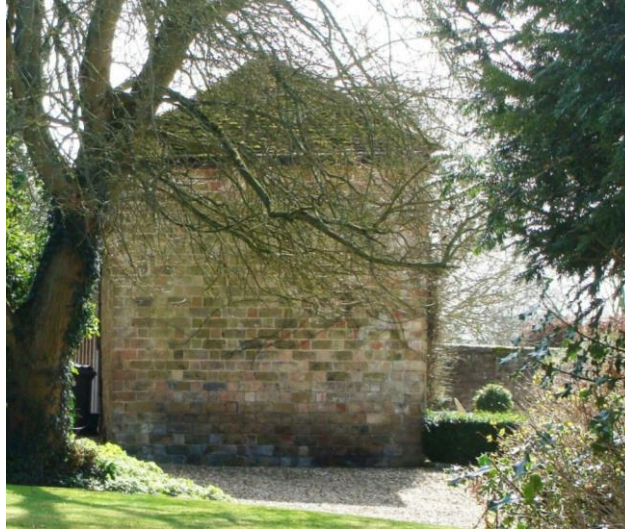
5.18. Important buildings within the curtilages of Listed Building. Building within the grounds and in proximity to The Old Vicarage. Red brick (would appear to be rat trap bonding) with pyramidal tiled roof. Shown as being attached to main building on late 19th century mapping.

Picture 6. Ancillary building in the curtilage of The Old Vicarage, viewed from road. Unusual brick construction - Rat Trap bonding.

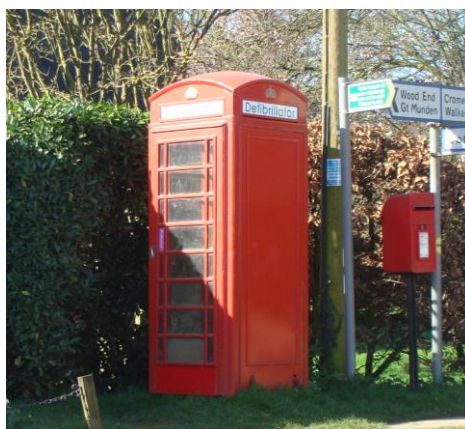
5.26. K6 Telephone Kiosk. Designed 1935 by Sir Giles Gilbert Scott. Made by various contractors. Cast iron. Square kiosk with domed roof. Unperforated crowns to top panels and margin glazing to windows and door. Many of this type are listed but this one is not.

Picture 10. Well restored K6 Telephone kiosk, an iconic piece of British tradition. Its continued use as a Defibrillator is most welcome. This use is becoming increasingly common.

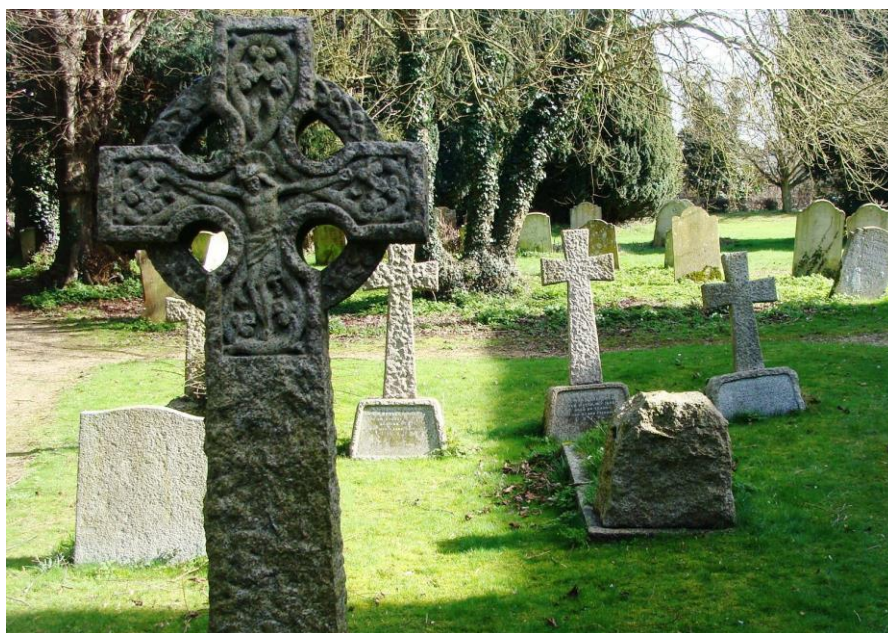
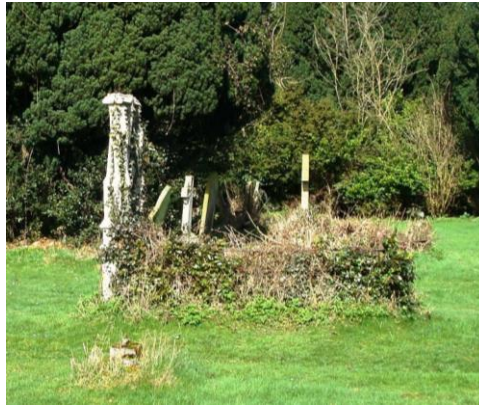
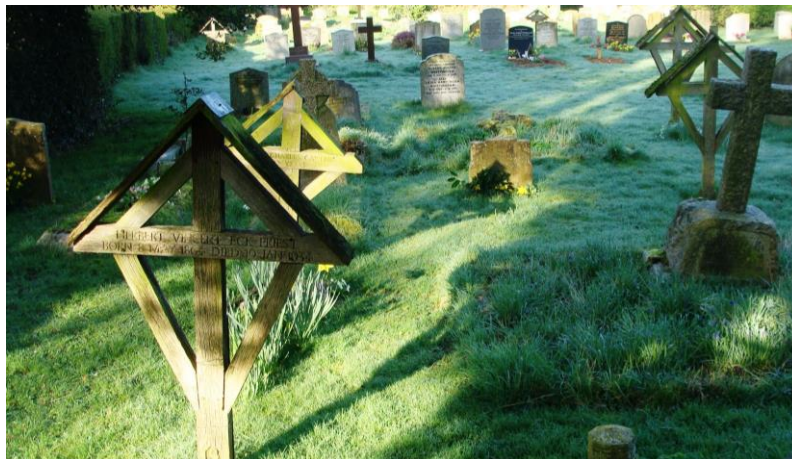
5. 29.The Churchyard. The churchyard is a most important open space that can be accessed and viewed from several footpaths. It contains many fine trees and gravestones. Some of the latter are constructed of wood which are unusual. Some of these are beginning to deteriorate and little effort would be required to rectify those in need of repair (see picture below). It is important such simple repair works are carried out for their continued survival.

Pictures 12-14. The churchyard contains a range of interesting grave markers. The middle picture shows a tomb in serious need of repair; even a simple task such as removing the ivy would assist. Those in the lower picture illustrate some that are constructed of wood which are distinctive and uncommon. They are relatively modern and for example, the one to the front of the lower picture marks the grave of Herbert Eck who died in 1934 whose life the fieldworker was advised is commemorated in a north west window of the church. A number of these markers are in need of repair, particularly the 'roof' element. This could be executed at modest cost. Is there a local tradition associated with this design?

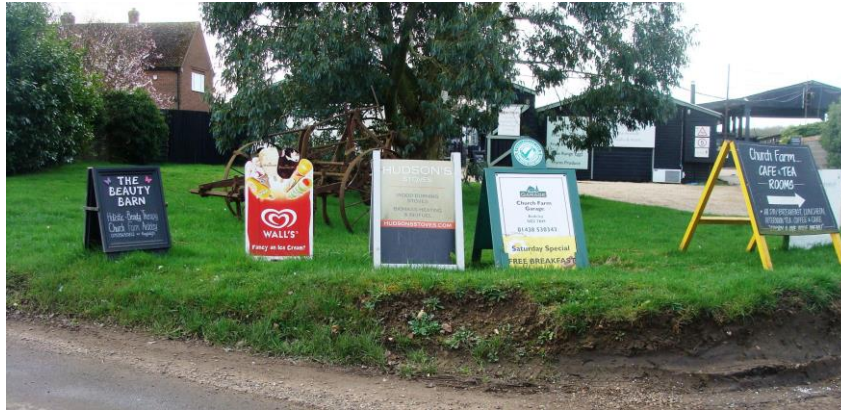
5.36. Signage at entrance to Church Farm. Explore with owners the potential of making improvements.

Picture 19. Discuss potential of making improvements with owner/s.

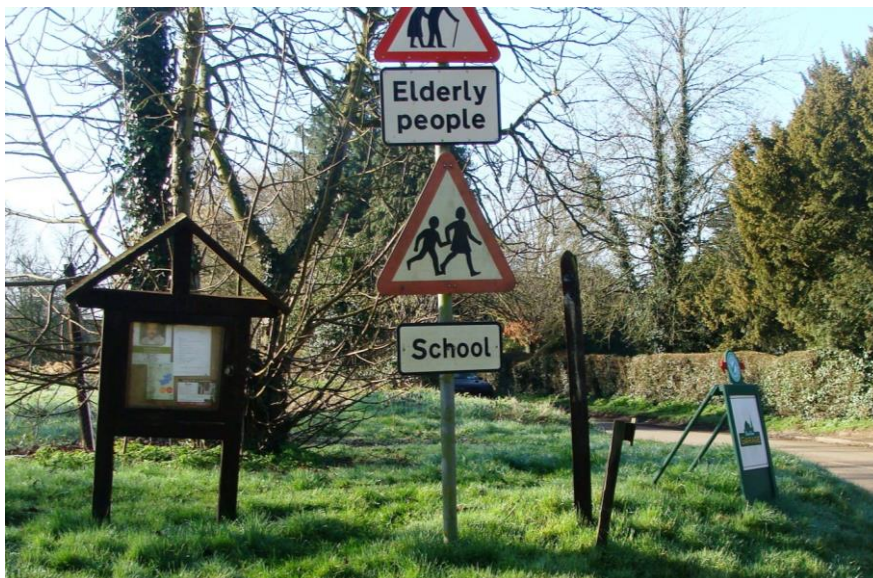
5.37. Collection of miscellaneous signage corner of School Lane. The possibility of achieving some improvements is worthy of investigation.

Picture20. Are all of these signs necessary? Could they be re-sited more appropriately? At least those out of vertical alignment could be reset.

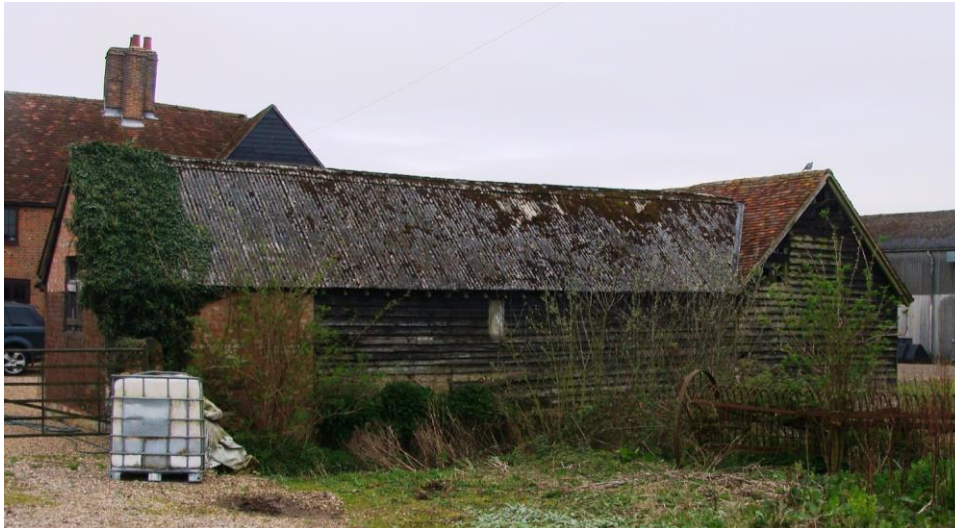
Picture 30. Building to front of Listed Fir Tree Farmhouse. Securing its improvement would represent a significant gain.

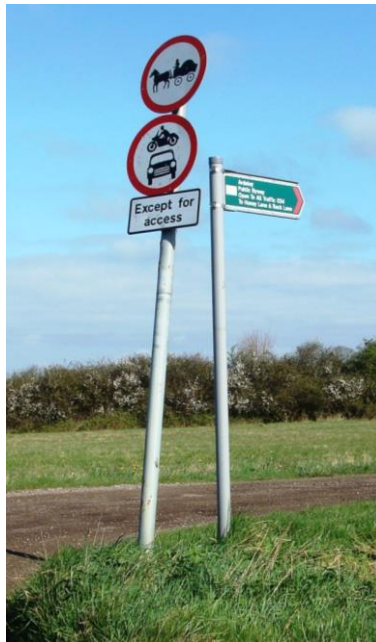
Picture 33. Pole out of correct vertical alignment detracts. Would it be possible to combine all necessary information on one pole?

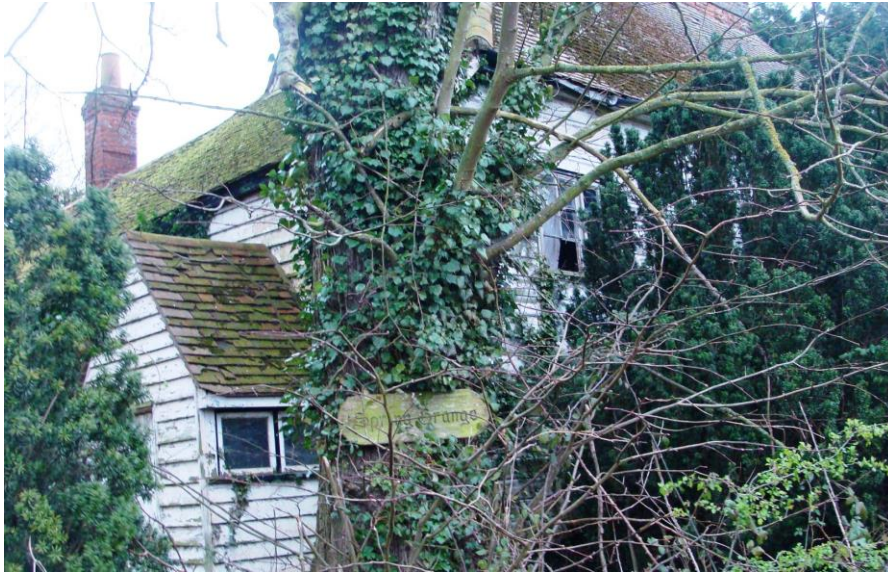
Picture38. Spring Grange - a building on the Council's Heritage at Risk Register in need of restoration.

5.106. Opportunities to secure improvements. Repair and restore listed building Spring Grange and associated ancillary building. Repair and restore ancillary listed buildings to Coates Manor Farmhouse. Without prejudice grant

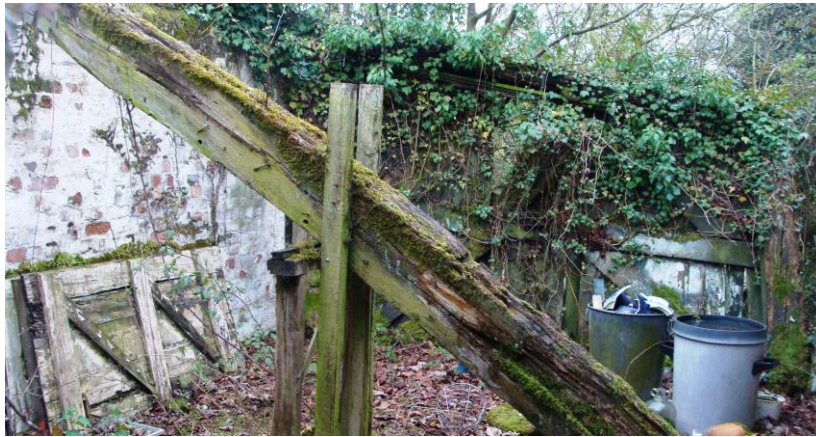
5.86. Ancillary building within curtilage of Spring Grange. In very poor condition. The fieldworker has been advised this site has recently been acquired (Application for 3 dwellings now submitted). It is hoped appropriately sensitive restoration works can be carried out.

Picture 42. Ancillary curtilage listed building within curtilage of Spring Grange that is in very poor condition. It has been on the Council's Heritage at Risk register for a number of years and this structure together with the main building (see above) continues to deteriorate.

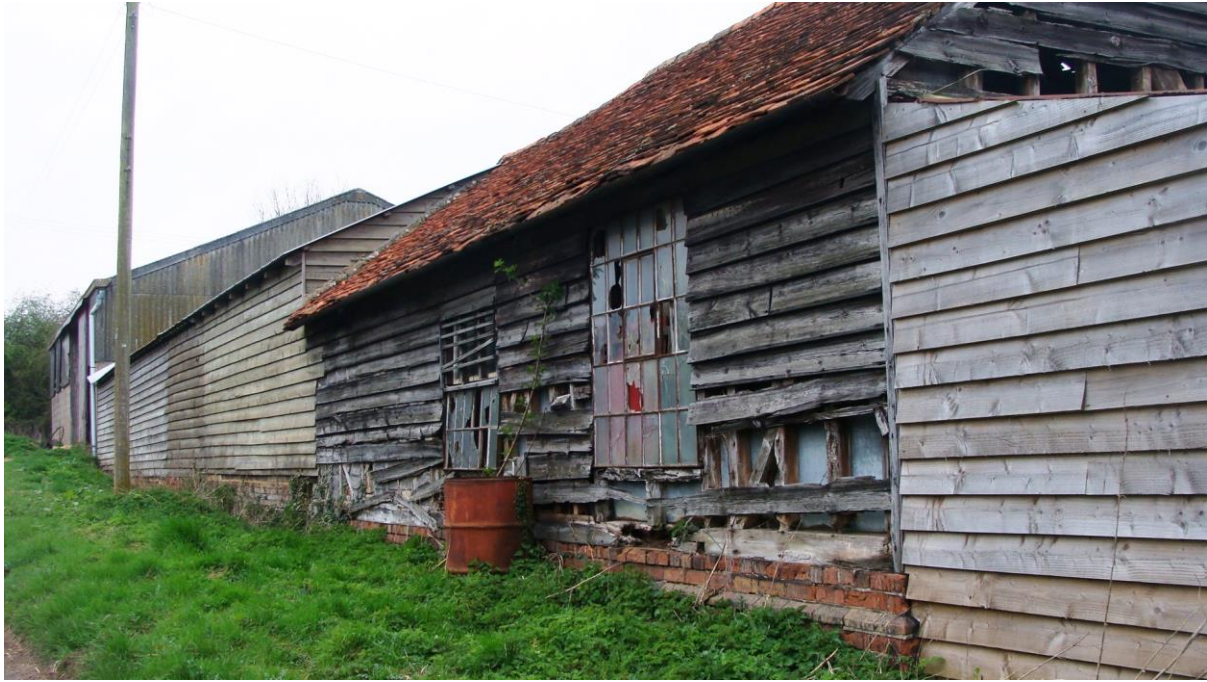
Picture 43. Buildings interpreted as curtilage listed at Coates Manor Farm on the Council's Heritage at Risk Register in urgent need of repair on this important approach to the village.
