THUNDRIDGE AND WADESMILL CONSERVATION AREA APPRAISAL AND MANAGEMENT PLAN

ADOPTED 2016

ADOPTED MAY 2016.

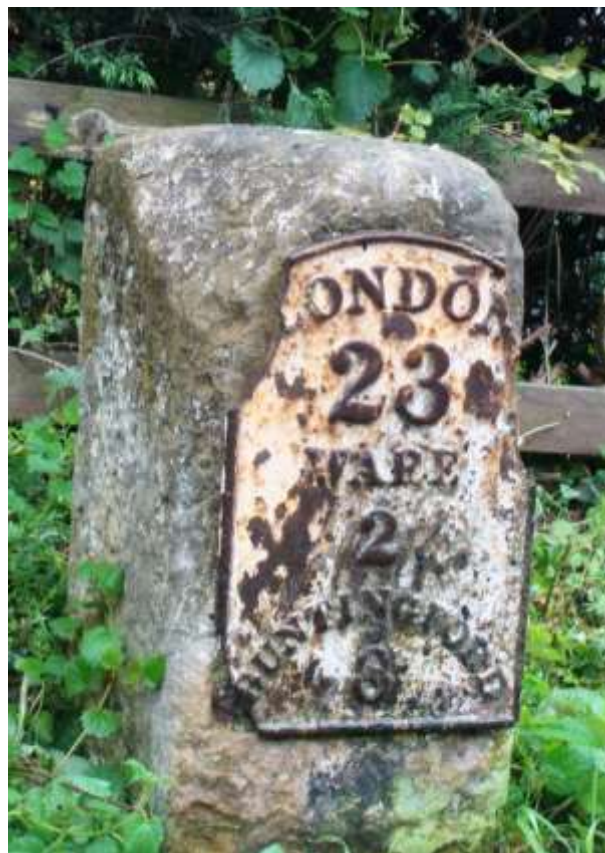
18th century milestone for Wadesmill Turnpike Trust in need of repair. Included on the Council's Buildings at Risk Register.

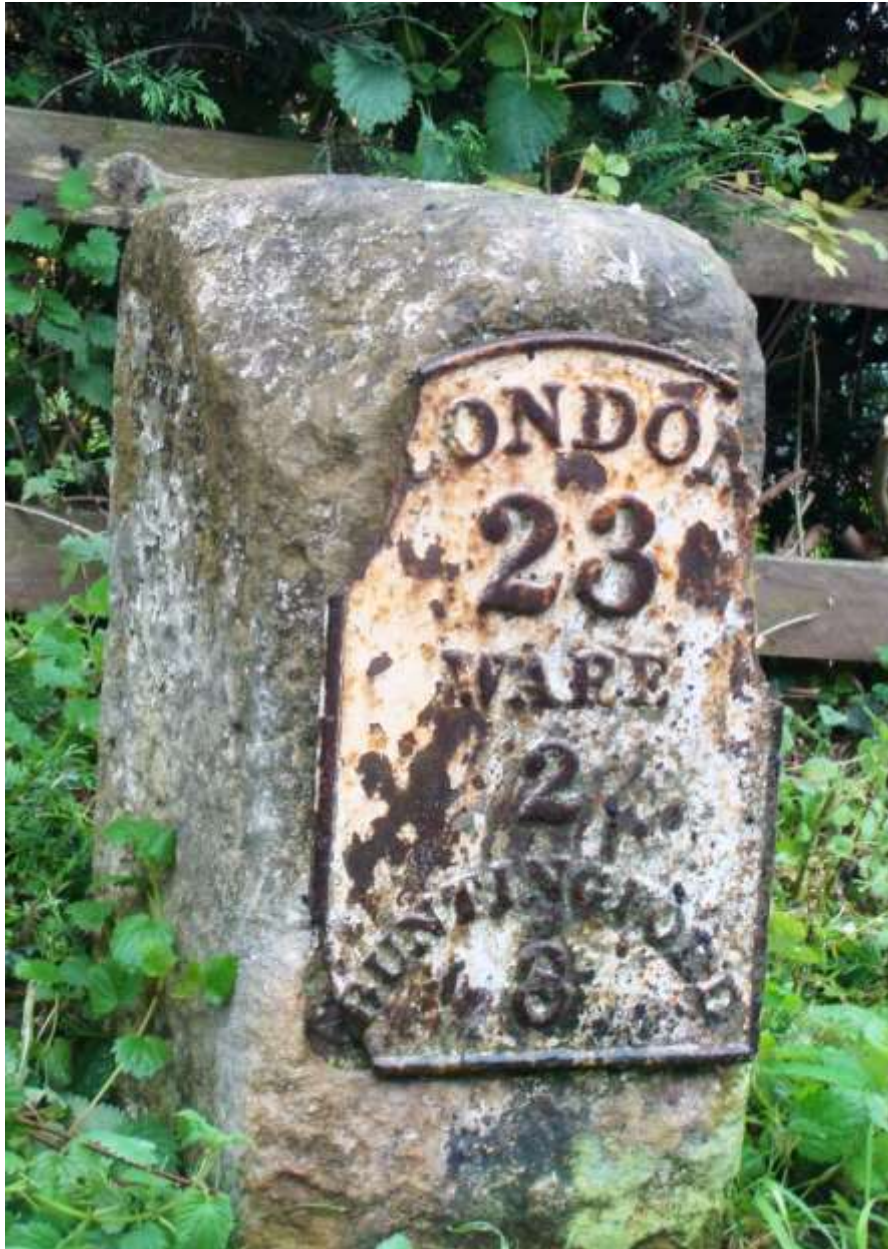
5.8. Milestone on south corner of track to Athena Cottage Grade II. Circa 1742 for Wadesmill Turnpike Trust, inscription covered by iron lettered plate circa 1804 possibly to design of McAdam. White freestone with cast iron front plate. A low square pillar of stone with large front plate of iron. Segmental curved top and raised bead all round plate. Inscription reads "LONDON/23/WARE/2/BUNTINGFORD/8". The first and last words are raised in segmental arcs. The milestone is on the Council's Heritage at Risk Register.

Picture 1. 18th century milestone for Wadesmill Turnpike Trust in need of repair. Included on the Council's Heritage at Risk Register.

5.45. *Other actions.* Contact HCC and seek repairs to 18th century milestone on the Cambridge Road. Amend EHDC mapping on District Plan documents relating to Youngsbury Park and Garden. Amend EHDC and Historic England mapping in respect of the Clarkson Memorial.

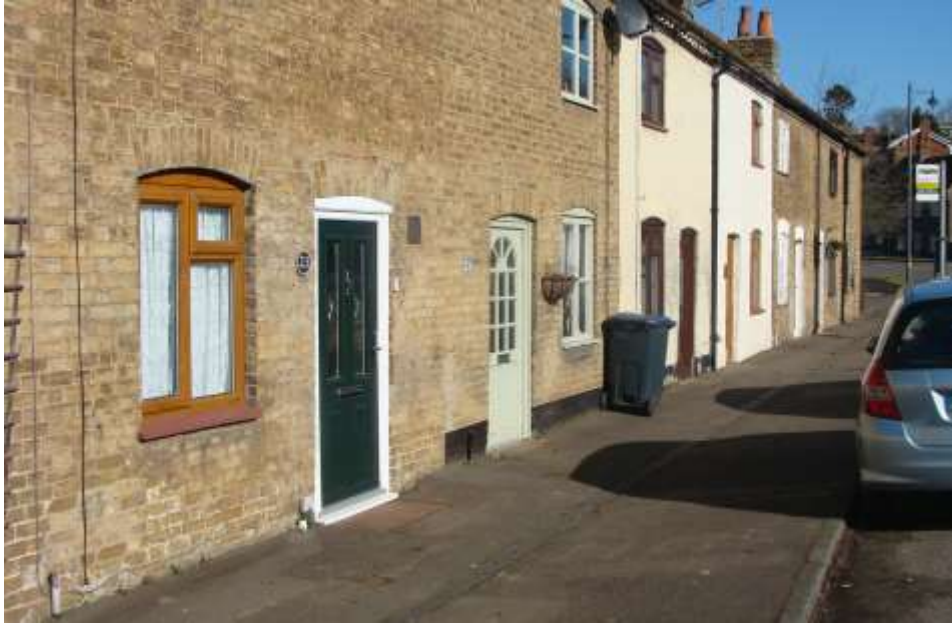
5.10. Nos. 20 to 29 Cambridge Road - Grade II. Terrace of houses. Late 18th century. Grey/yellow brick with old red tile roof, hipped at ends. 2-storeys. Each house has a door remote from the shared chimney and one front window to each floor. 2-light casement windows set flush. Doors and windows on each floor have segmental arches.

Picture 3. 20-29 Cambridge Road. Terrace of Listed Buildings dating from late 18th century. Whilst doors and windows are in original openings, a more pleasing result would have been achieved had common designs been applied (see picture below).

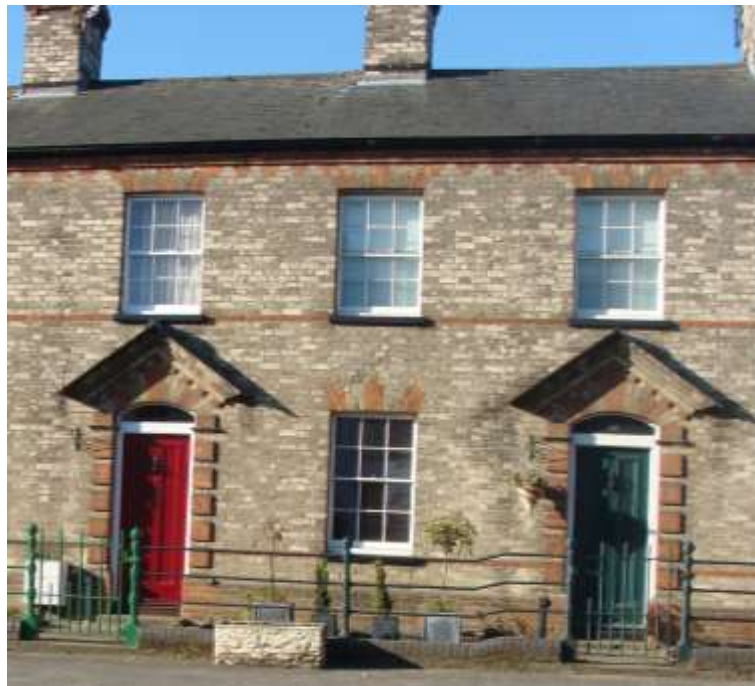
Picture 4. A terrace not local to Thundridge and Wadesmill: the purpose of this photo is to illustrate the importance of design detail. The retention of detail of an historic listed terrace depends on simple repetitive detailing, including original windows and doors. Expression of ownership can be provided by painting doors different colours. Compare with previous picture.

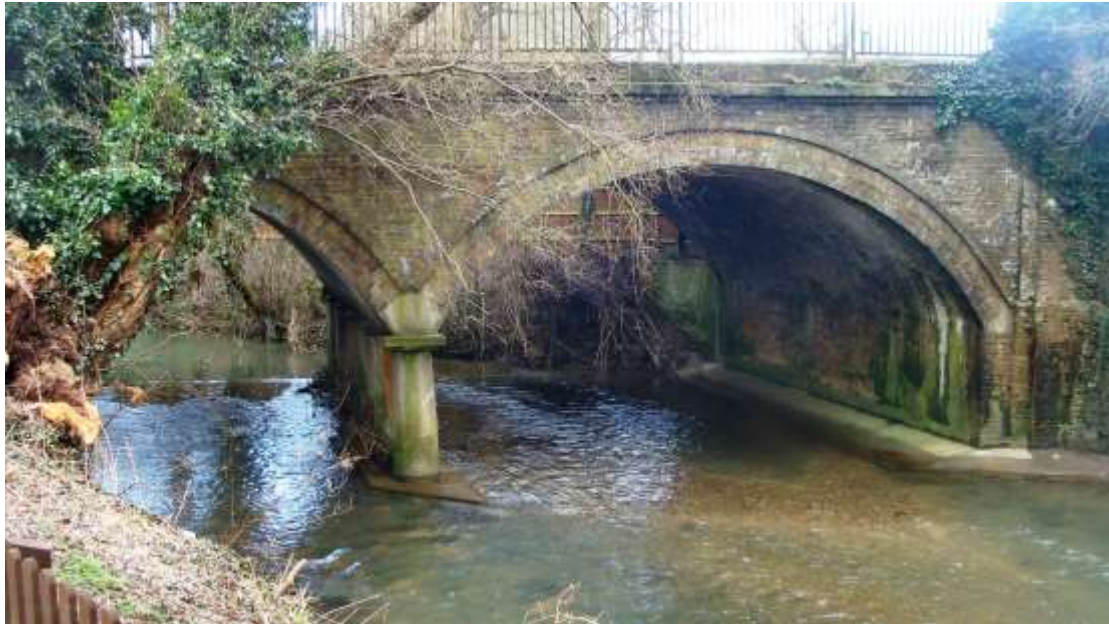
5.11. Wadesmill Bridge over River Rib in middle of village - Grade II. Road bridge over River Rib. 1824-5 by Mr. Robson for Cheshunt Turnpike Trustees: contractors Brough & Smith of London. Grey/yellow brick with grey granite columns, string course, and haunched beams

and reused limestone copings. 2 semi-circular arches of 25 foot span, resting centrally on a row of 6 unfluted Greek Doric columns, each of 2 drums of grey granite, with an angled haunching of granite at the springing of each arch. The chamfered stone coping and pier cappings were probably reused from the 1767 repairs to the previous bridge. The original iron latticed side rails to the central spans were replaced to a simpler pattern after being damaged in 1966. An unusual Neo-Classical design. Branch Johnson notes that it is one of the best bridges in the county.

Picture 5. Listed road bridge over River Rib. Considered to be very fine in some of its detailing.

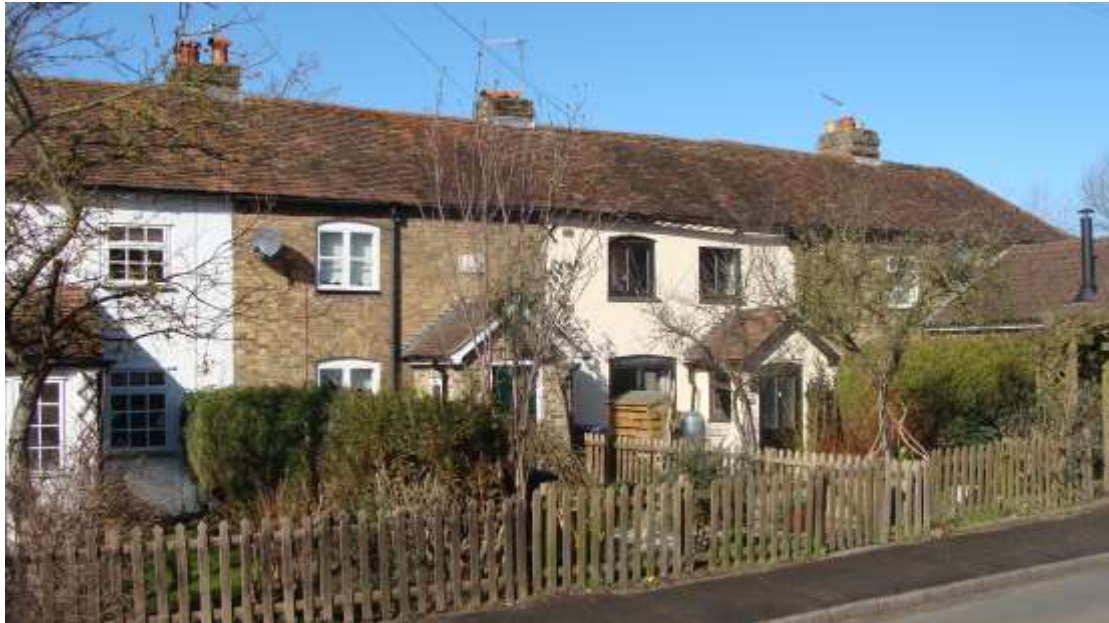
5.12. No. 31 Cambridge Road. Grade II. 'D G 1797' on wall plaque over door. Grey/yellow brick with old red tile roof. A 2-storeys small house set in a contemporary row of similar houses now altered. Dentilled brick eaves courses and segmental brick arches to door, on right, and the 2-windows, one to each floor. 2-light flush wooden casements. Small rectangular date plaque with raised surround.

Picture 6. 31 Cambridge Road. The centrally located house with the plaque is listed. Others in the terrace described as having been 'altered' demonstrate the conflicting problems of resolving a good environmental solution to small historic properties versus providing additional accommodation.

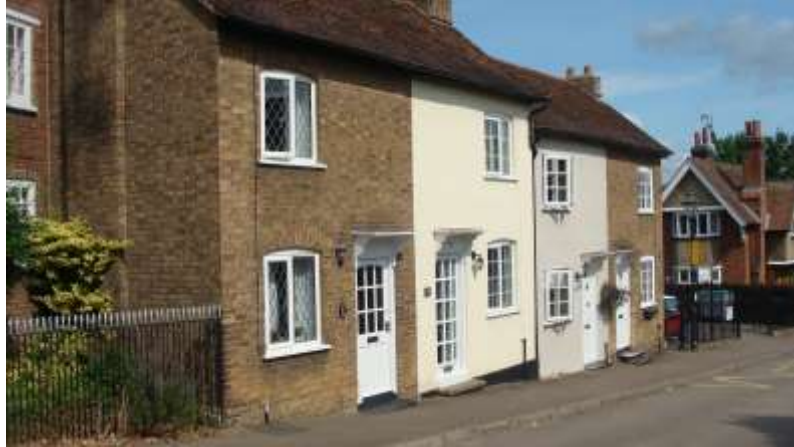
5.20. Nos.17-23 Ermine Street. Group of late 19th/ early 20th century cottages of brick construction with tiled roofs and chimneys, some of which are tall, with pots. Properties have been individually modified where a variety of modern doors and windows have created an overall uncoordinated design solution. No. 23 retains original windows.

Picture 11. Nos.17-23 Ermine Street - had the various treatments of surfaces, windows and doors been coordinated the result would have been more pleasing.

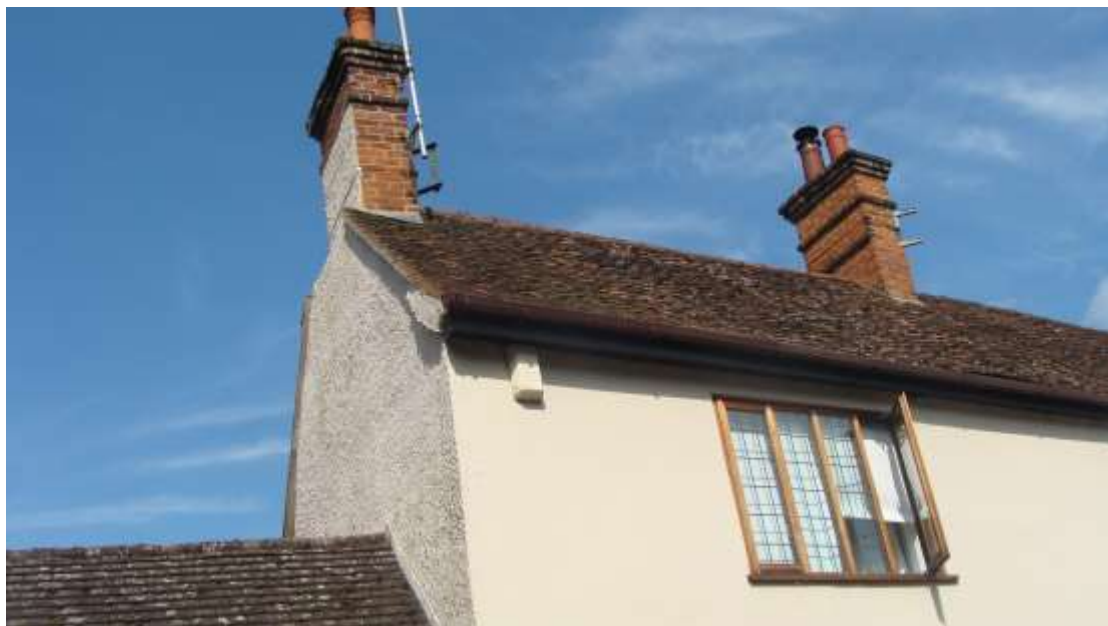
5.21. Nos. 35-37 Ermine Street/ corner of Old Church Lane. Two storey render with old tiled roof and 2 no. chimneys with pots. Modern windows. The roofscape of this group adds to the quality of this strategic corner location. An Article 4 Direction to provide protection for selected features may be appropriate subject to further consideration and notification.

Picture 12. Good quality roofscape on strategic corner location of Ermine Street and Old Church Lane that should be retained.

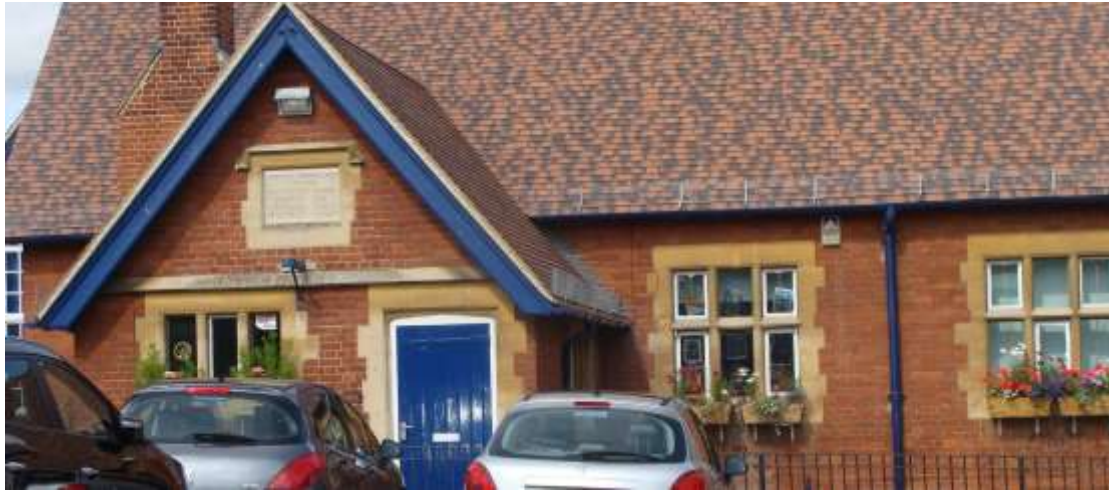
5.22. Thundridge school - Ermine Street. Single storey red brick building with tiled roof. Original stone window and door detailing. Entrance door and wooden barge board detail assumed to be original. Plaque to front reads *National School for Infants Thundridge Parish Erected 1894. H A Mason Vicar E G Hanbury Treasurer*. As it is important to retain selected features in their original form on this school building an Article 4 Direction may be appropriate subject to further consideration and notification.

Picture 13. School building Ermine Street. An important component of the Conservation Area both in terms of visual and historic importance. Some fine original features that should be retained.

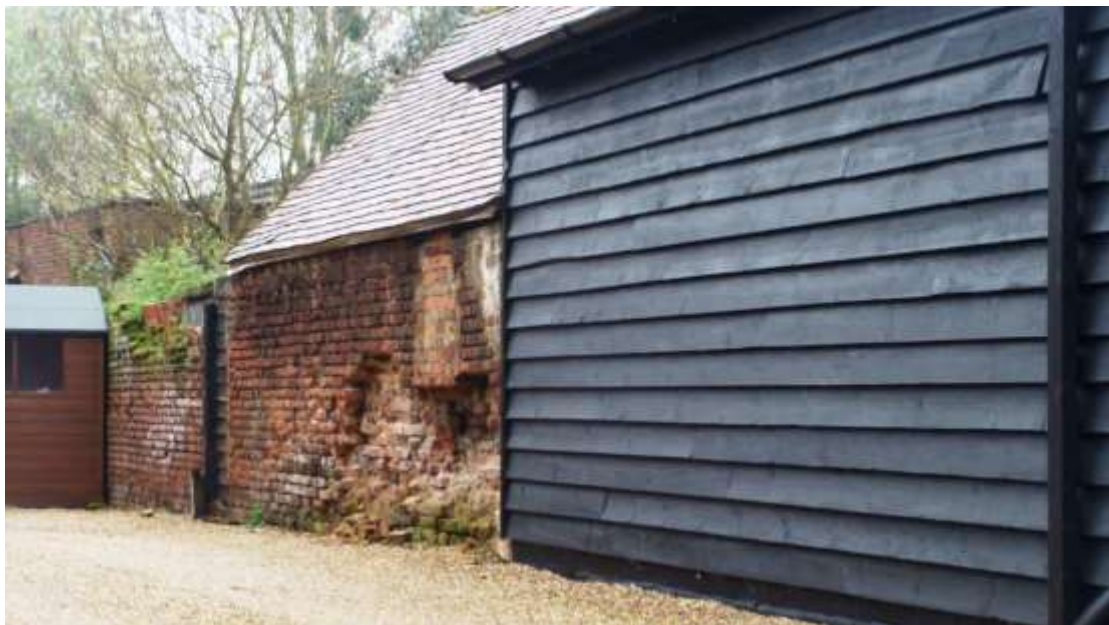
5.24. Trinity Barn and associated outbuildings. The main building is two storey weather boarded with slate roof. Associated buildings are single storey with tiled and slate roofs. Assumed to have previously been part of Rennesley Farm complex (although not processed as being curtilage listed). A well detailed and sympathetic conversion. The brickwork to one ancillary building believed to form part of the complex needs repair.

Picture 15. Ancillary building assumed to form part of Trinity Barn complex whose brickwork is in need of repair.

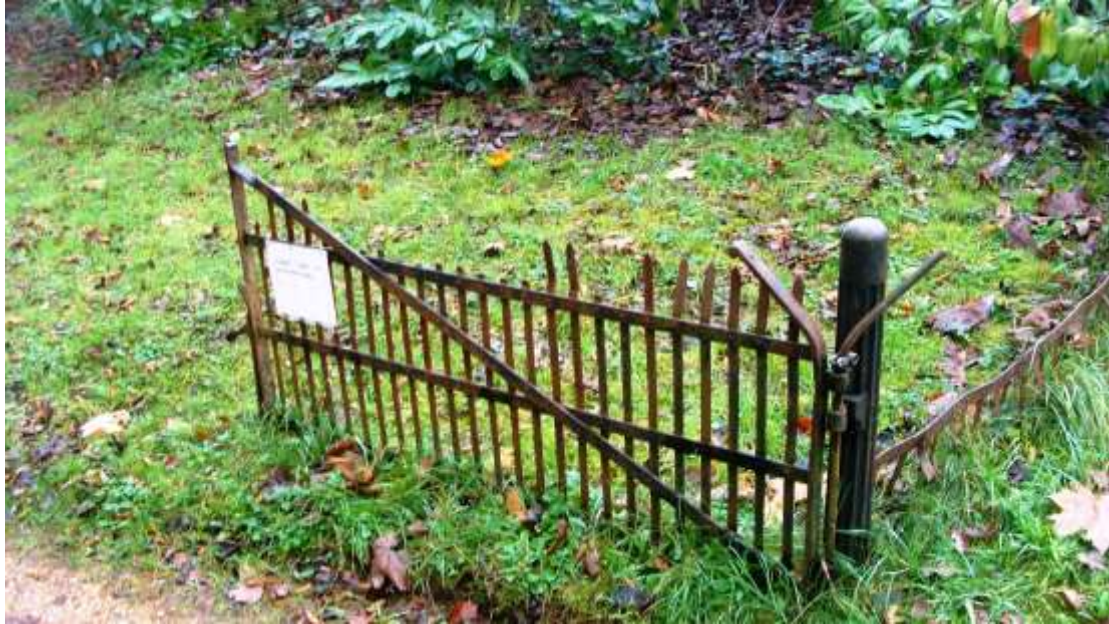
5.26. Wall surrounding churchyard constructed of brick with slate triangular section capping detail. Also curious iron gates and associated low metal railings in need of repair.

Picture 16. Curious iron gates probably contemporary with the church in need of repair - a challenge but nevertheless possible.

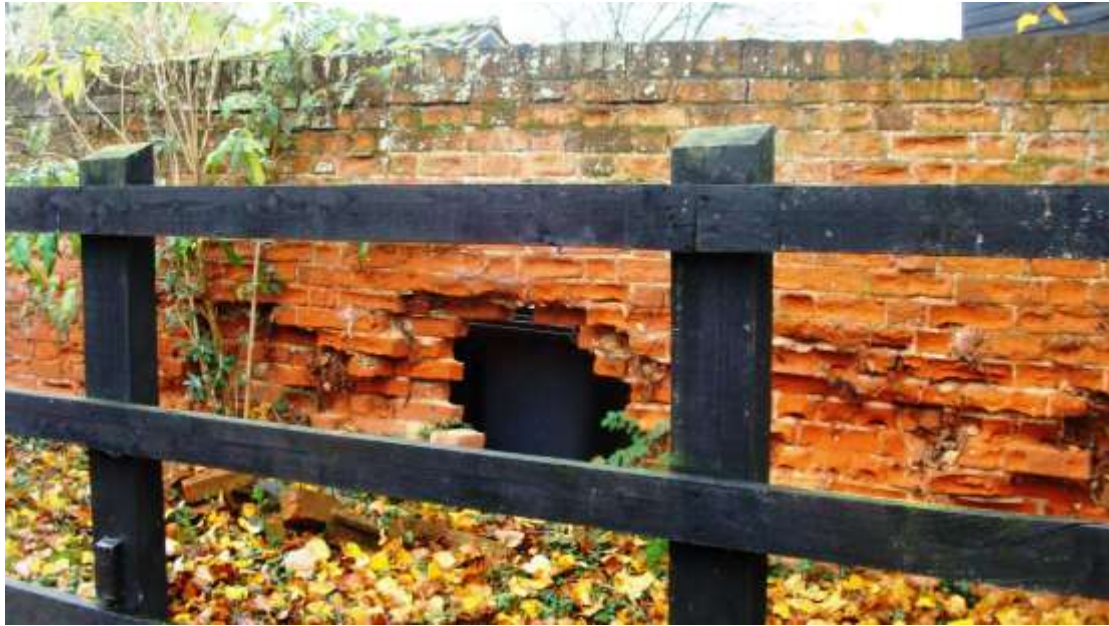
5.28. Walls at Rennesley Farmhouse. One brick wall in deteriorating condition and included on the Council's Heritage at Risk Register. It may be possible for the Council to assist and it is recommended the owner approach the Conservation Team in this respect and seek further advice.

Picture 17. 19th century wall at Rennesley Farmhouse in urgent need of repair. The potential of grant assistance from EHDC exists.

19th century brick wall in urgent need of repair.	Rennesley Farm.	Seek owner's co-operation in initiating repairs possibly in association with assistance from the Council.
Utility poles.	Particularly on Ermine Street.	Parish Council may wish to discuss with the utility company the potential of reducing impact in selected location/s.
Other Actions.		
Contact Hertfordshire County Council and seek repairs to 18th century milestone on the Cambridge Road.		
Amend EHDC mapping on District Plan documents relating to grade II* Youngsbury park and garden.		
Amend EHDC mapping in respect of the Clarkson Memorial.		
Advise Historic England regarding mapping error relating to Clarkson Memorial.

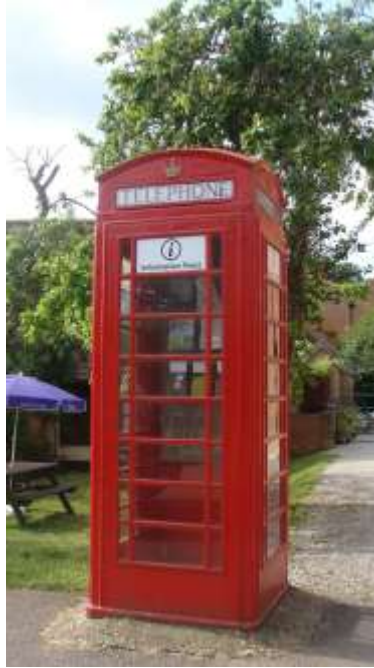
5.30. K6 Telephone Kiosk. Many are listed although this one is not. Looking at mid 20th century mapping, it would appear to be in original position. Designed 1935 by Sir Giles Gilbert Scott. Made by various contractors. Cast iron.

Picture 19. K6 Telephone kiosk, well maintained and in good condition, now an information point.

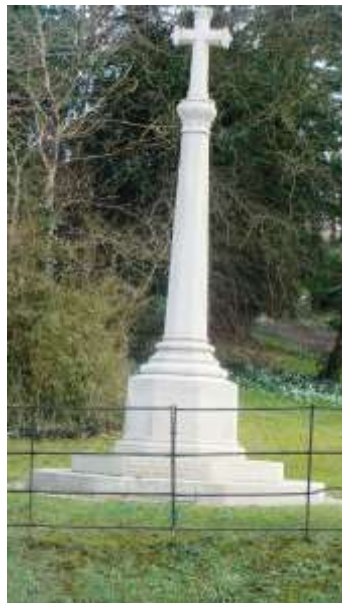
5.31. War Memorial. Stone tapered octagonal shaft surmounted by cross on stepped octagonal base commemorating those from Thundridge who gave their lives in both World wars.

Picture 20. War Memorial well maintained and in good condition.

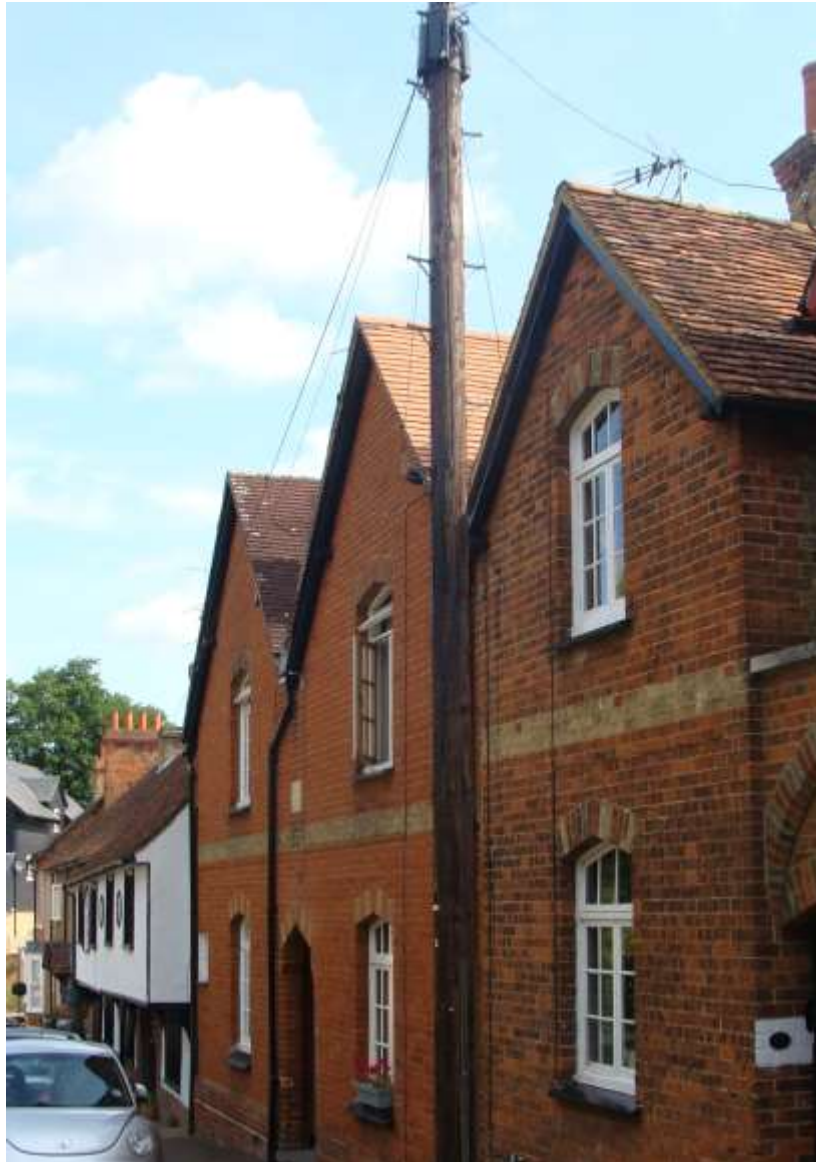
5.42. Utility poles. There are a number throughout the Conservation Area whose presence is perhaps most intrusive on Ermine Street detrimentally affecting the appearance of some important buildings. In the first instance it is suggested the appropriate utility company be approached with a view to seeking their long term co-operation in reducing the visual impact of some of this overhead infrastructure.

Picture 25. Utility poles detract from the high quality of the Conservation Area in this location on Ermine Street. The potential of resolving the situation could be explored with the utility company.

5.43. Opportunities to secure improvements. Discuss potential of improving area of open land to east of commercial premises north of Rennesley Farm. Repair curtilage wall at Rennesley Farm. Discuss potential of improving frontage to no. 8 Ermine Street. The Parish Council may wish to approach the utility company and explore the potential of reducing the visual impact of selected utility poles at Ermine Street.
